MUNICIPAL STRUCTURE INSPECTION FORM

BRIDGE

Structure Name Pautois Bridge
Structure Number B5
Date of Inspection August 9, 2024
Project No.
Consultant HP Engineering Inc.

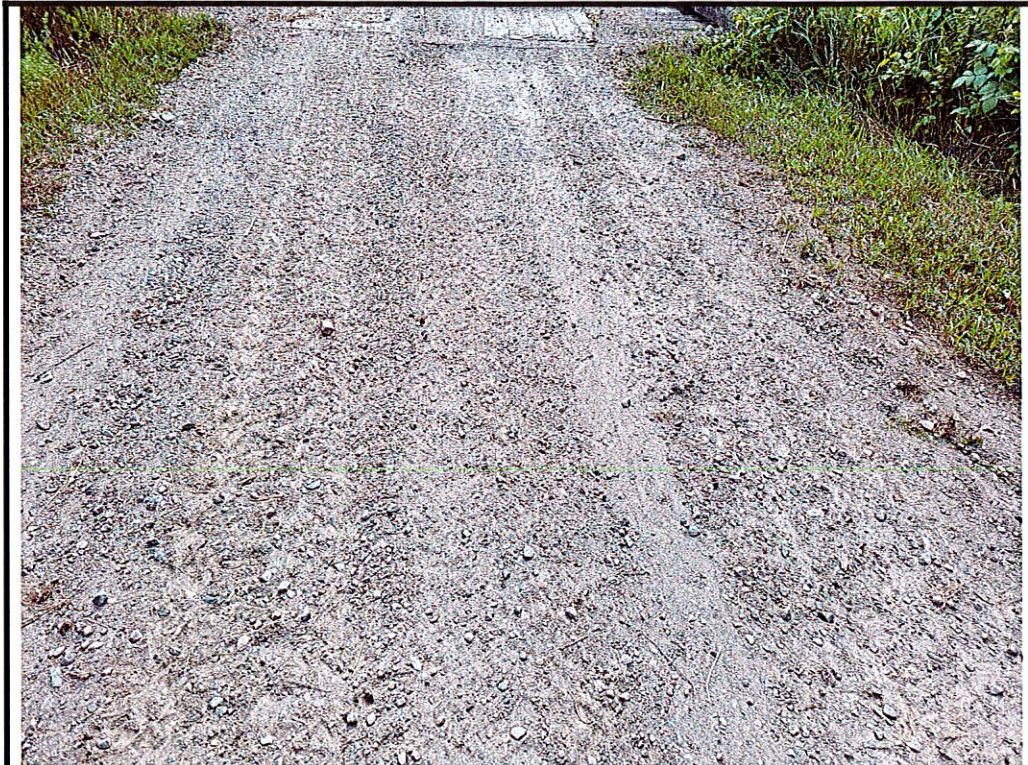
Photo 7 Loose gravel, tire rutting & potholes at ends of deck on approach wearing surface

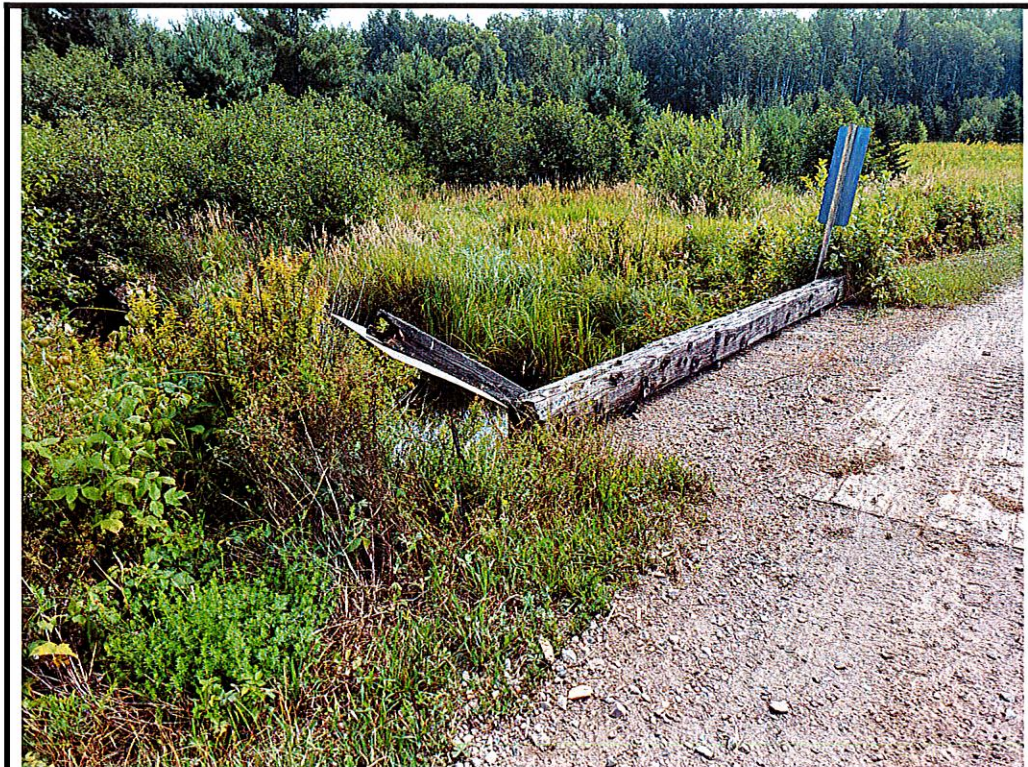
Photo 8 Hazard sign leaning away from roadway on NE corner of deck

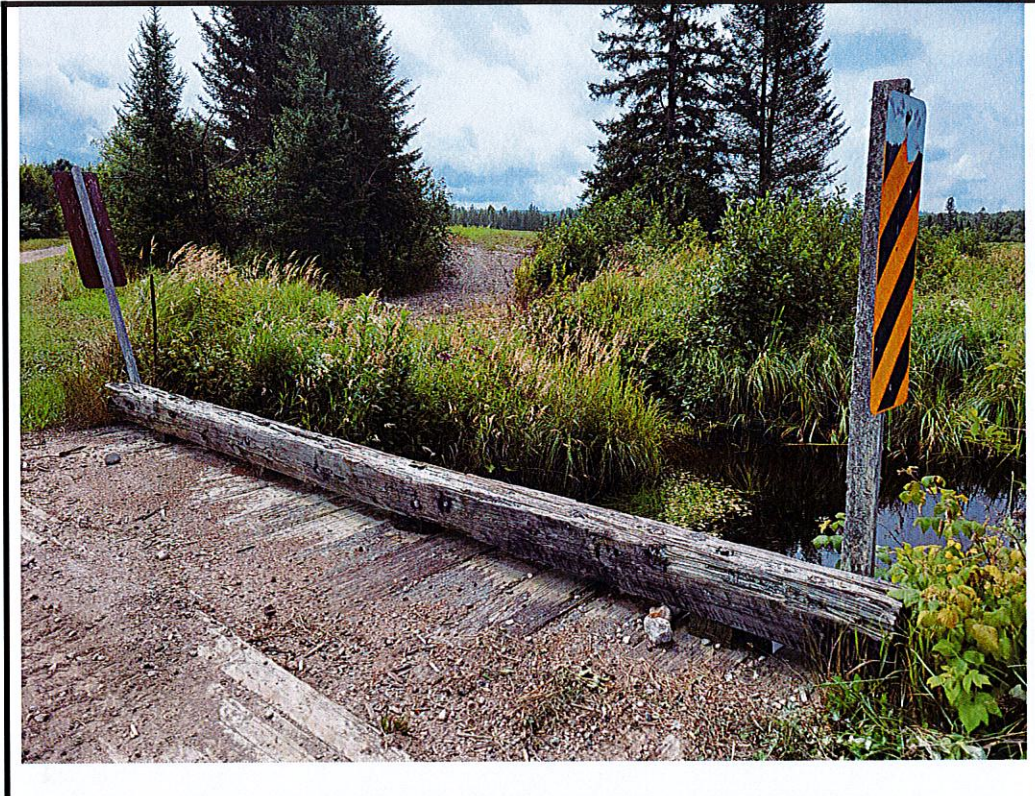
Photo 9 Rot, checks and splits on timber curb along west edge of deck

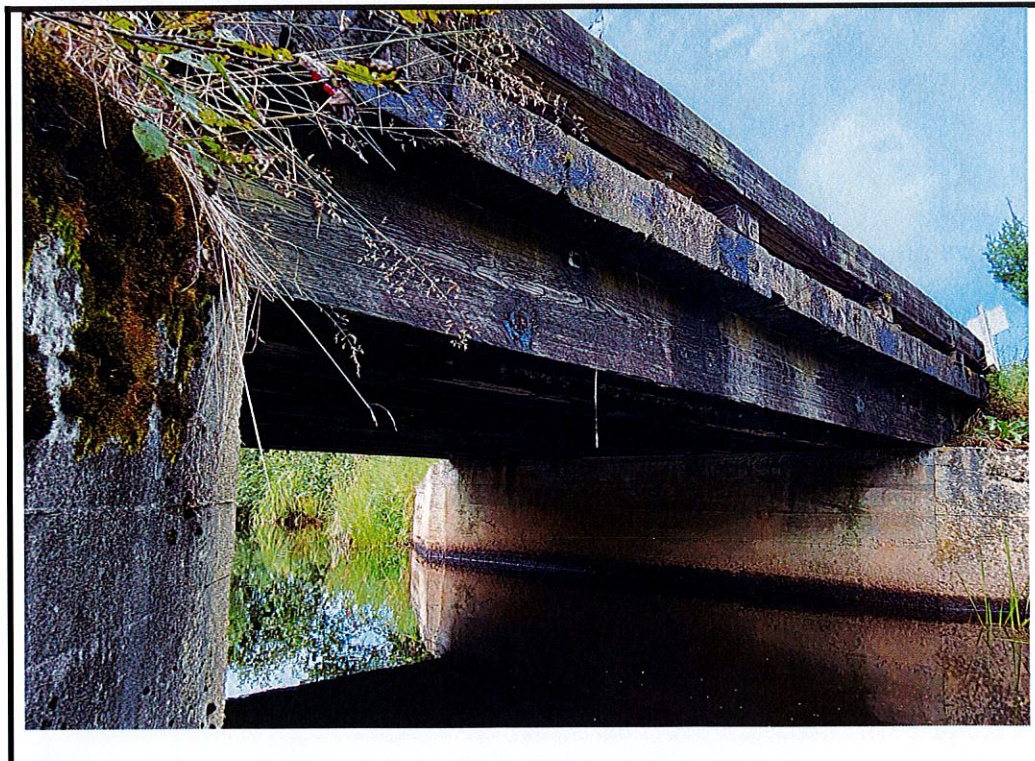
Photo 10 Weathering on timber girders

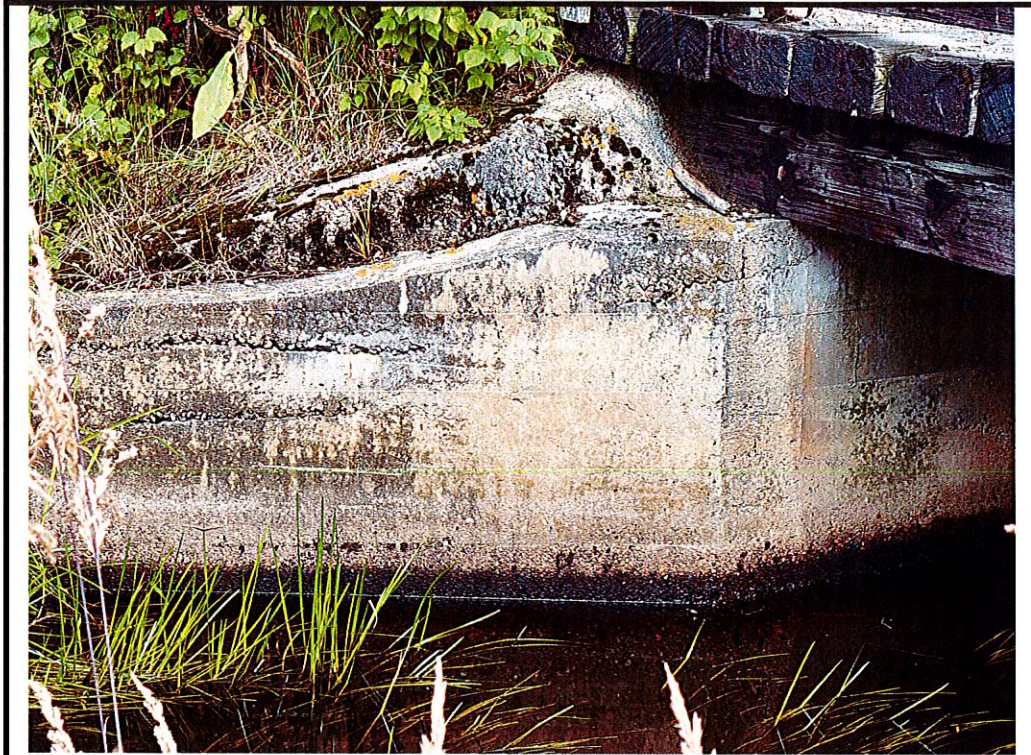
Photo 11 Moderate honeycombing and scaling noted on NW wingwall

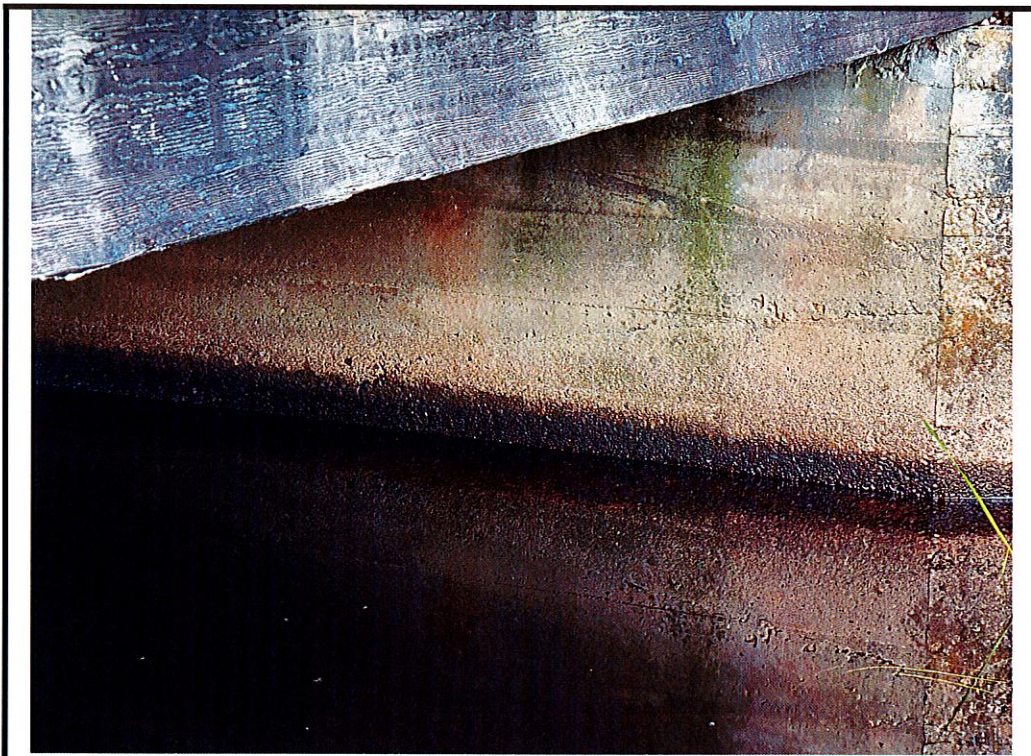
Photo 12 Moderate scaling on base of north abutment wall

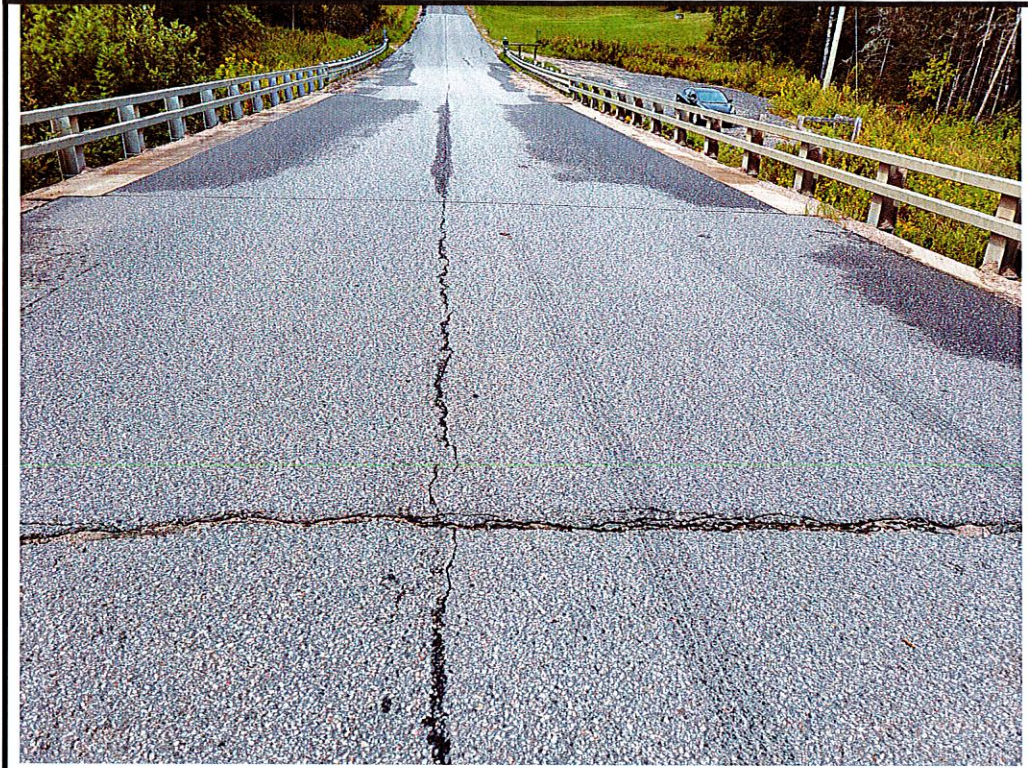
Photo 7 Wide transverse and longitudinal cracks on west approach wearing surface

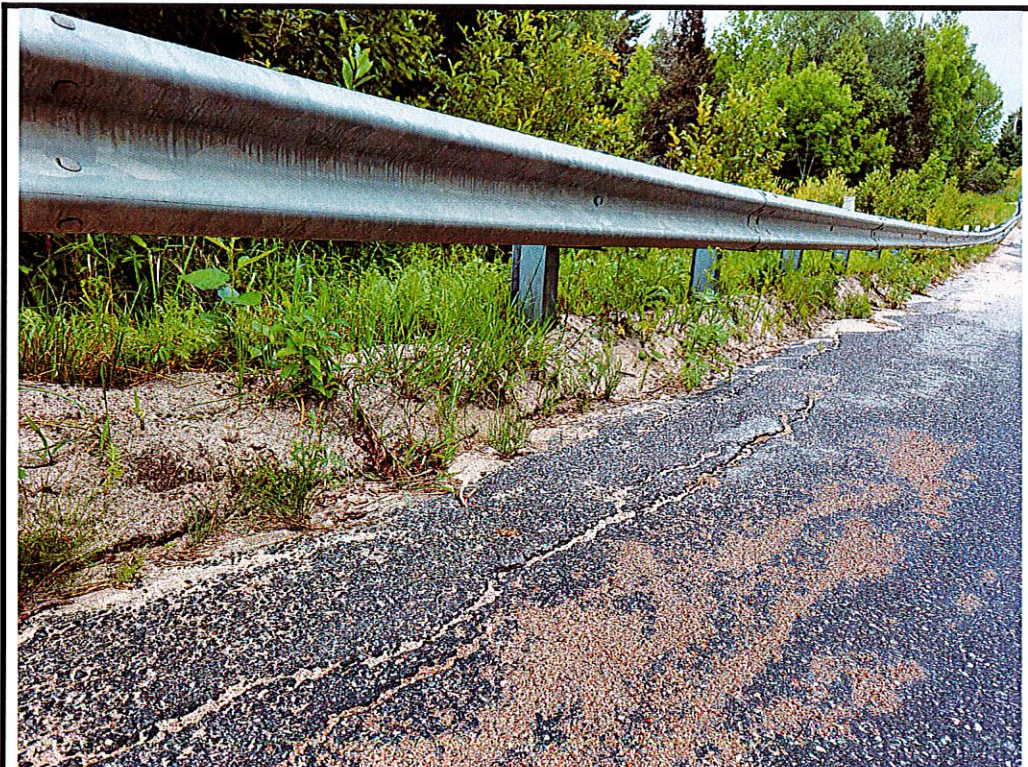
Photo 8 Accumulation of dirt and debris below approach guide rail

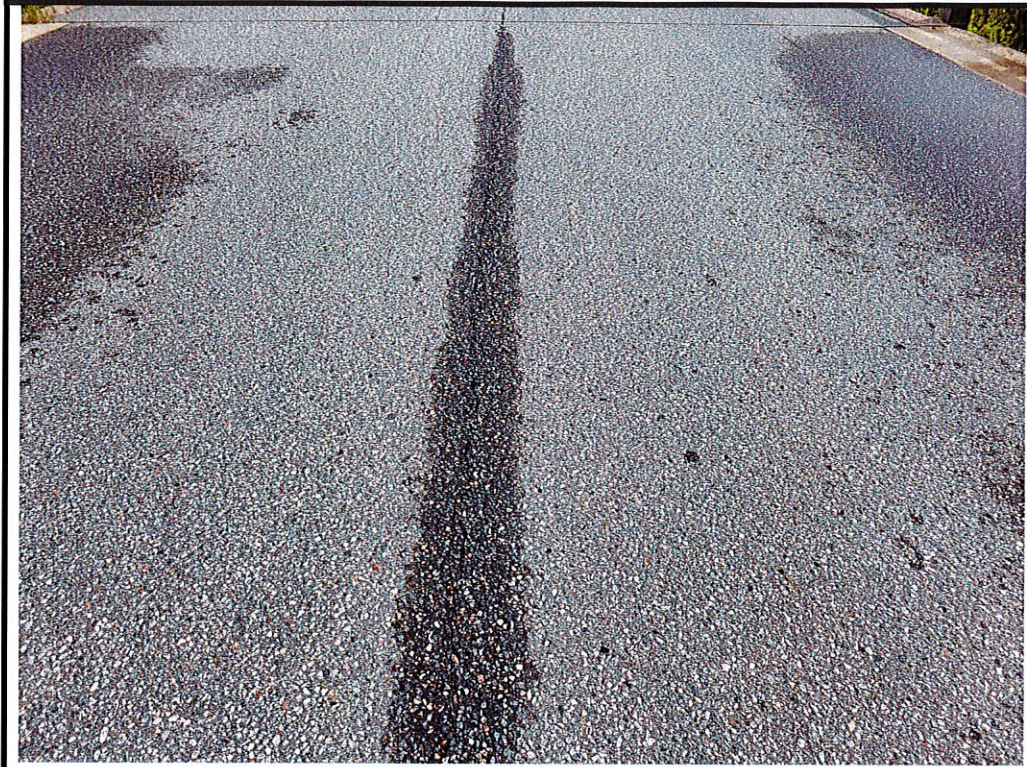
Photo 9 Wide longitudinal center-line crack on deck wearing surface

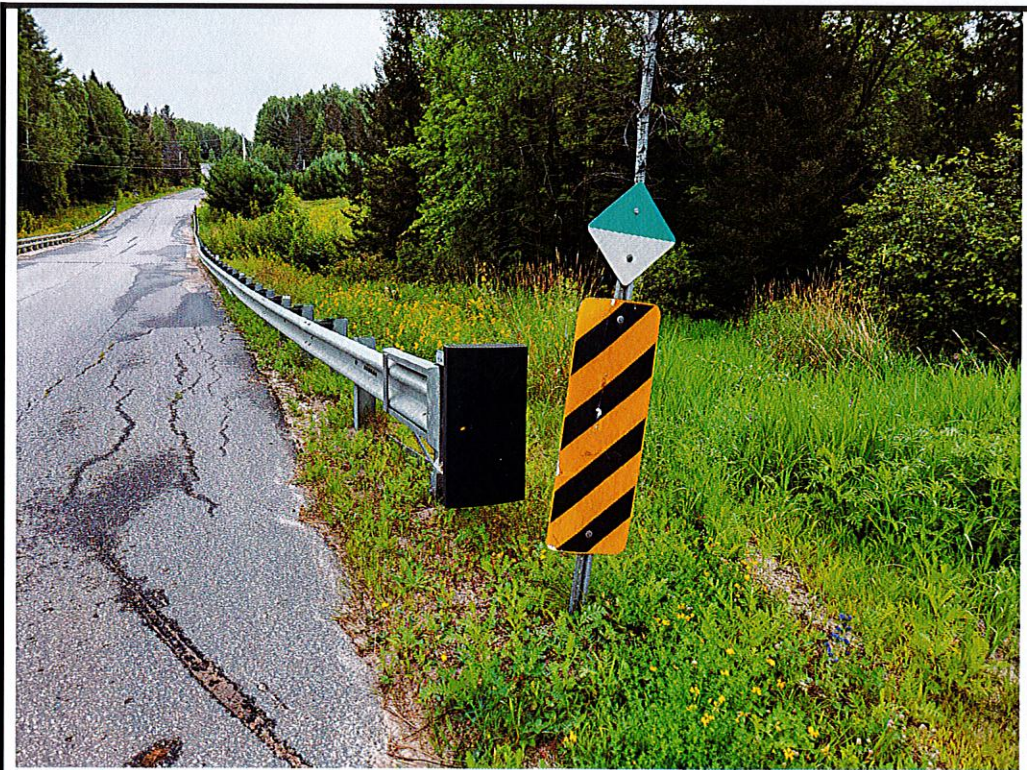
Photo 10 Hazard sign at SW approach is leaning and has minor dents and abrasions

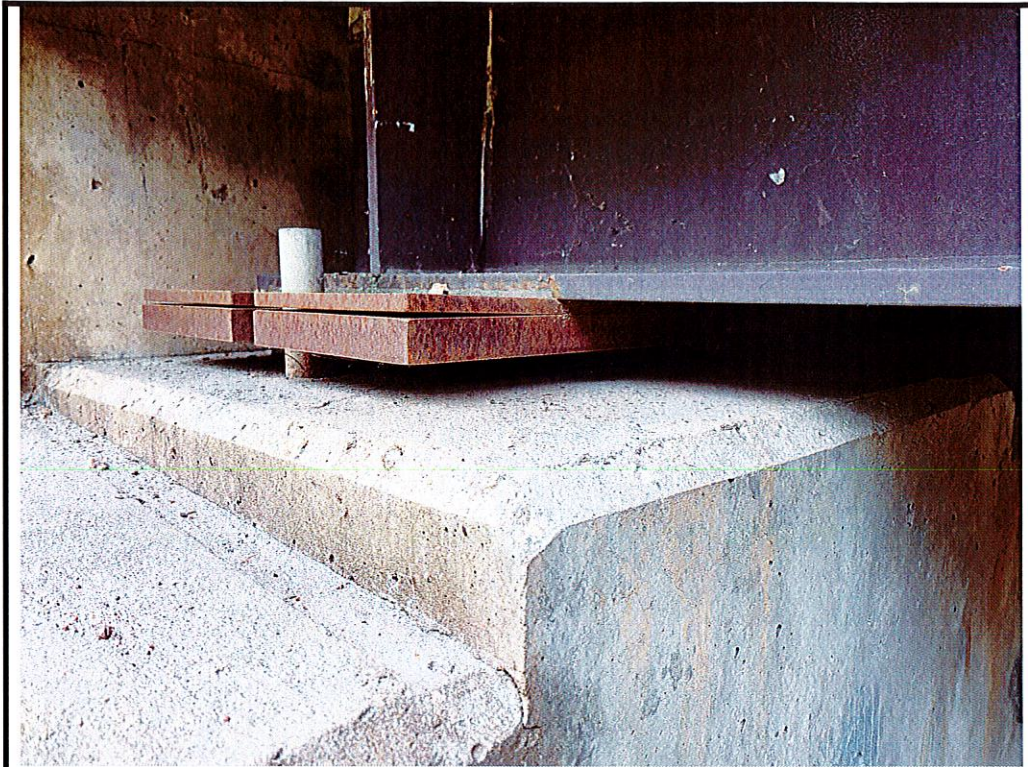
Photo 11 Minor deformation and light corrosion on steel bearing plate, NE bearing

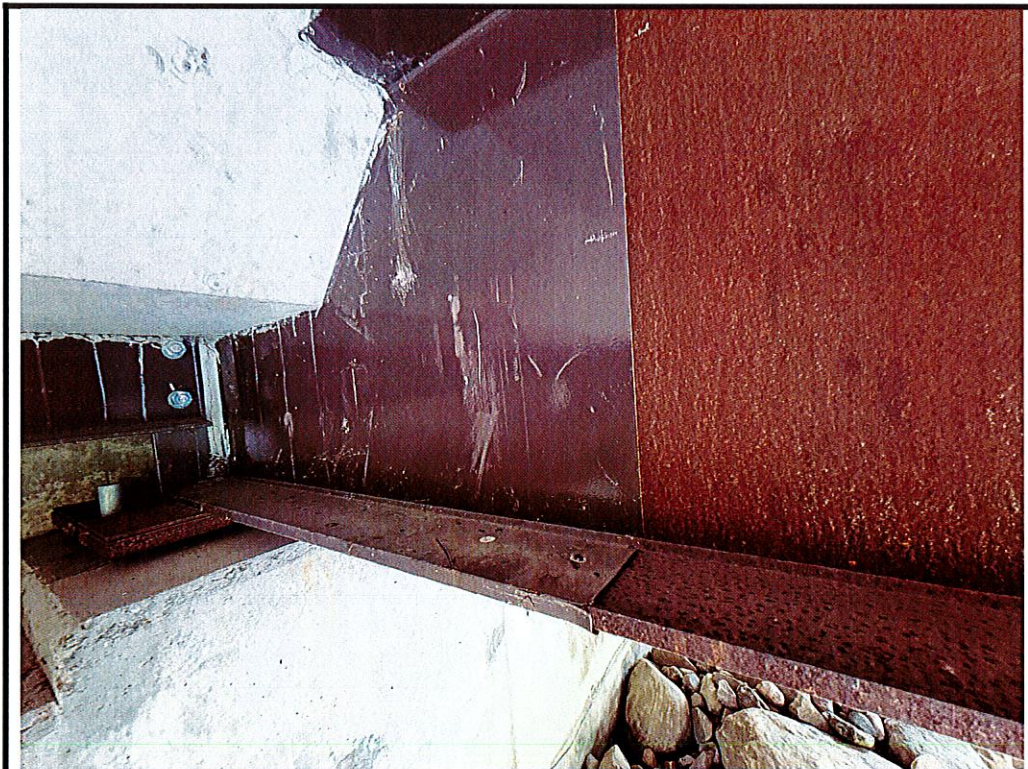
Photo 12 Localized coating failure (delamination) on girder ends

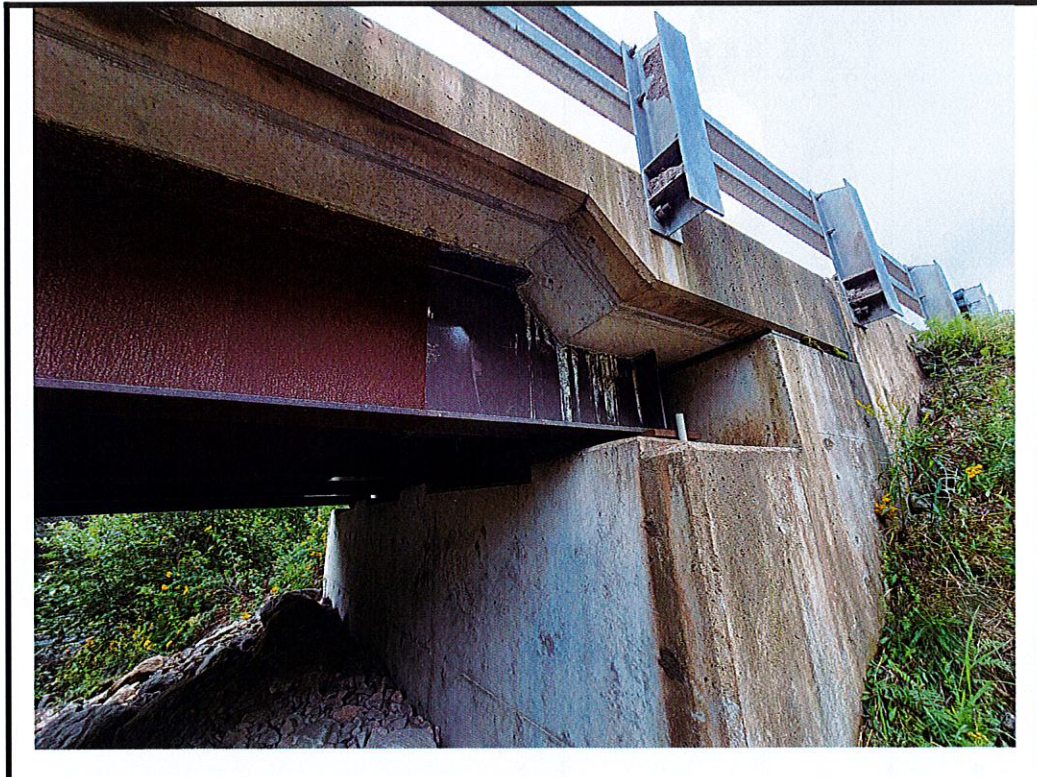
Photo 14 Damp staining on exterior soffit and wingwall SE corner of structure

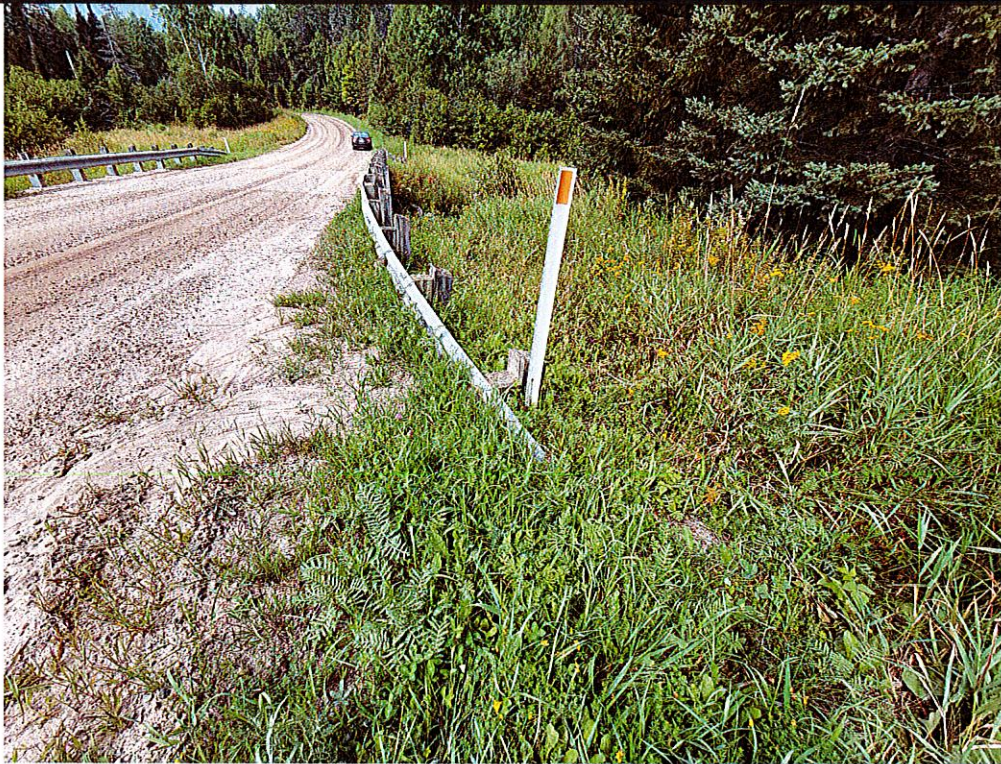
Photo 7 Substandard end treatment at south east approach barrier

REPAIR AND REHABILITATION REQUIRED		Priority			Estimated Cost
Element	Repair and Rehabilitation Required	6 - 10 Years	1 - 5 Years	< 1 year	
Approach Barrier	Install new approach guiderail and approved end treatments			X	\$ 48,000.00
					\$ -
					\$ -
					\$ -
					\$ -
					\$ -
					\$ -
					\$ -
					\$ -
Total Cost					\$ 48,000.00

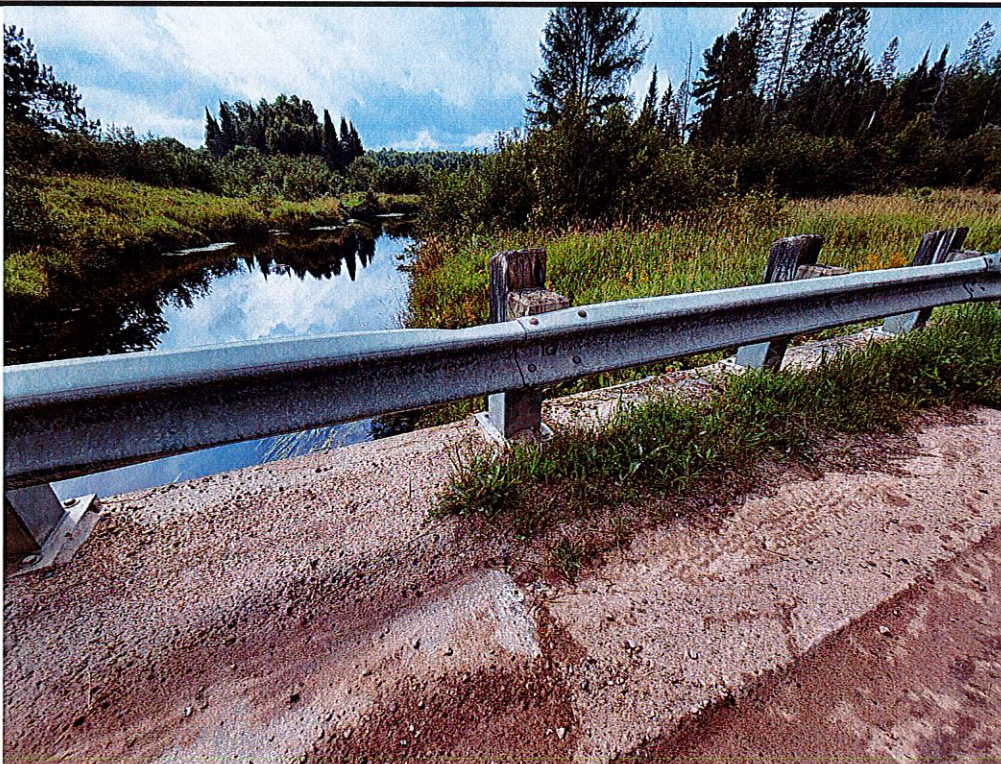
Photo 8 Deformed steel beam deck barrier on north edge of deck

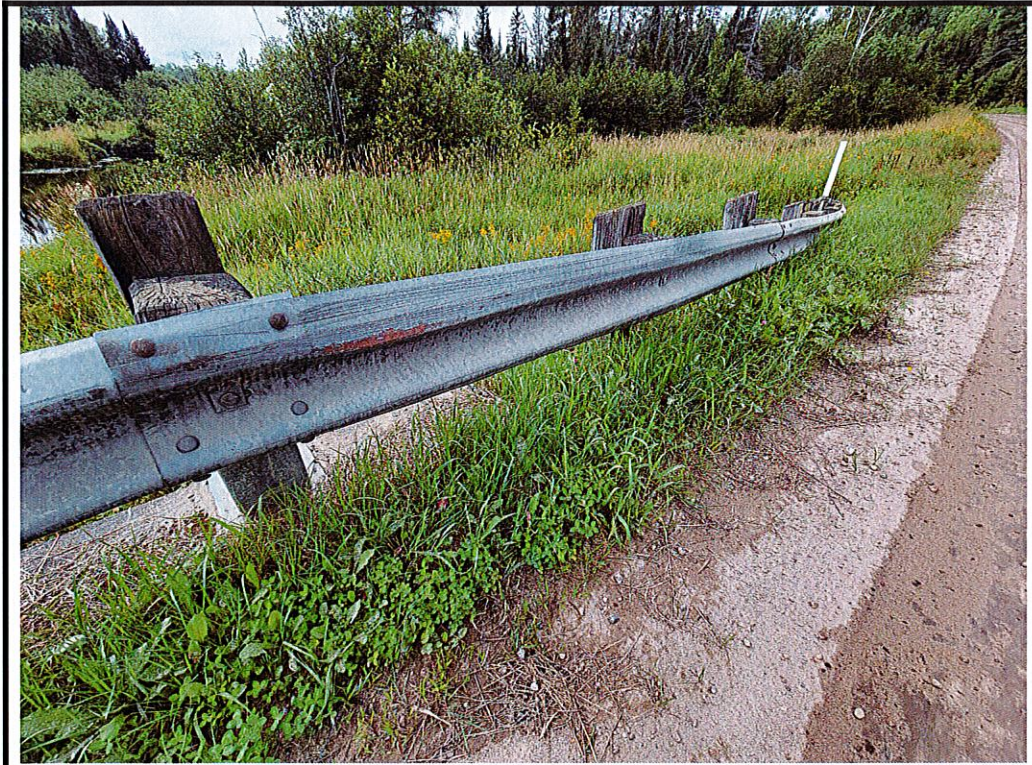
Photo 9 Dents, abrasions, and substandard end treatment on NW approach guide rail

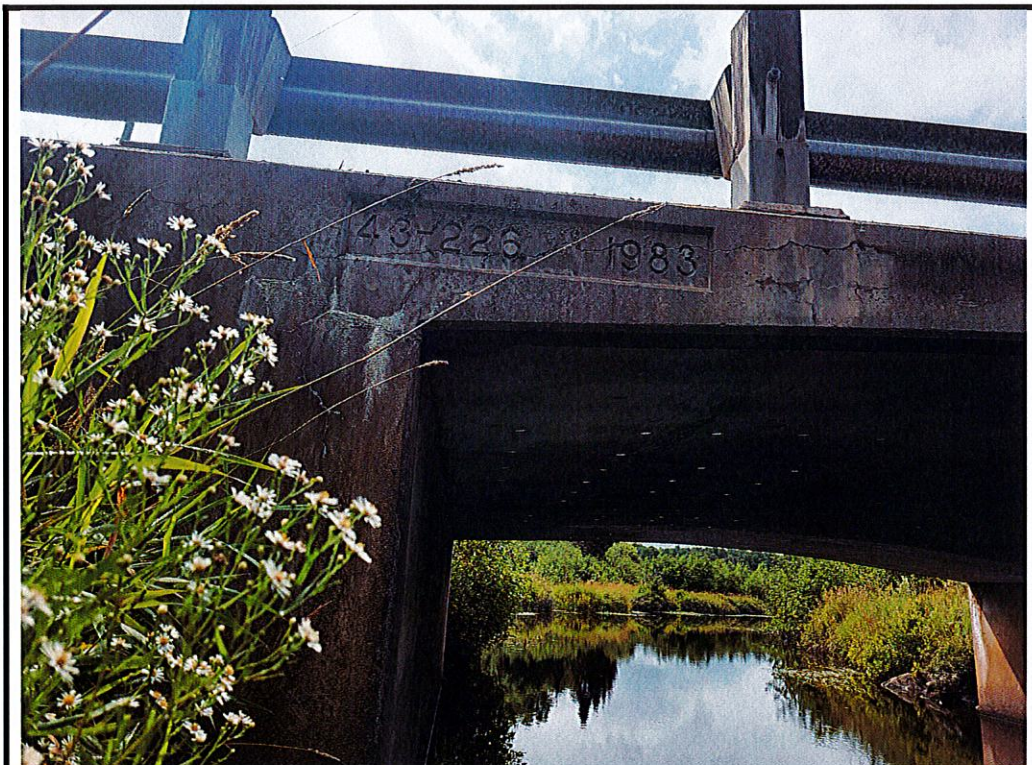
Photo 10 Wide horizontal cracks and isolated concrete delamination on north soffit exterior

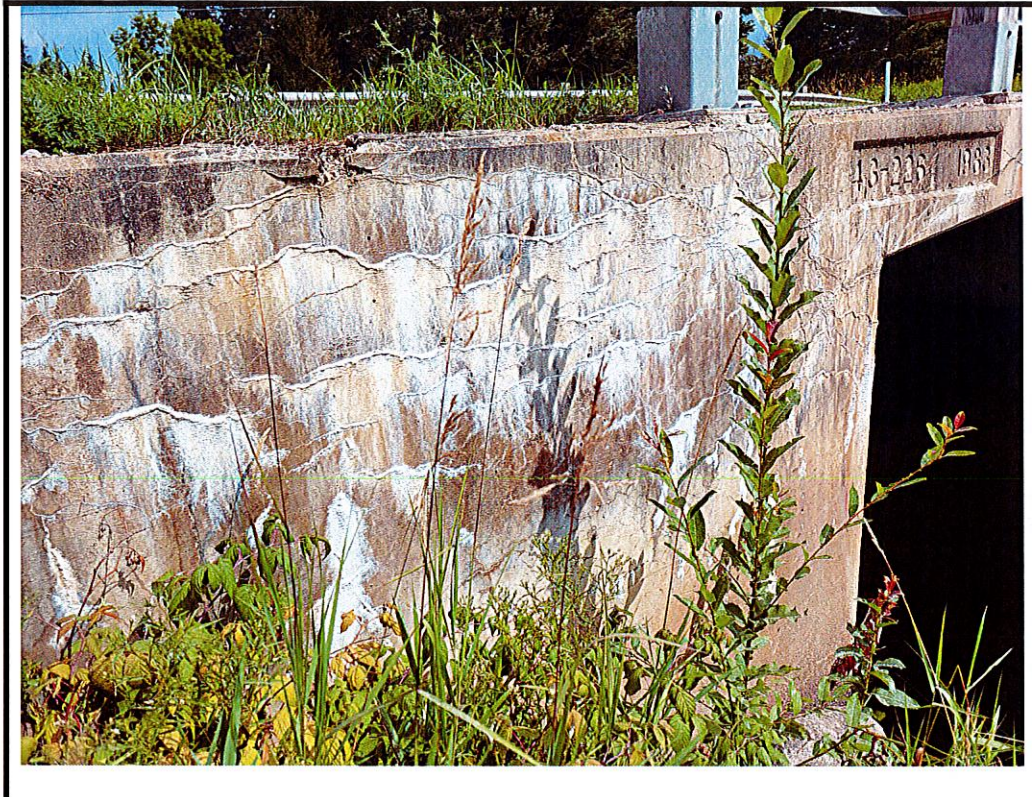
Photo 11 Horizontal and vertical cracks with efflorescence and small spall on SW wingwall

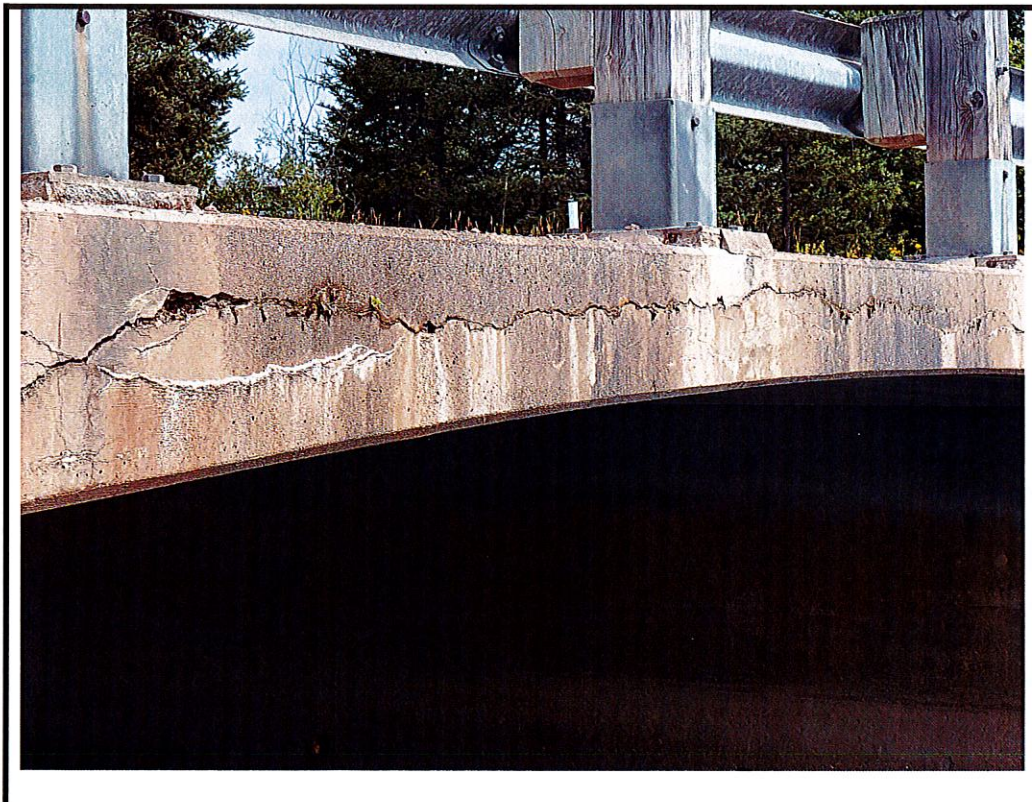
Photo 12 Wide horizontal cracks with efflorescence on south exterior soffit

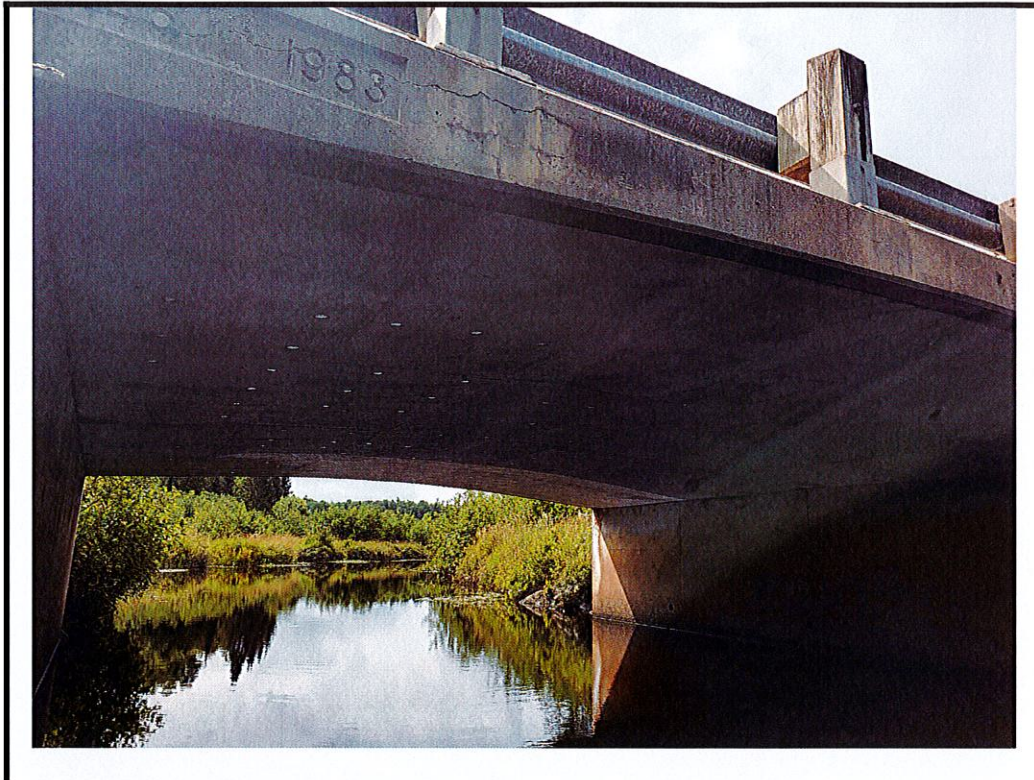
Photo 13 Light scaling on deck soffit

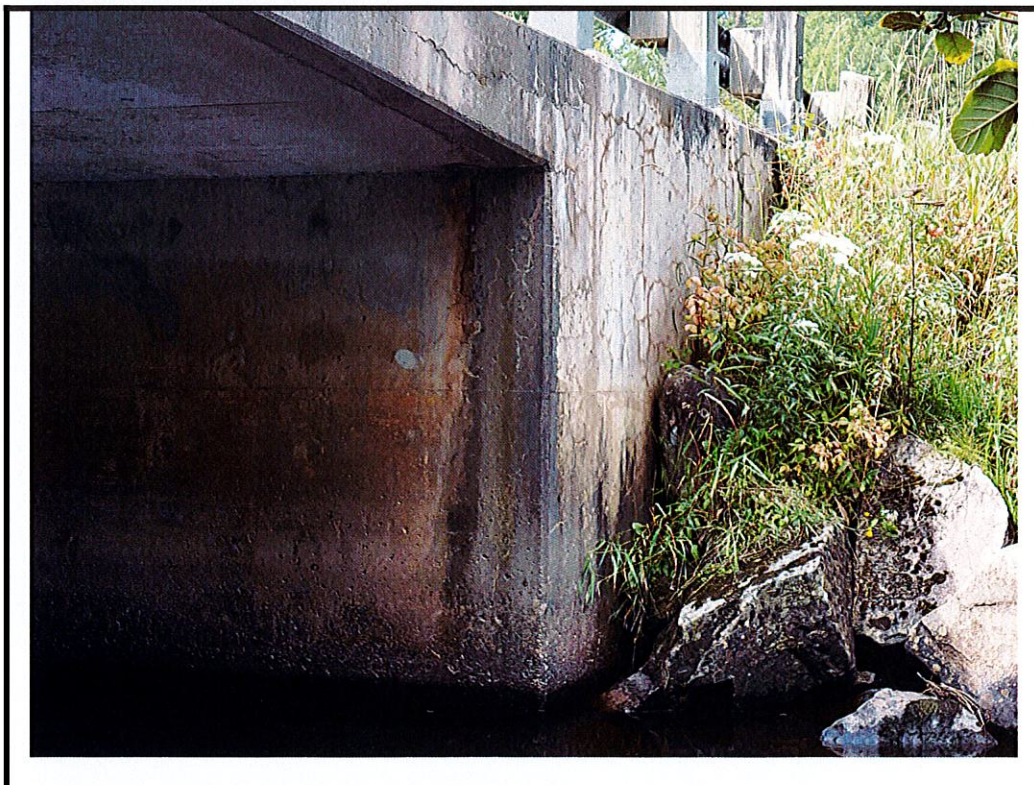
Photo 14 Narrow map cracks on SE wingwall
