Corporation of the Municipality of Calvin Council Resolution

Englobe – Asbestos Management Program, PSAB 3280 Compliance Framework Results

Subject: **Asbestos Management Program and PSAB Compliance Framework**
RFP No. CAL - ASB - 2025 - Asbestos Management Plan
Municipality of Calvin - 1355 Peddlers Drive. Mattawa, Ontario
Englobe Project No: 02512850.000

1 Introduction

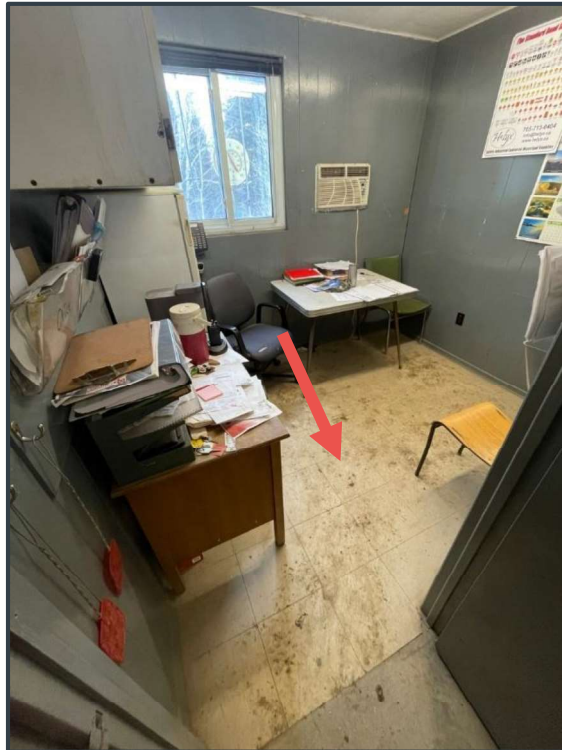
- Non-friable 12"x12" (30cm x 30cm) beige with red streaks vinyl floor tiles contain 2% Chrysotile asbestos (Englobe Sample ID: 02A-C). These tiles were observed in the following locations in the project area:
 - Approximately 5.5 m² observed in good condition within the office area.
 - Approximately 0.5 m² observed in fair condition below the table in office area.

Photograph 2: Asbestos-containing 12" x 12" (30cm x 30cm) beige with red streaks vinyl floor tiles in the Public Works Garage Office (Englobe Sample ID: 02A-C)

- The breaking, cutting, drilling, abrading, grinding, sanding, or vibrating of non-friable ACMs (i.e. Vinyl Floor Tiles) can be conducted using Type 1 asbestos precautionary measures, provided the material is wetted to control the spread of dust or fibers, and the work is done only by means of non-powered hand-held tools. If these conditions cannot be met, then more stringent (Type 2 or Type 3) work procedures are required.

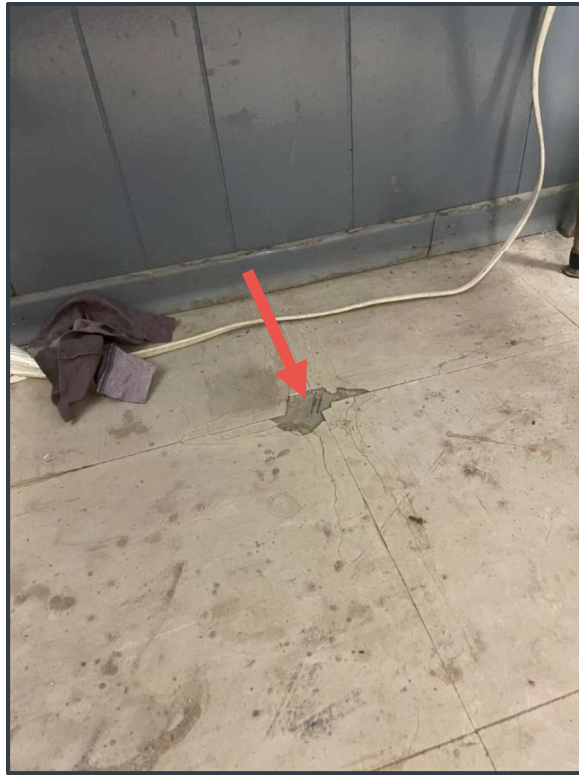
Photograph 3: Fair condition asbestos-containing 12" x 12" (30cm x 30cm) beige with red streaks vinyl floor tiles in the Public Works Garage Office (Englobe Sample ID: 02A-C)

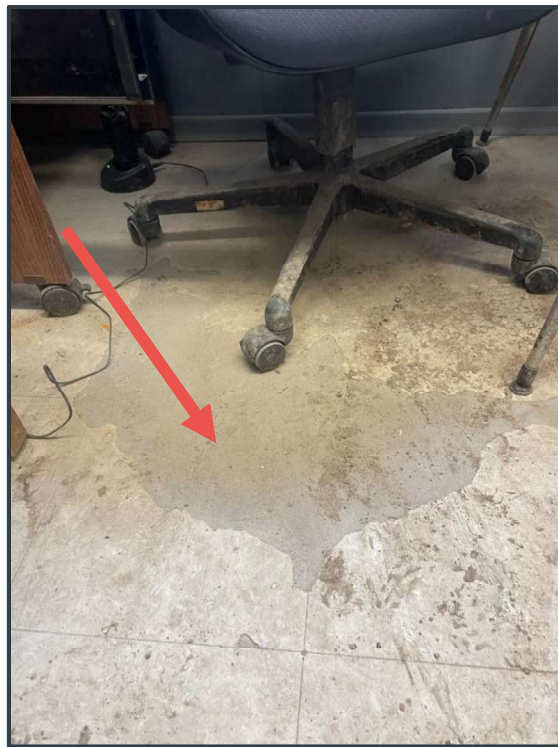
Photograph 4: Fair Condition asbestos-containing 12" x 12" (30cm x 30cm) beige with red streaks vinyl floor tiles in the Public Works Garage Office (Englobe Sample ID: 02A-C).

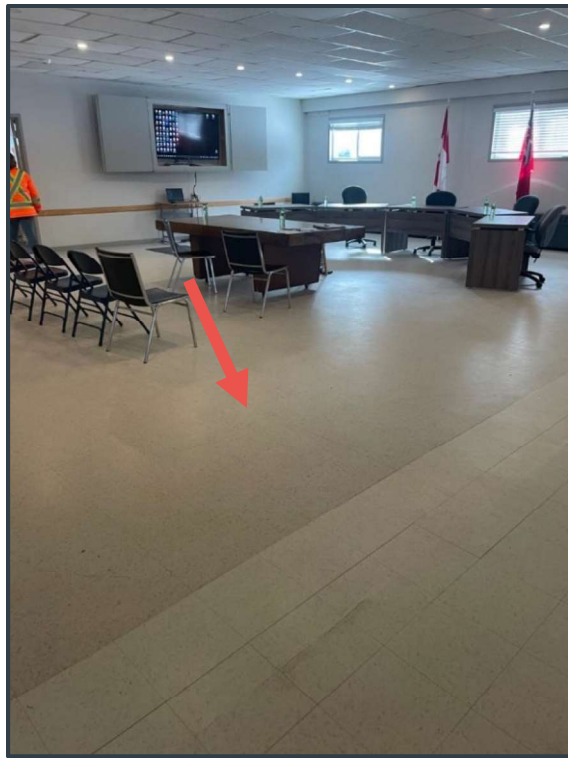
- Non-friable 12"x12" (30cm x 30cm) beige with black specs vinyl floor tiles contain 2% Chrysotile asbestos (Englobe Sample ID: 09A-C). These tiles were observed in the following locations:

- Approximately 100 m² observed in good condition located in the existing Hall.
 - Approximately 6 m² observed in good condition located in the Men's Washroom.

Photograph 5: Asbestos-containing 12" x 12" (30cm x 30cm) beige with black specs vinyl floor tiles in the Municipal Complex Existing Hall (Englobe Sample ID: 09A-C)

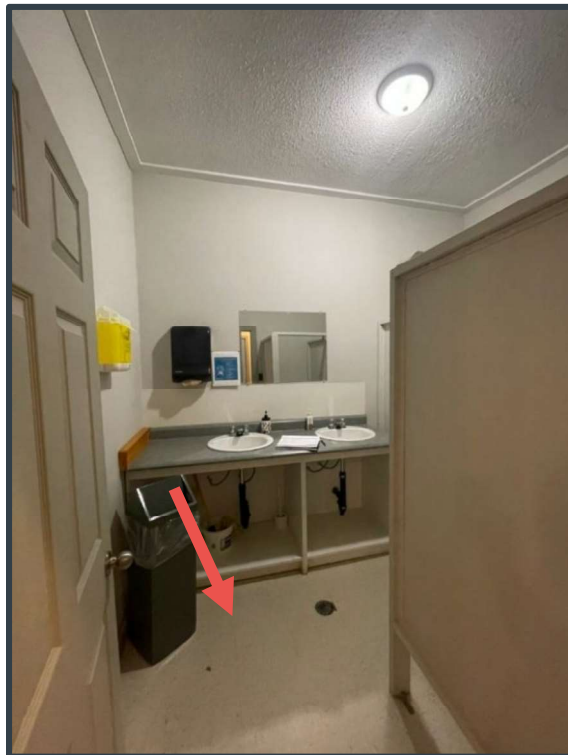
Photograph 6: Asbestos-containing 12" x 12" (30cm x 30cm) beige with black specs vinyl floor tiles in the Municipal Complex Men's Washroom (Englobe Sample ID: 09A-C)

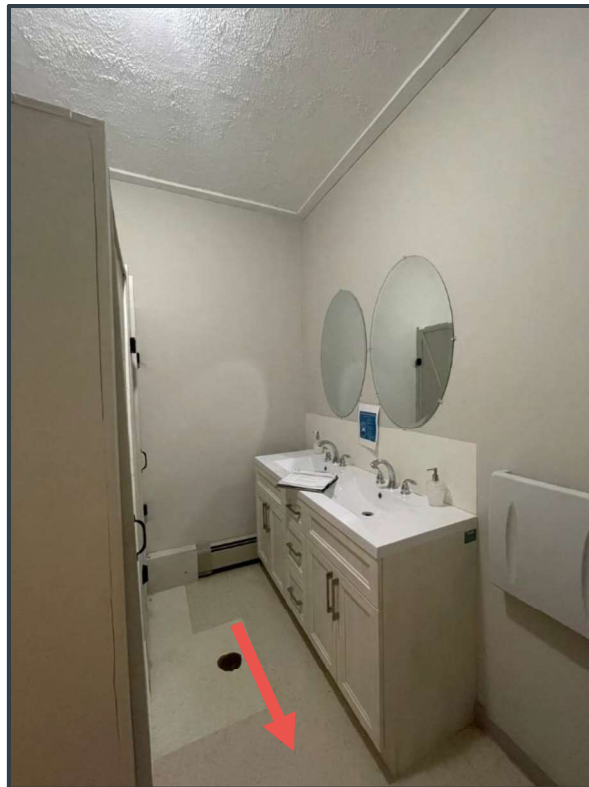
- Approximately 6 m² observed in good condition located in the Women's Washroom.
 - Approximately 7 m² assumed to be concealed under vinyl plank flooring in the Janitors Room.

Photograph 7: Asbestos-containing 12" x 12" (30cm x 30cm) beige with black specs vinyl floor tiles in the Municipal Complex Women's Washroom (Englobe Sample ID: 09A-C)

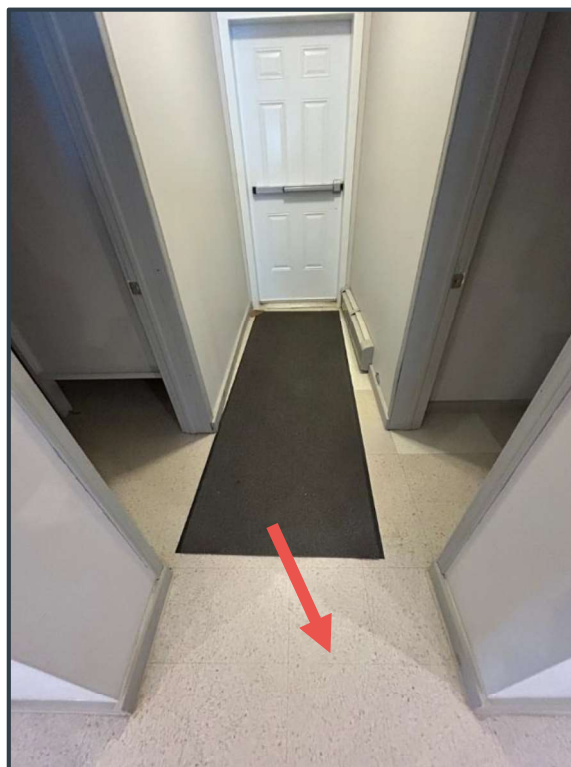
- Approximately 4 m² observed in good condition located in hallway.
 - Approximately 10 m² assumed to be concealed under carpet in the New Office.
 - Approximately 9.5 m² assumed to be concealed under carpet in the Existing Office 1.

Photograph 8: Asbestos-containing 12" x 12" (30cm x 30cm) beige with black specs vinyl floor tiles in the Municipal Complex Hallway (Englobe Sample ID: 09A-C)
