Municipality of Calvin

1355 & 1238 Peddlers Drive Facility and Building Condition Assessment – Final

1355 & 1238 Peddlers Drive
Mattawa, Ontario

April 13, 2026
RJC No. KIN.143609.0001

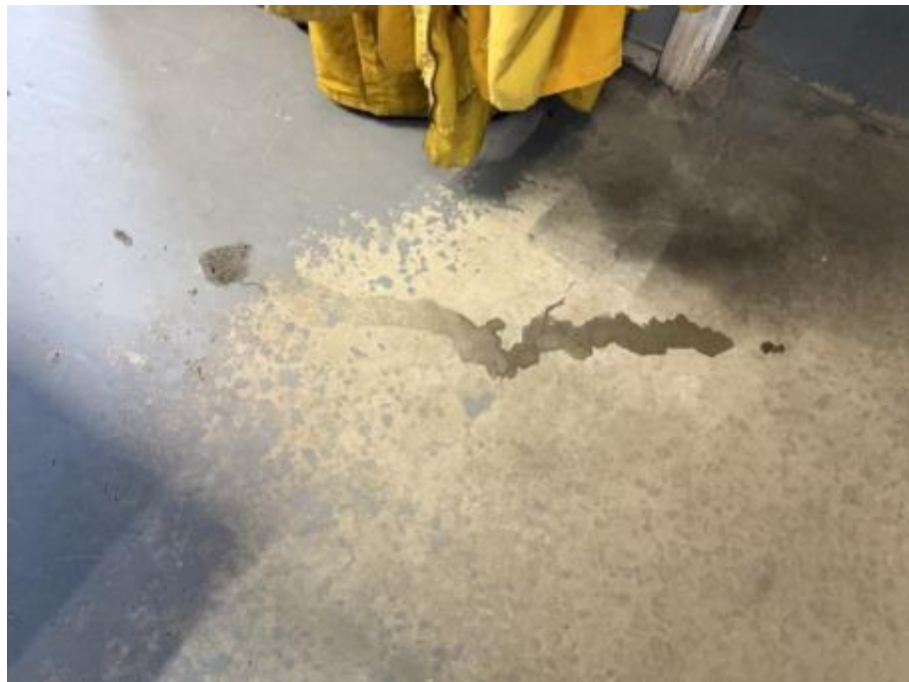
Based on our visual review, the slab-on-grade and foundation systems appear to be in fair condition, suffering from localized signs of deterioration in the form of slight slab-on-grade cracking within the fire hall, and localized spalling/impact damage at the slab edge at the overhead vehicle doors. (Refer to Photographs 2-3, in Appendix A).

Photo 2: Fire Hall – Slab-on-Grade Cracking

While slab-on-grade shrinkage cracking is generally not a structural concern, and the slab is expected to perform beyond the timeframe of this assessment, it is recommended that the municipality budget to complete slab-on-grade localized crack repairs, and resurfacing in the long-term (11-20 years), in order to maintain a state of good repair, and avoid potential risk to safety in the form of trip hazards and vehicle damage if the deterioration increases.

Our opinion of probable present cost at a class D level (+/-25%) to complete the localized slab-on-grade repairs in the long-term (11-20 Years), in Q1 2026 dollars is **\$25,000.00 + H.S.T.**

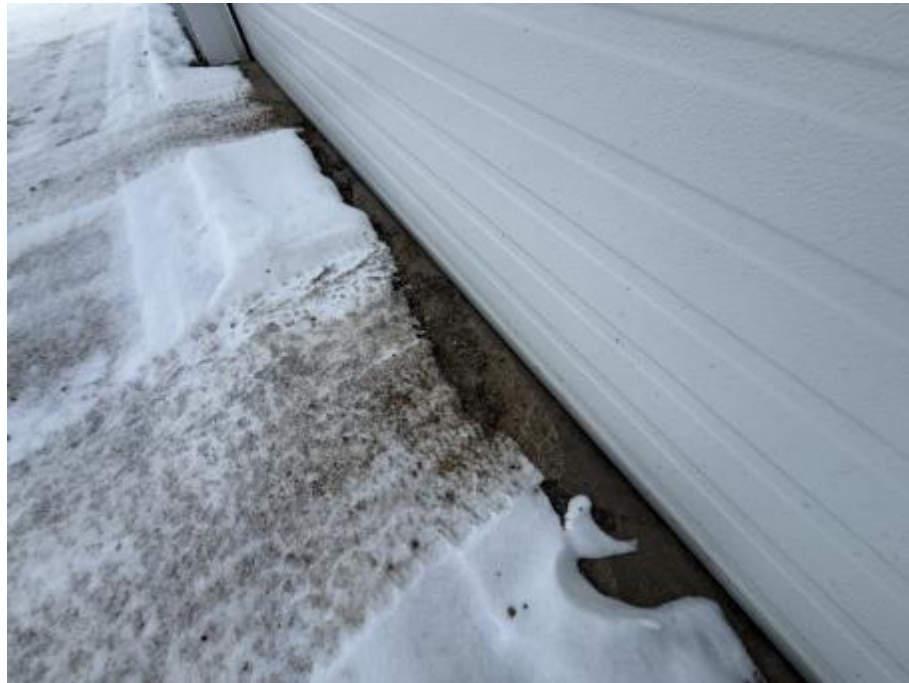
Photo 3: Fire Hall – Slab Spall at Overhead Door

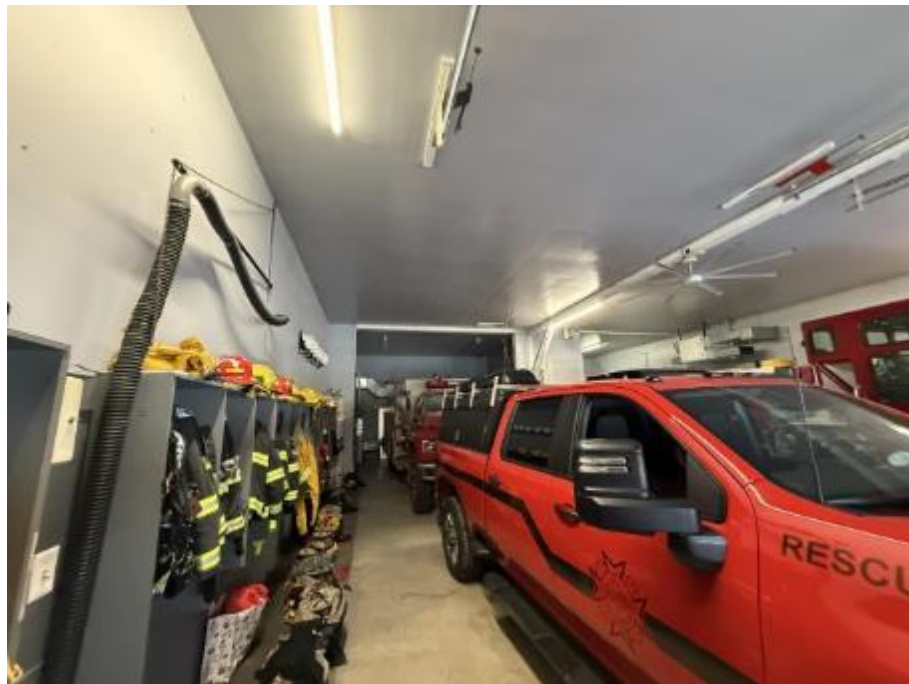
At the time of our review, the interior of the structure was fully enclosed with gypsum board interior finishes, preventing a visual review of the present condition of the underlying wood structure. No significant signs of undesirable displacement or cracking was observed in the finishes at the time of our review, which can be indicative of structural deterioration. (*Refer to Photograph 4, in Appendix A*).

Photo 4: Fire Hall – Overview of Interior Finishes and Existing Vehicle Exhaust Tube

If well constructed and waterproofing is maintained, the structural framing can be expected to last the lifespan of the structure without significant capital repairs. The municipality is recommended to have periodic reviews conducted over the lifespan of the structure, to monitor its continued performance.

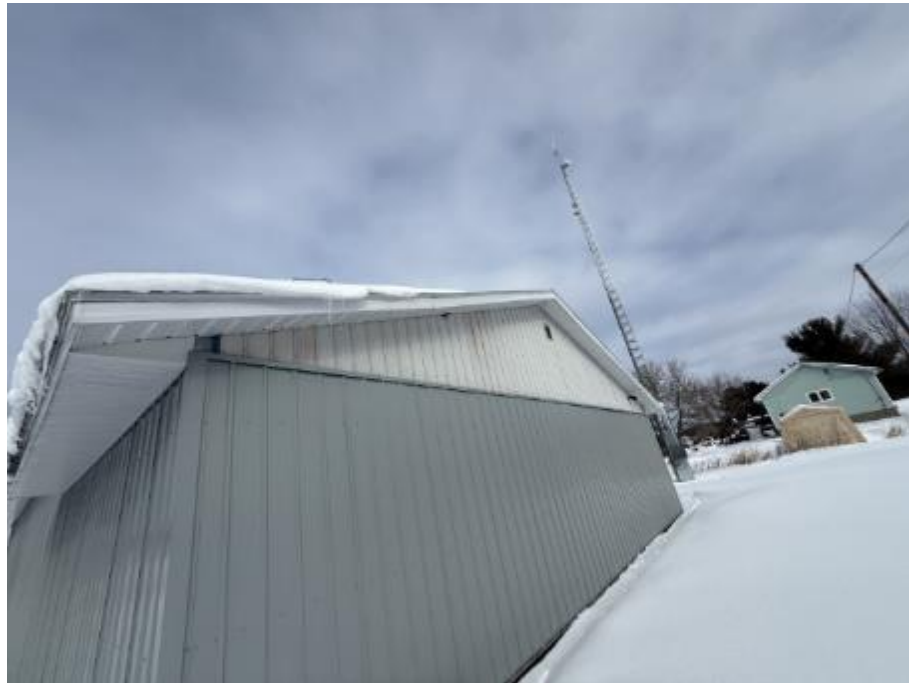
The grey painted metal siding which is installed at/around the ground floor area appears to be in good-fair condition and is assumed to be what was repaired/replaced most recently in 2018.

The white painted siding which is installed within the upper gable roof area appears to be in fair condition showing signs of moisture related deterioration in the form of staining and mild corrosion.

Photo 5: Fire Hall – Overview of Two Vintages of Siding

The upper-level siding which was not replaced in 2018 is anticipated to require replacement in the intermediate-term (6-10 years)

Our opinion of probable present cost at a class D level (+/-25%) to complete replacement of the upper gable cladding, in Q1 2026 dollars is **\$25,000.00 + H.S.T.**

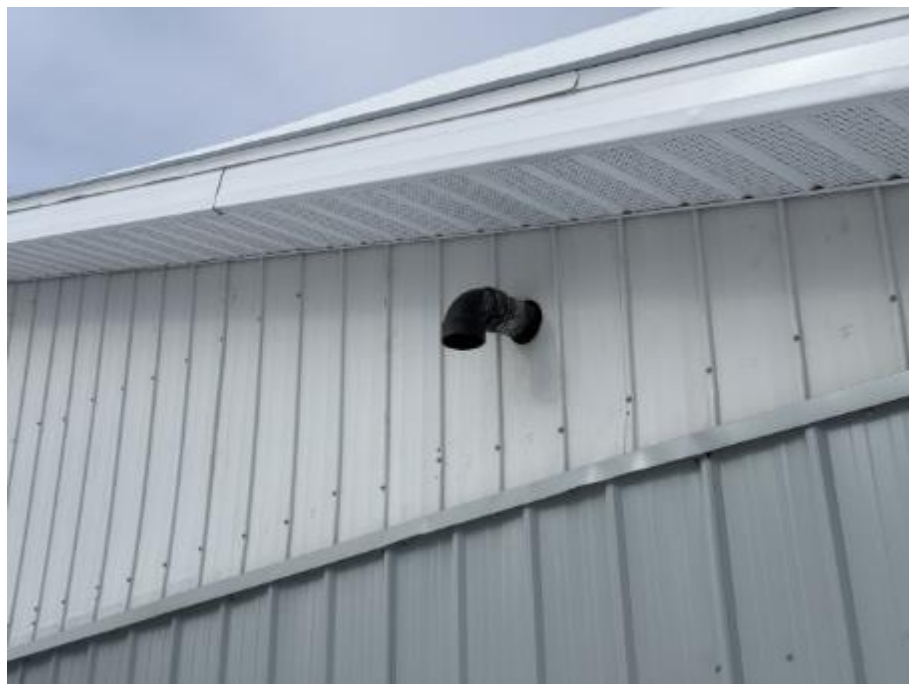
Within both vintages and types of siding, there appear to be localized penetrations in the system, typically for mechanical and electrical services, which are unsealed or poorly sealed, leaving potential avenues for moisture and pest infiltration into the wall assembly.

Photo 6: Fire Hall – Typical Penetration

The municipality is recommended to complete a wholesale building envelope sealant repair program at all penetrations, windows and door rough openings in the immediate term (0-2 years) to prevent moisture and pest infiltration and maintain overall building thermal energy performance.

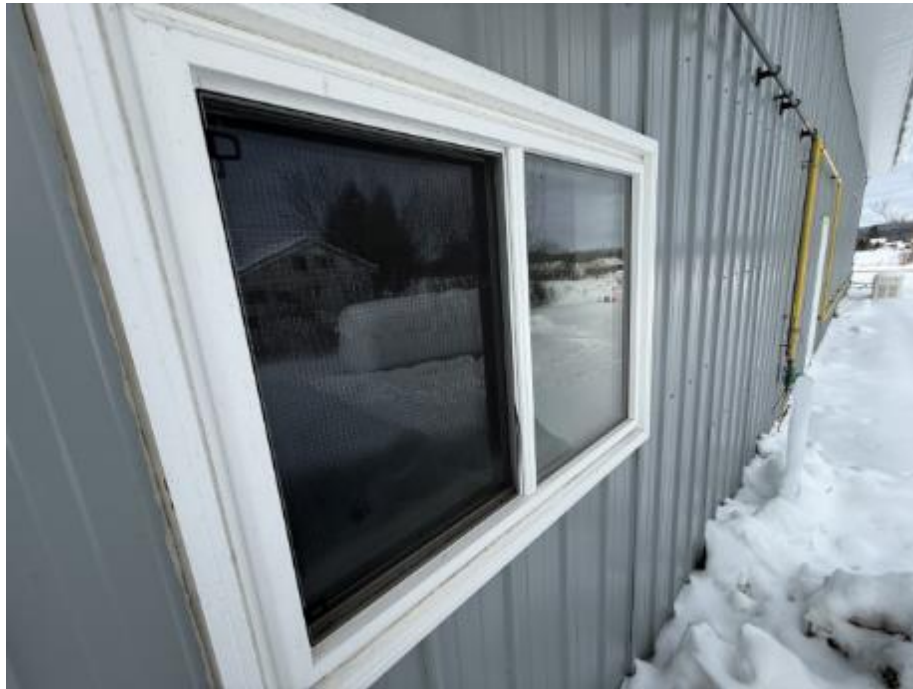
The windows appear to be in good condition, however the sealant around the windows appears to be in fair condition, suffering from deterioration in the form of gaps, and cracking.

Photo 7: Fire Hall – Typical Windows and Sealants

The municipality is recommended to plan for the replacement of the windows at the end of their service life in the long-term (11-20 years).

Our opinion of probable present cost at a class D level (+/-25%) to complete a wholesale window replacement, in Q1 2026 dollars is **\$7,500.00 + H.S.T.**

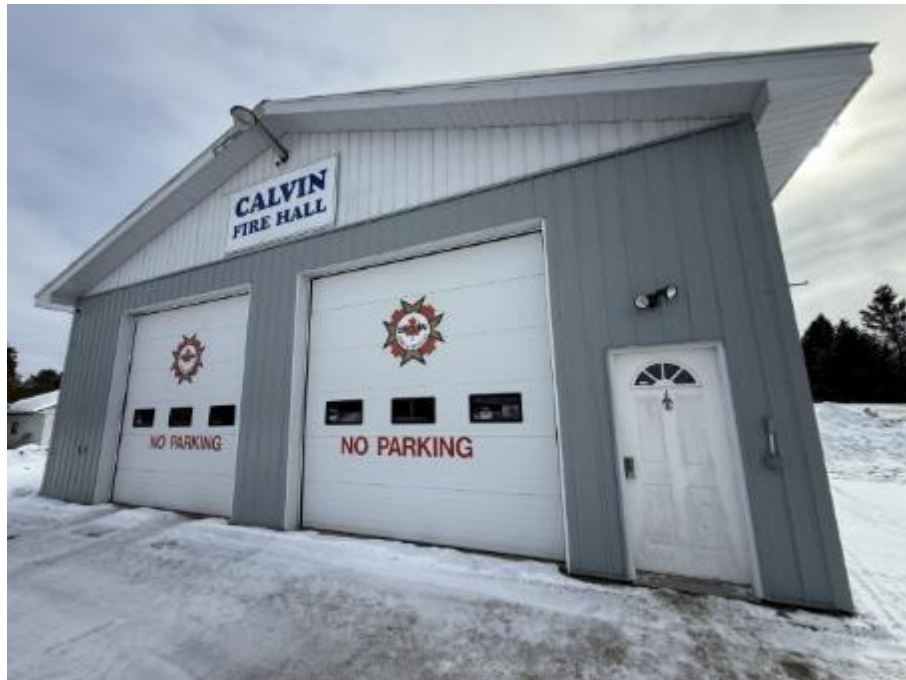
The two exterior insulated panel doors, appear to be in fair present condition, with minor signs of wear-related damage to the trim, kick plates etc. It is unknown when these doors were installed, however they are assumed to be replacement doors since original construction in 1976. The municipality is recommended to plan for the replacement of these doors at the end of their service life in the intermediate term (6-10 years).

The two overhead doors appear to be in good present condition, and the municipality is recommended to plan for replacement at the end of their service life in the long-term (11-20 years).

Photo 8: Fire Hall – Typical Garage and Man Doors

Our opinion of probable present cost at a class D level (+/-25%) to complete wholesale exterior man-door replacements, in Q1 2026 dollars is **\$7,500.00 + H.S.T.**

Our opinion of probable present cost at a class D level (+/-25%) to complete wholesale overhead-door replacements, in Q1 2026 dollars is **\$25,000.00 + H.S.T.**

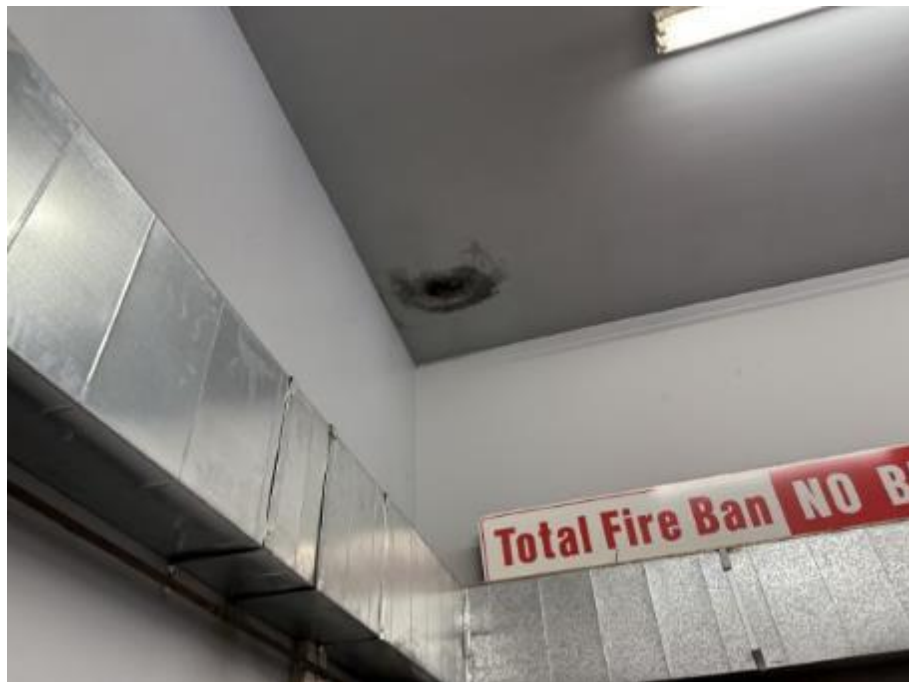
- In one location there was localized moisture staining on the gypsum board ceiling, which can indicate either a localized roof leak, or plumbing leak. It is currently unknown if the leak is active or if source of this stain has since been repaired.
- One location of metal flashing on the roof edge fascia appears to have failed, leading a portion of the edge wood fascia exposed to the elements.
- Moderate icicle and snow buildup was noted at the edges of the roof, which can be indicative of excess heat and energy loss through the roof.

Photo 10: Fire Hall – Stain in Ceiling

As part of general low-cost maintenance, we recommend that the municipality complete localized repairs on the potential leak and damaged flashing to protect the roof structure from moisture ingress. The cost for this work is below the threshold of this report.

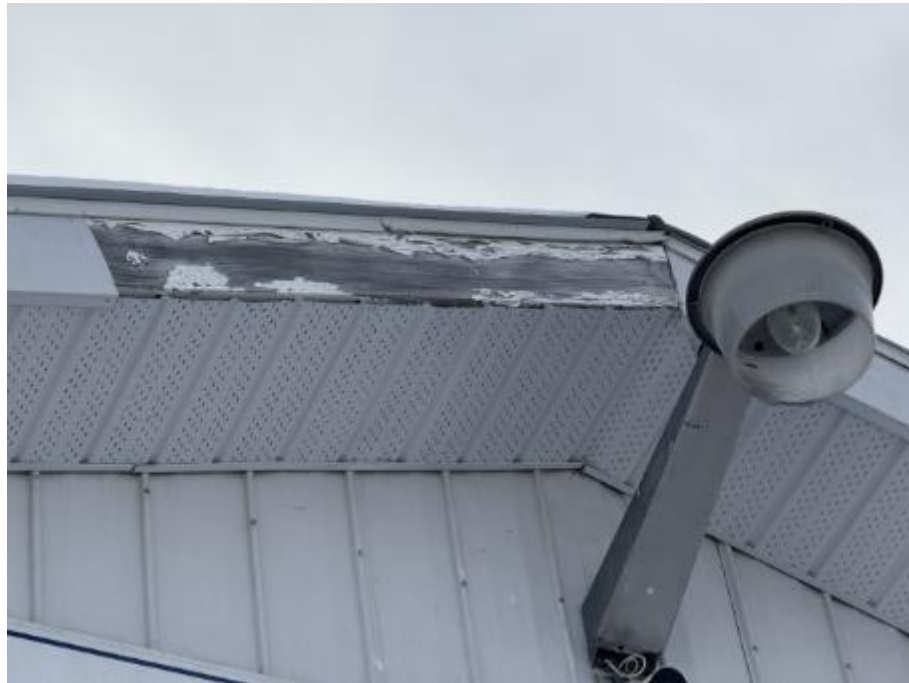
Replacement of the exterior sodium HID floodlighting with LED lighting would reduce energy consumption of the exterior lighting by between 40-75% as well as provide reduced maintenance costs for less-frequent replacement.

Photo 11: Fire Hall – Unprotected Fascia and existing HID Lighting

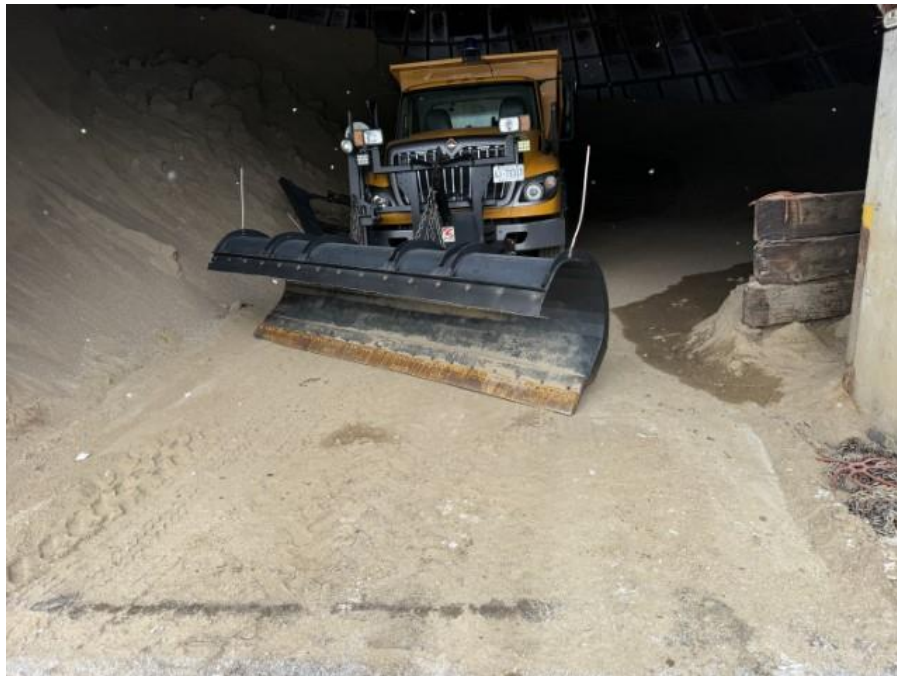
Photo 2: Sand Dome – Overview of Slab-on-Grade Condition

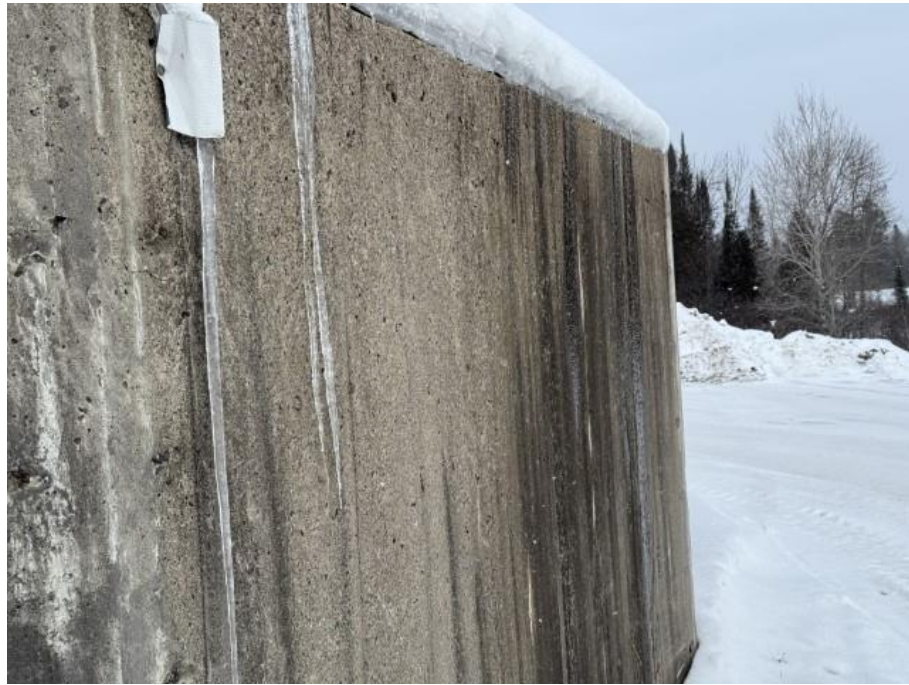
Photo 3: Sand Dome –Concrete Wall Staining

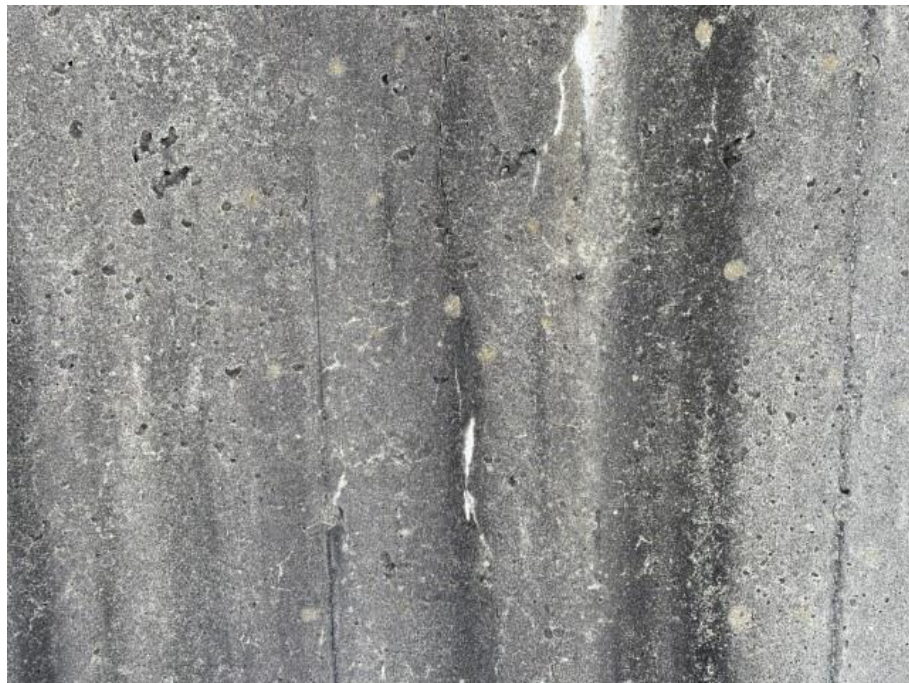
Photo 4: Sand Dome – Concrete Wall Cracking

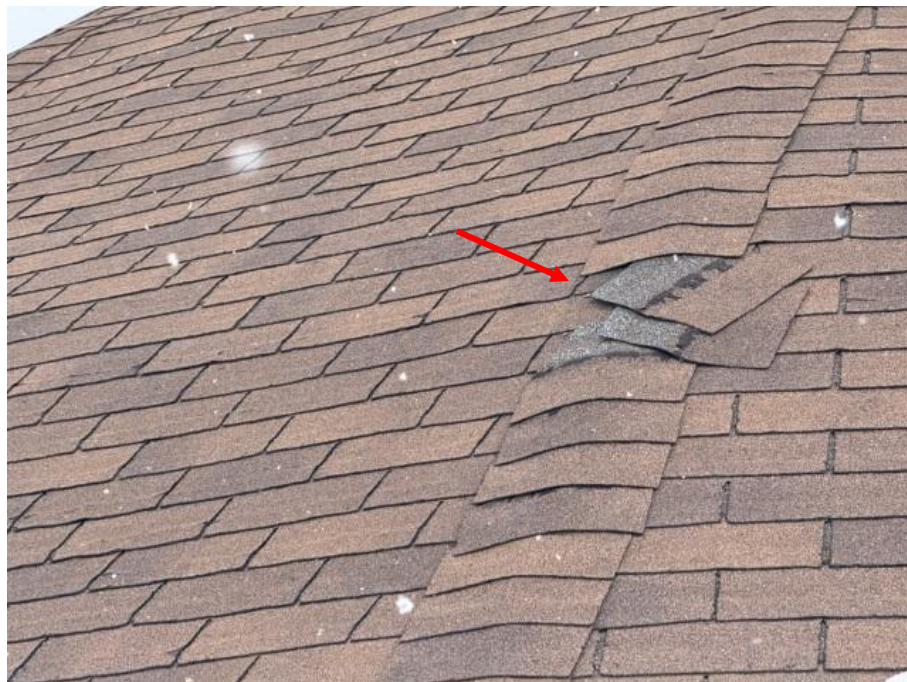
Photo 6: Sand Dome –Localized Shingle Failure

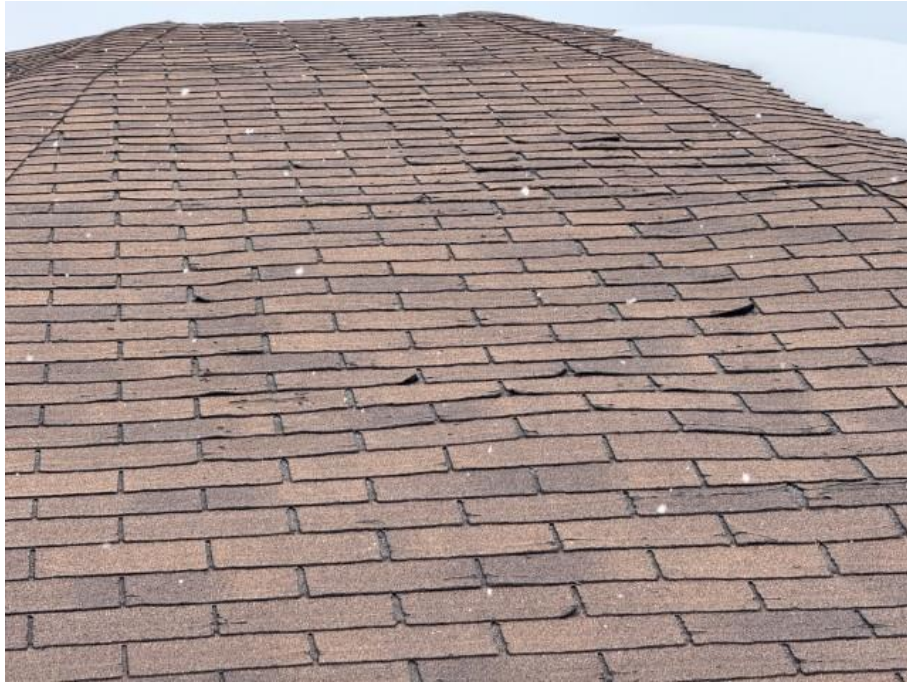
Photo 7: Sand Dome – Severe Asphalt Shingle Deterioration

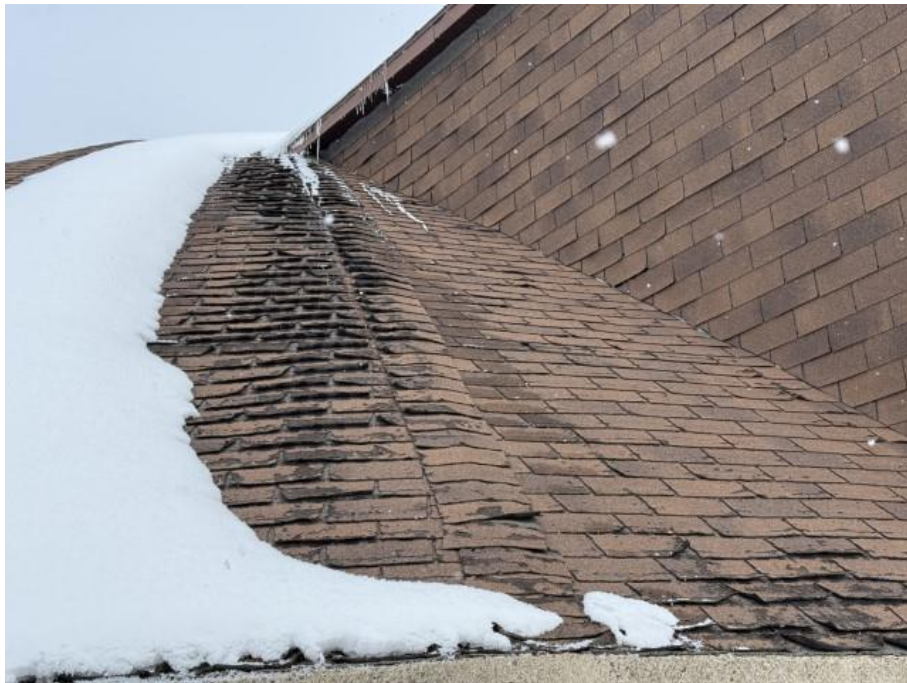
Photo 8: Sand Dome – Severe Shingle Deterioration

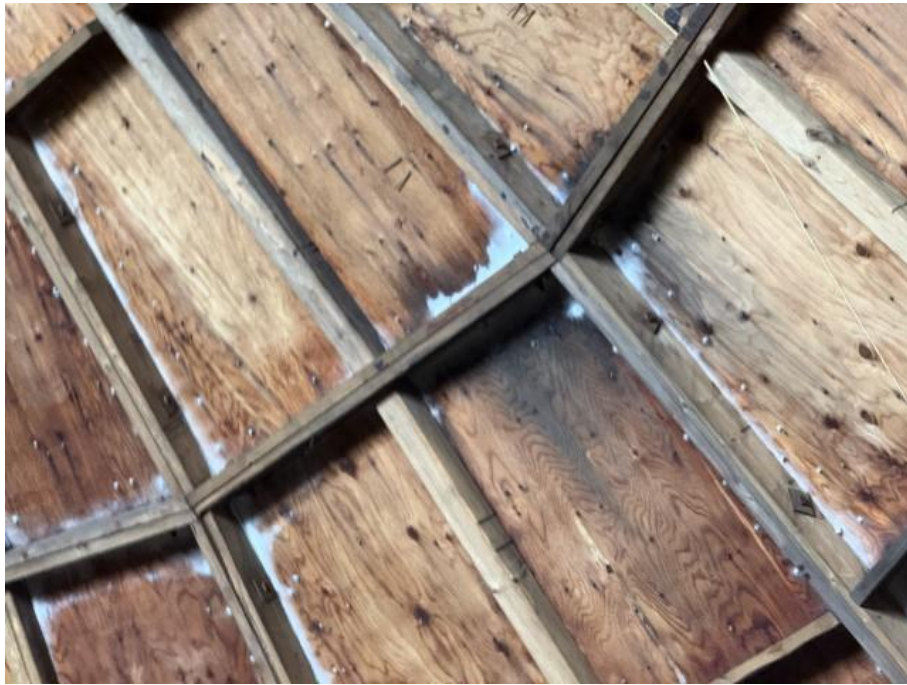
Photo 9: Sand Dome – Localized Sheathing and Framing Moisture Staining

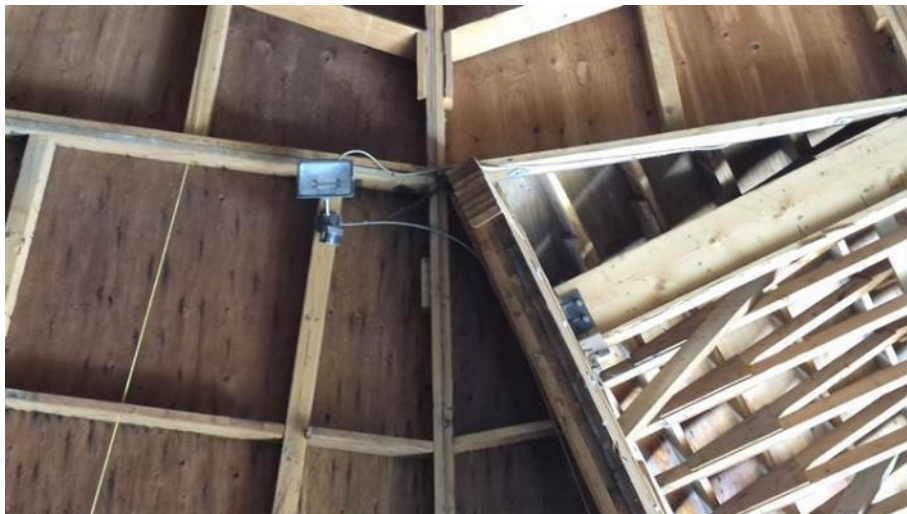
Photo 10: Sand Dome – Non-Functional Interior Light Fixture. Typical of 2

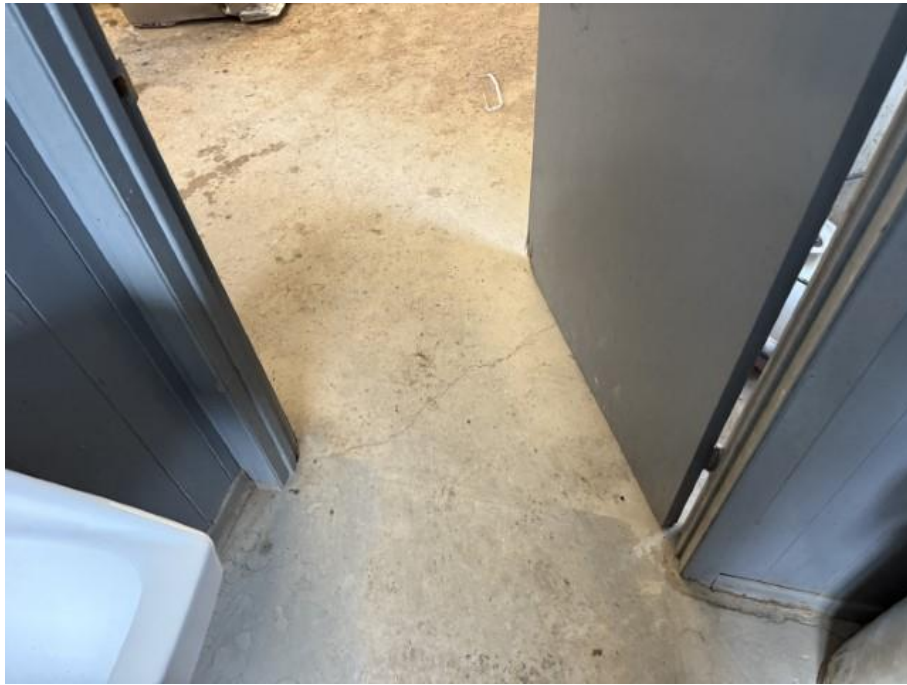
Photo 3: Municipal Garage – Typical Slab Cracking

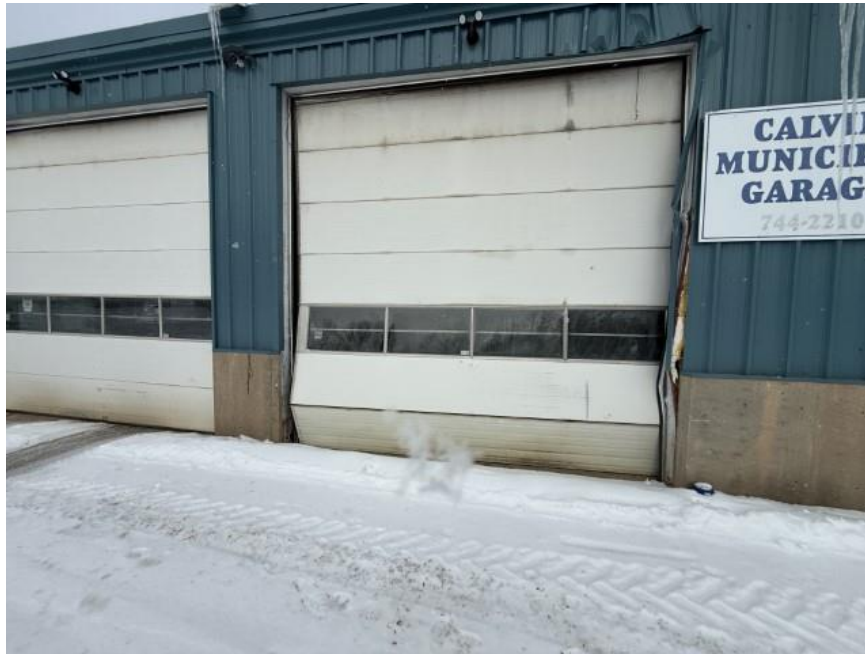
- A small rear addition to the Municipal Garage was completed in 2004 to provide additional interior machinery parking space.
- Snowplough impact damage recently occurred at the side of the middle overhead garage door in the Municipal Garage. It is further understood plans are in place to complete a door replacement and associated repairs through insurance.

Photo 7: Municipal Garage – Overview of Impact Damage

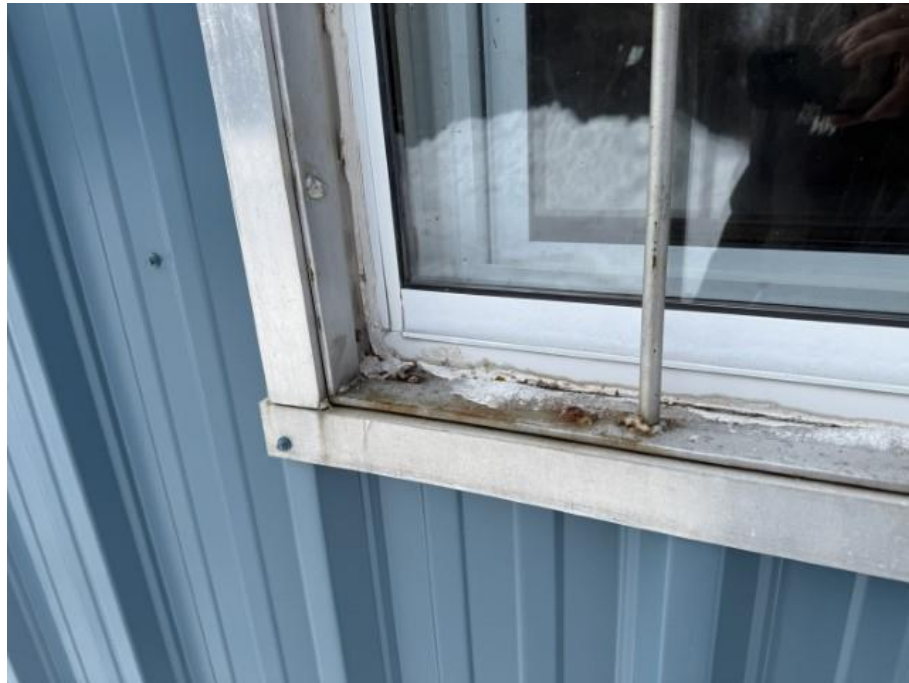
Photo 9: Municipal Garage – Overview of Exterior Windows and Sealant

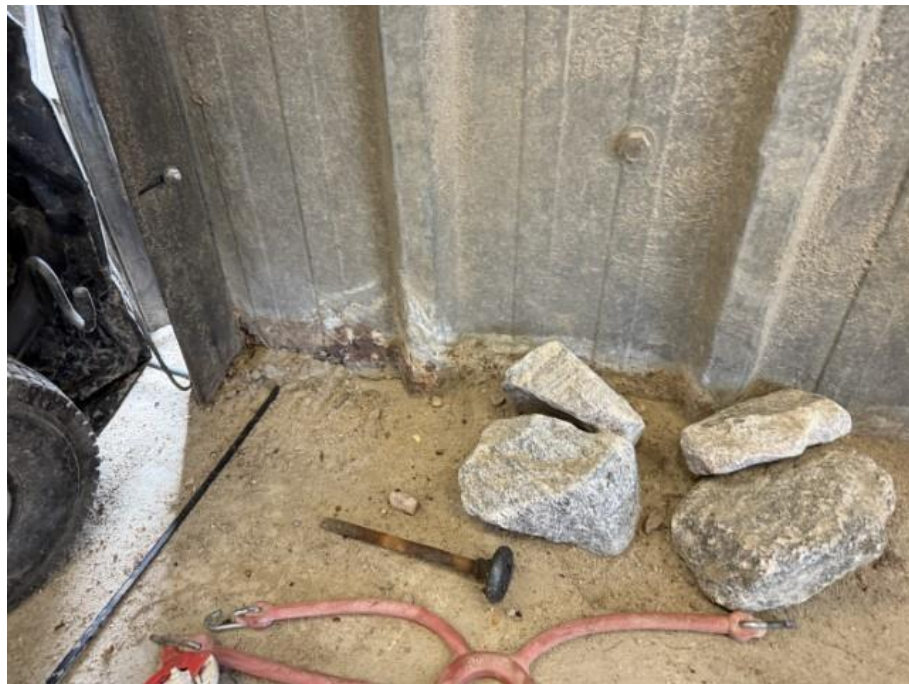
Photo 12: Municipal Garage –Base Cladding Corrosion

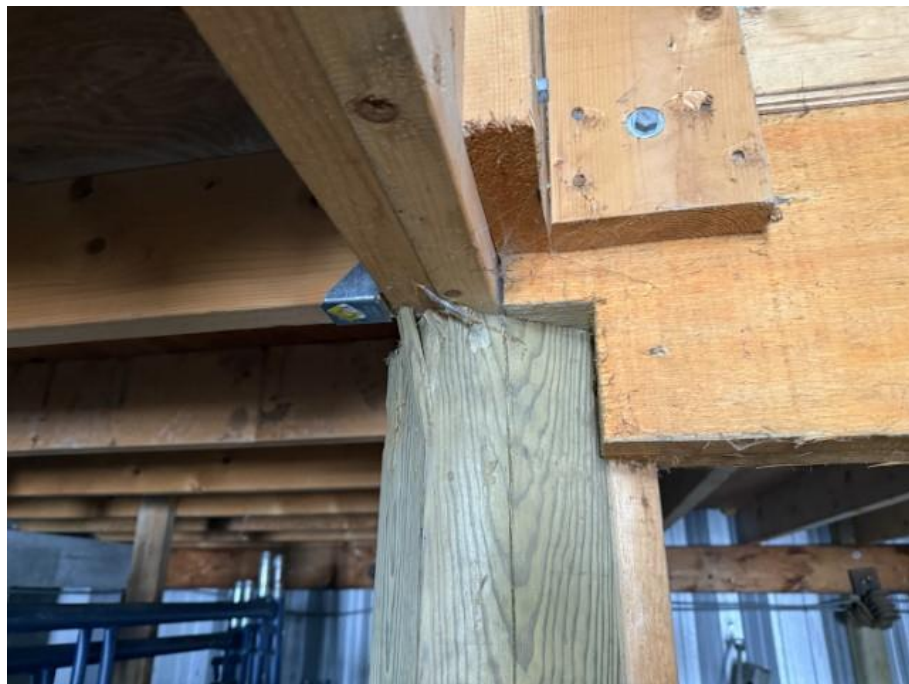
Photo 4: Quonset Hut – Localized Post Displacement

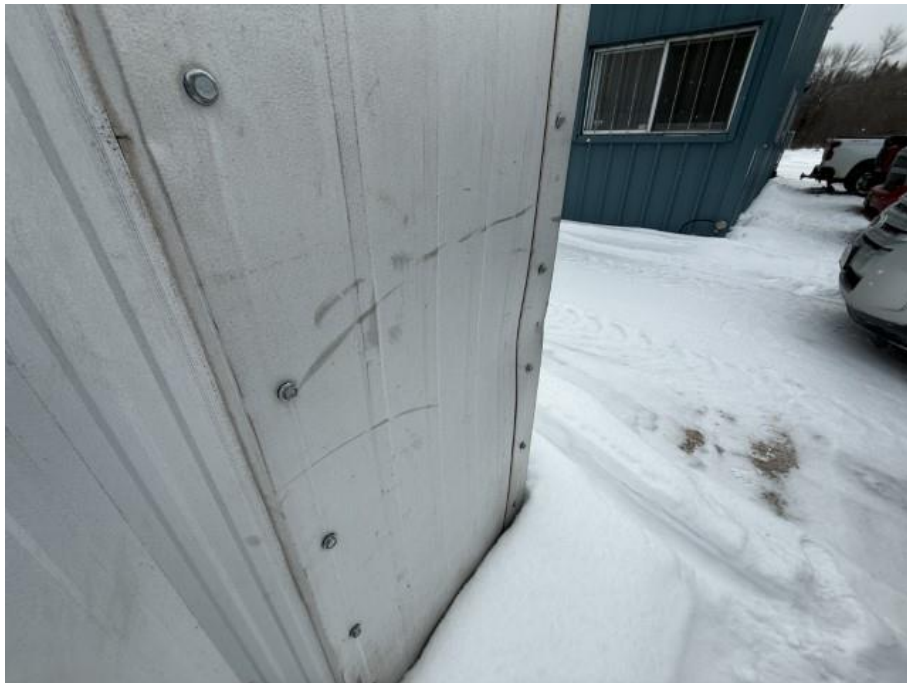
Photo 6: Quonset Hut – Localized siding Damage

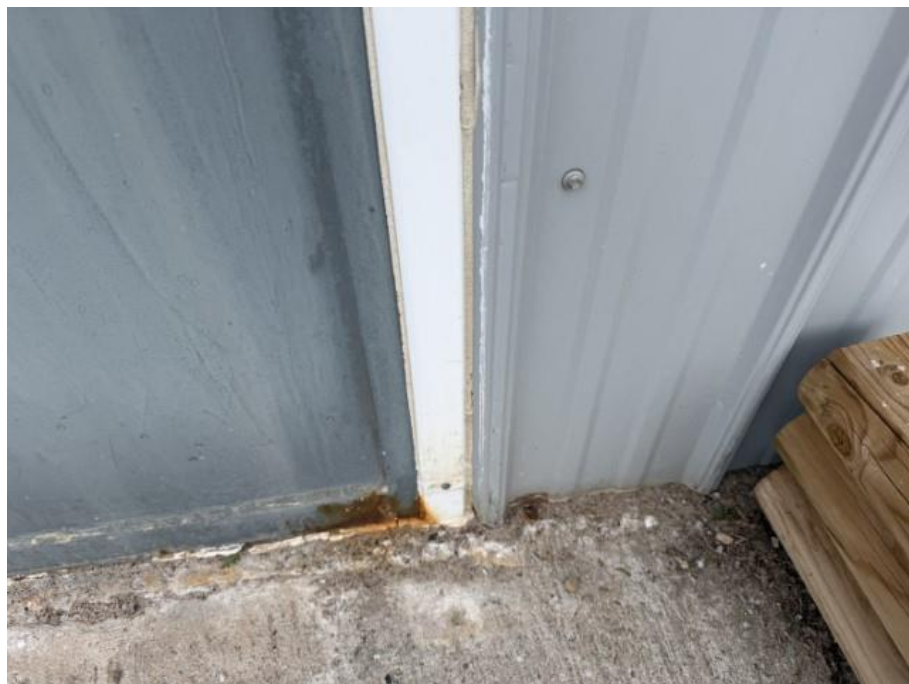
Photo 4: Recreation Hall - Typical Base of Door/Cladding Corrosion

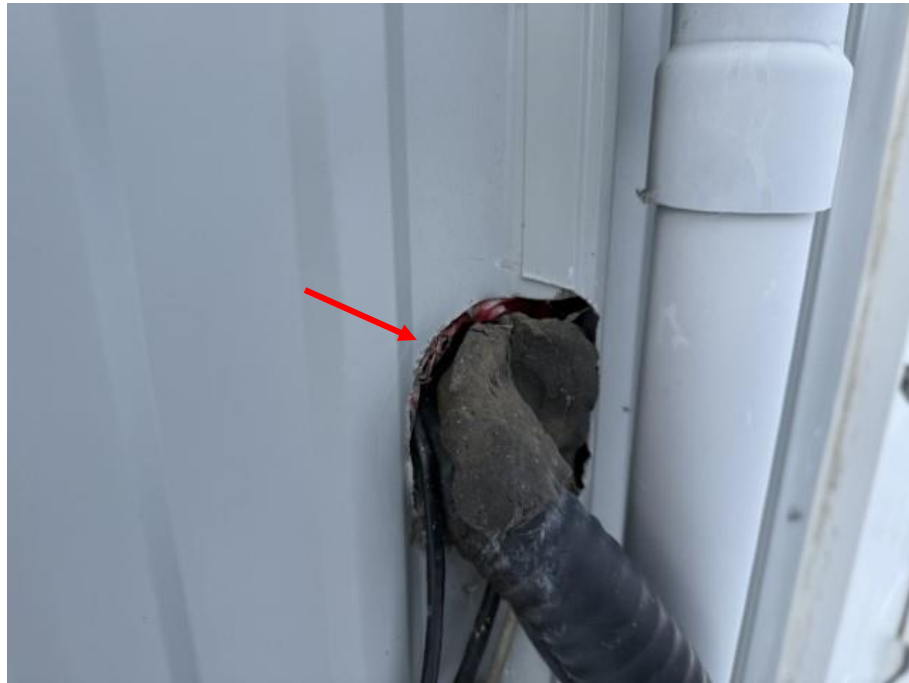
Photo 5: Recreation Hall – Unsealed Exterior Penetration

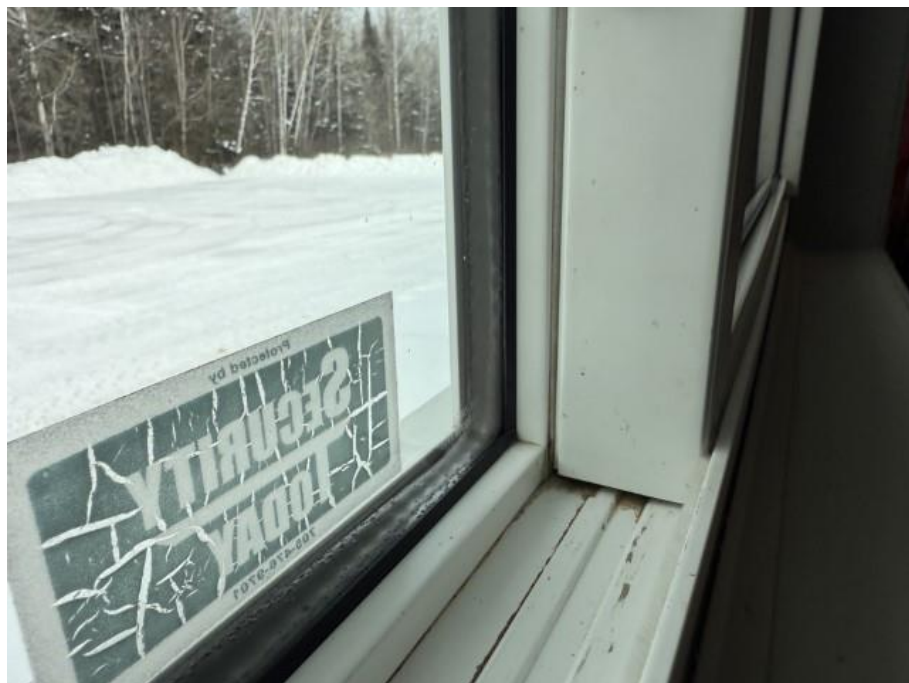
Photo 6: Recreation Hall –Interior Window Condition

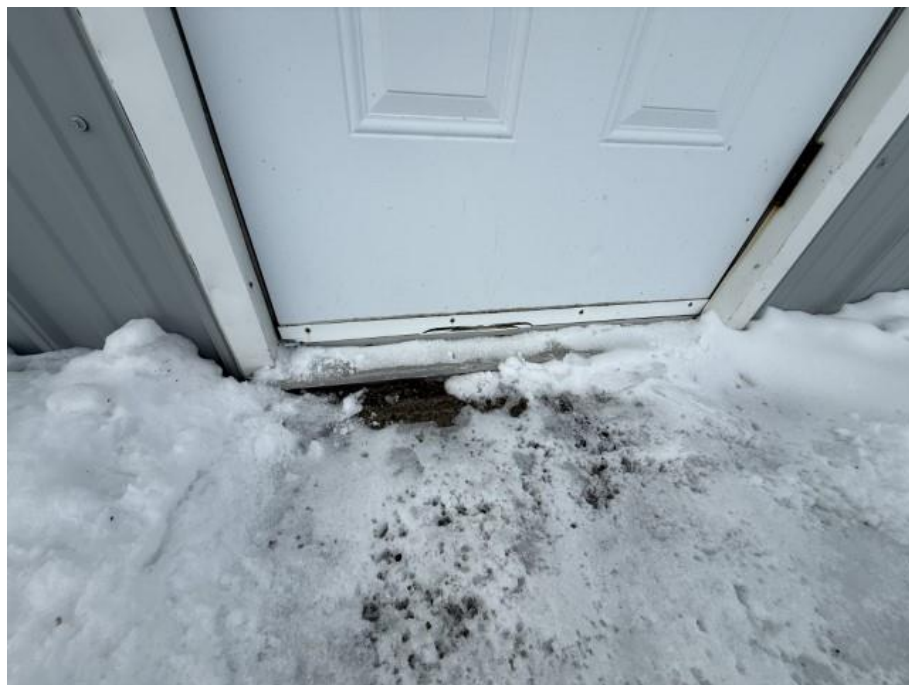
Photo 8: Recreation Hall –Door and Surround Typical Damage

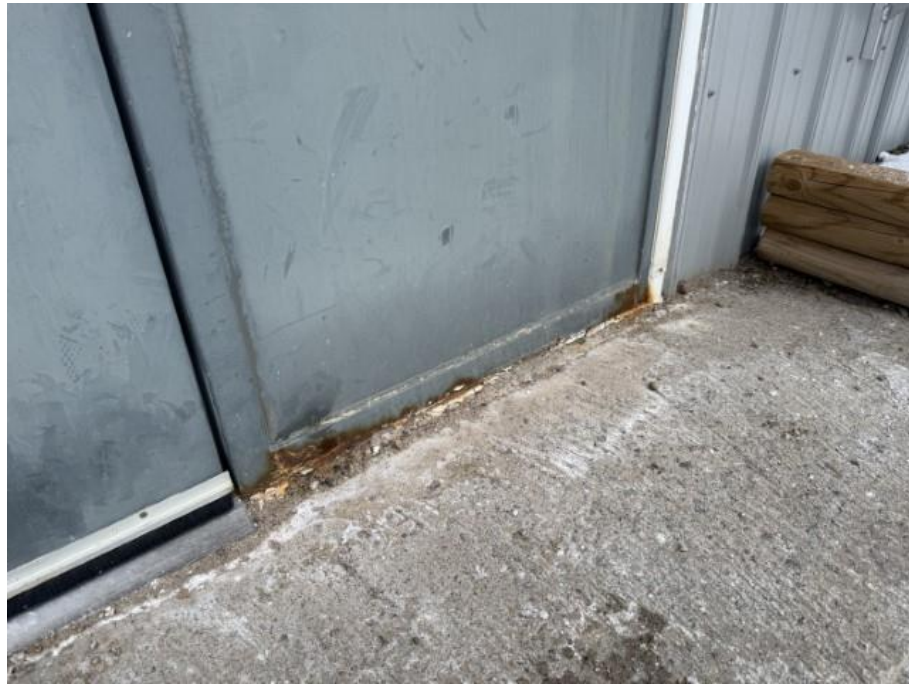
Photo 9: Recreation Hall – Door Base Corrosion

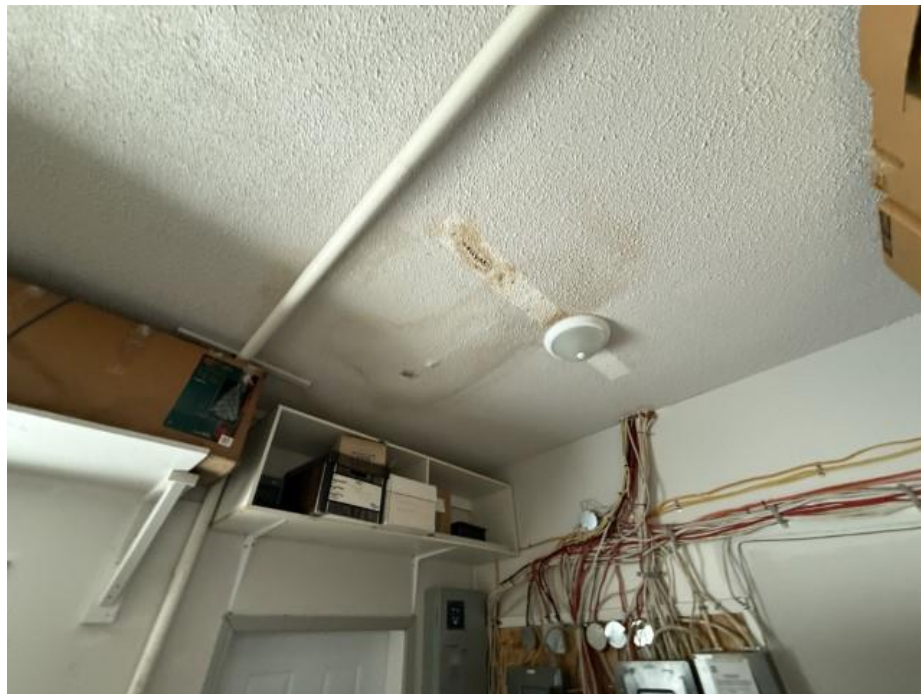
- Repetitive localized roof leaks have been noted within the Recreation Centre building during the springtime snow melt in two locations over the last approximately 3 years. No repairs have been undertaken to resolve.

Photo 10: Recreation Hall – Evidence of Roof Leaks

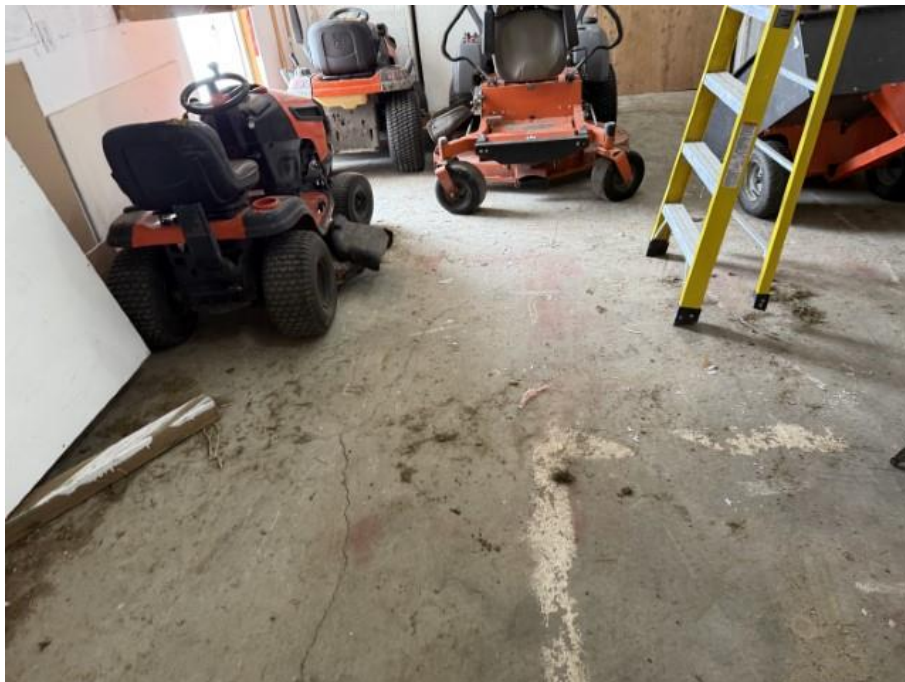
Photo 2: Changing/Storage Building – Overview of Slab Cracking

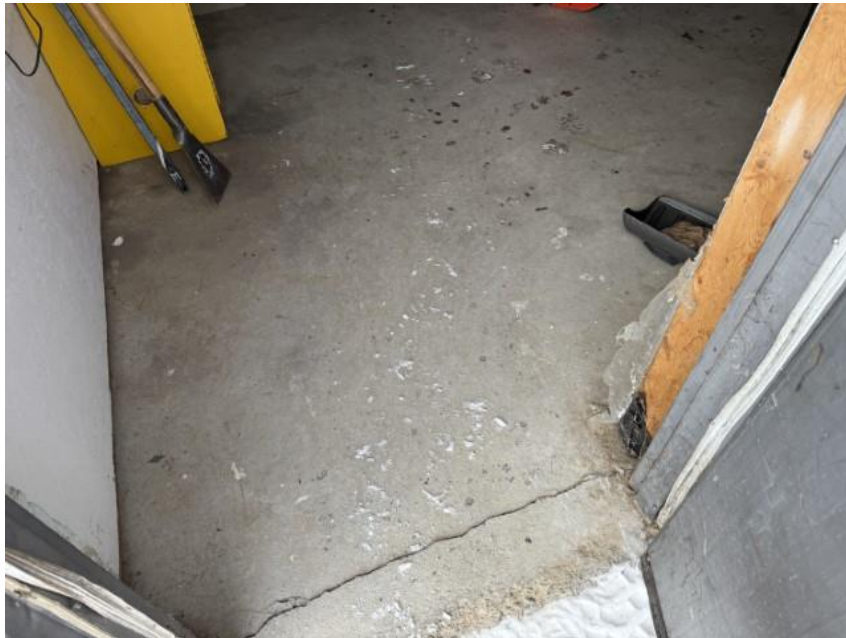
Photo 3: Changing/Storage Building – Cracking at Foundation-Slab

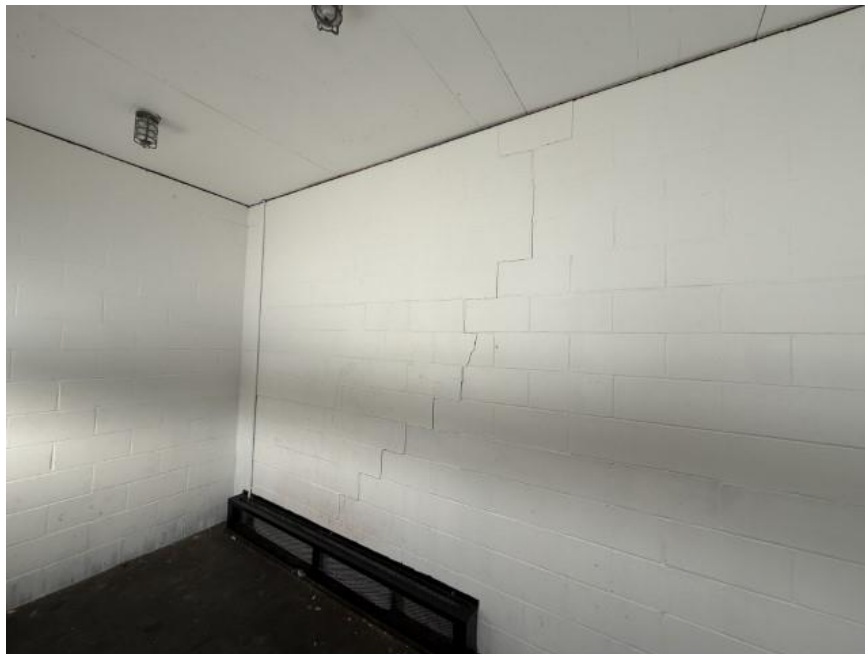
- It was reported that there is an underground tank which collects biowaste from the change room building washrooms. There are notable open joints and step cracking in the concrete masonry unit (CMU) block walls above this area. Staff note that the width of these cracks and openings varies significantly throughout the year.

Photo 4: Changing/Storage Building – Typical Step Cracking and Cracked CMU

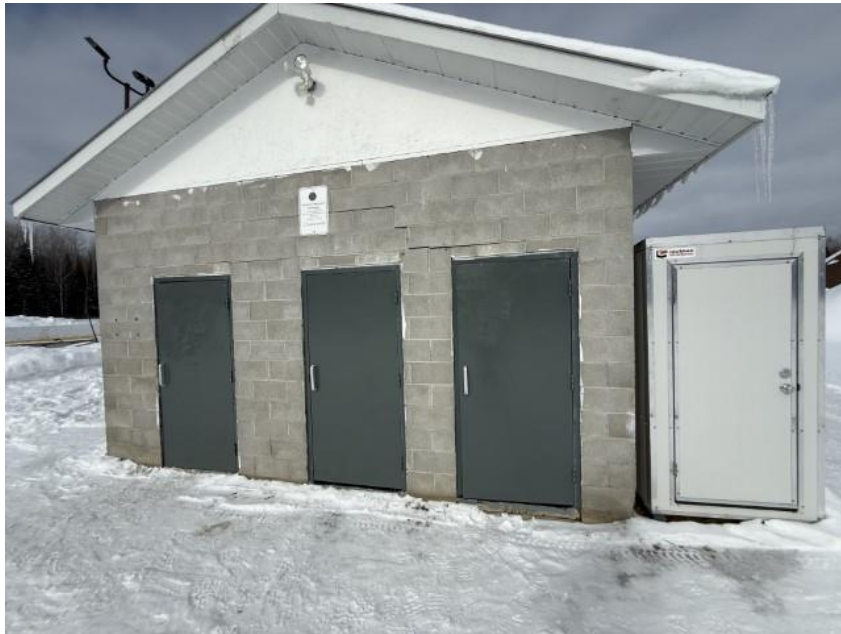
Photo 5: Changing/Storage Building – Doors and Overhead Step Cracking
