Road Needs Study

Corporation of the Municipality of Calvin

Final Report

Jp2g Project # 25-5304A

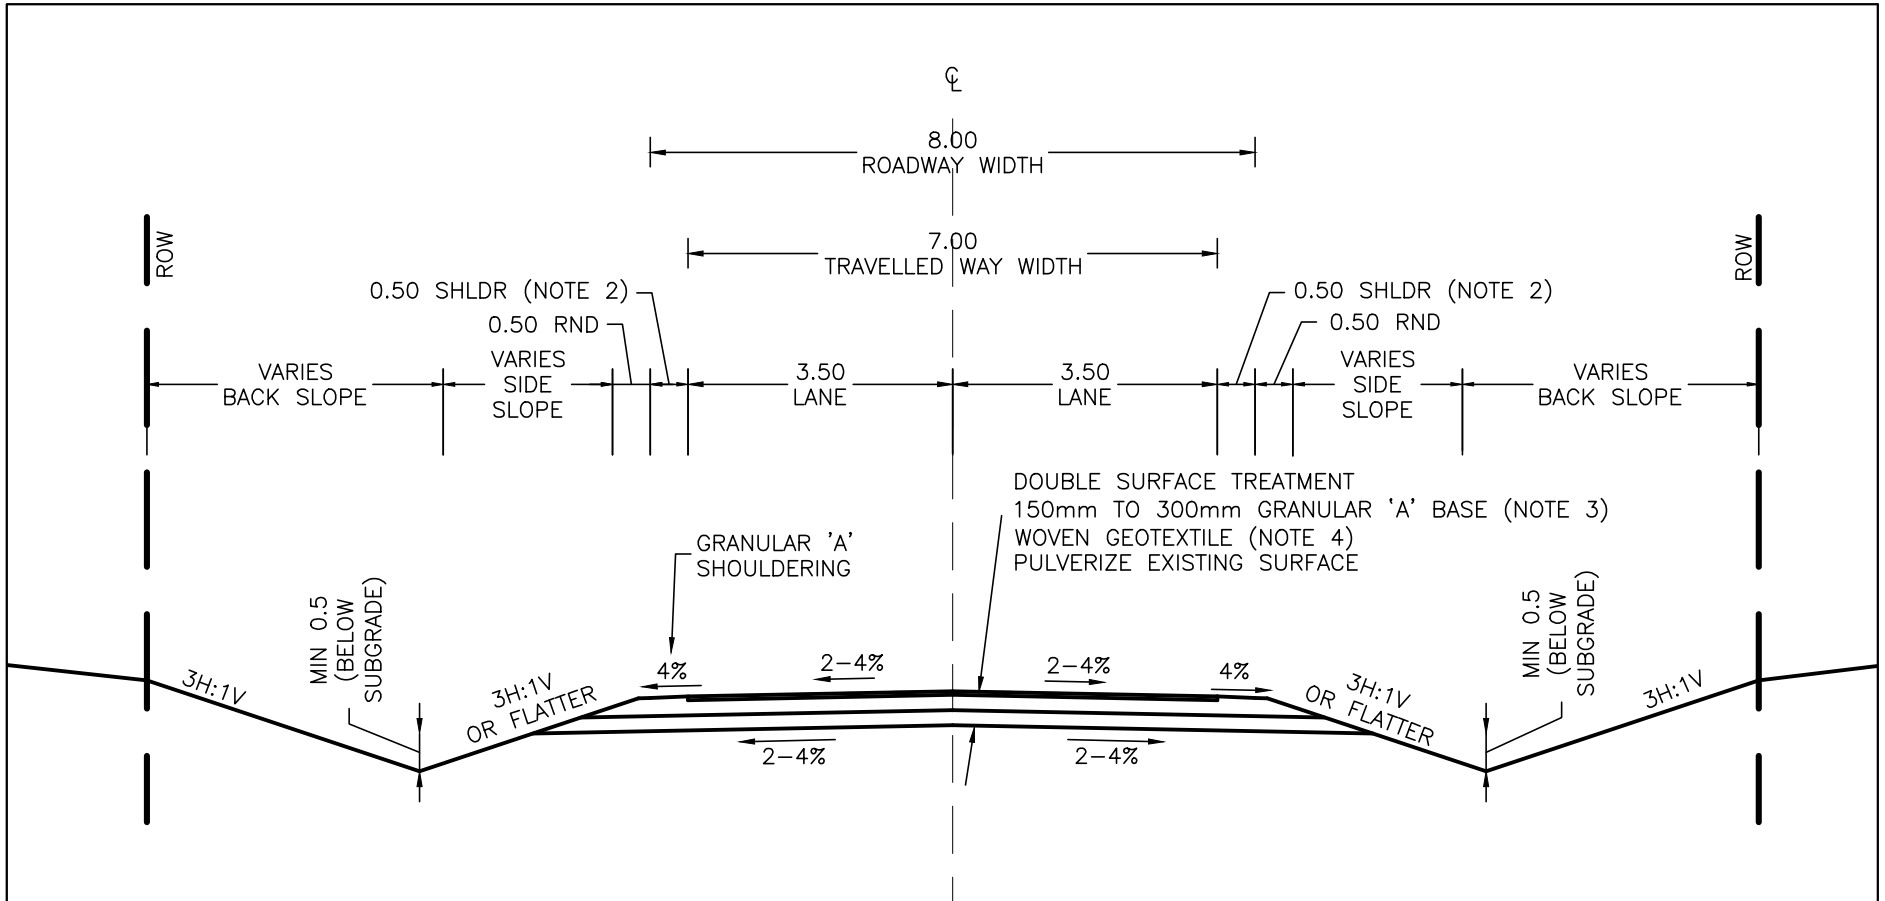
R1

1. ALL UNITS IN METERS UNLESS OTHERWISE NOTED.
2. WHERE TRAFFIC BARRIERS ARE USED, INCREASE SHOULDER WIDTH BY 0.5m ON TRAFFIC BARRIER SIDE, PLUS WIDTH TO SUPPORT FOR THE BARRIER.
3. DEPTH OF GRANULAR 'A' BASE TO BE AS PER GEOTECHNICAL RECOMMENDATIONS
4. WOVEN GEOTEXTILE TYPICALLY ONLY INSTALLED WHERE SEPARATION IS NEEDED BETWEEN THE SUBGRADE AND GRANULAR MATERIALS.
5. CROSS SECTION ELEMENTS AND DIMENSIONS AS PER "TAC GEOMETRIC DESIGN GUIDE FOR CANADIAN ROADS CHAPTER 11: SPECIAL ROADS", BASED ON DESIGN SPEED OF 80km/hr

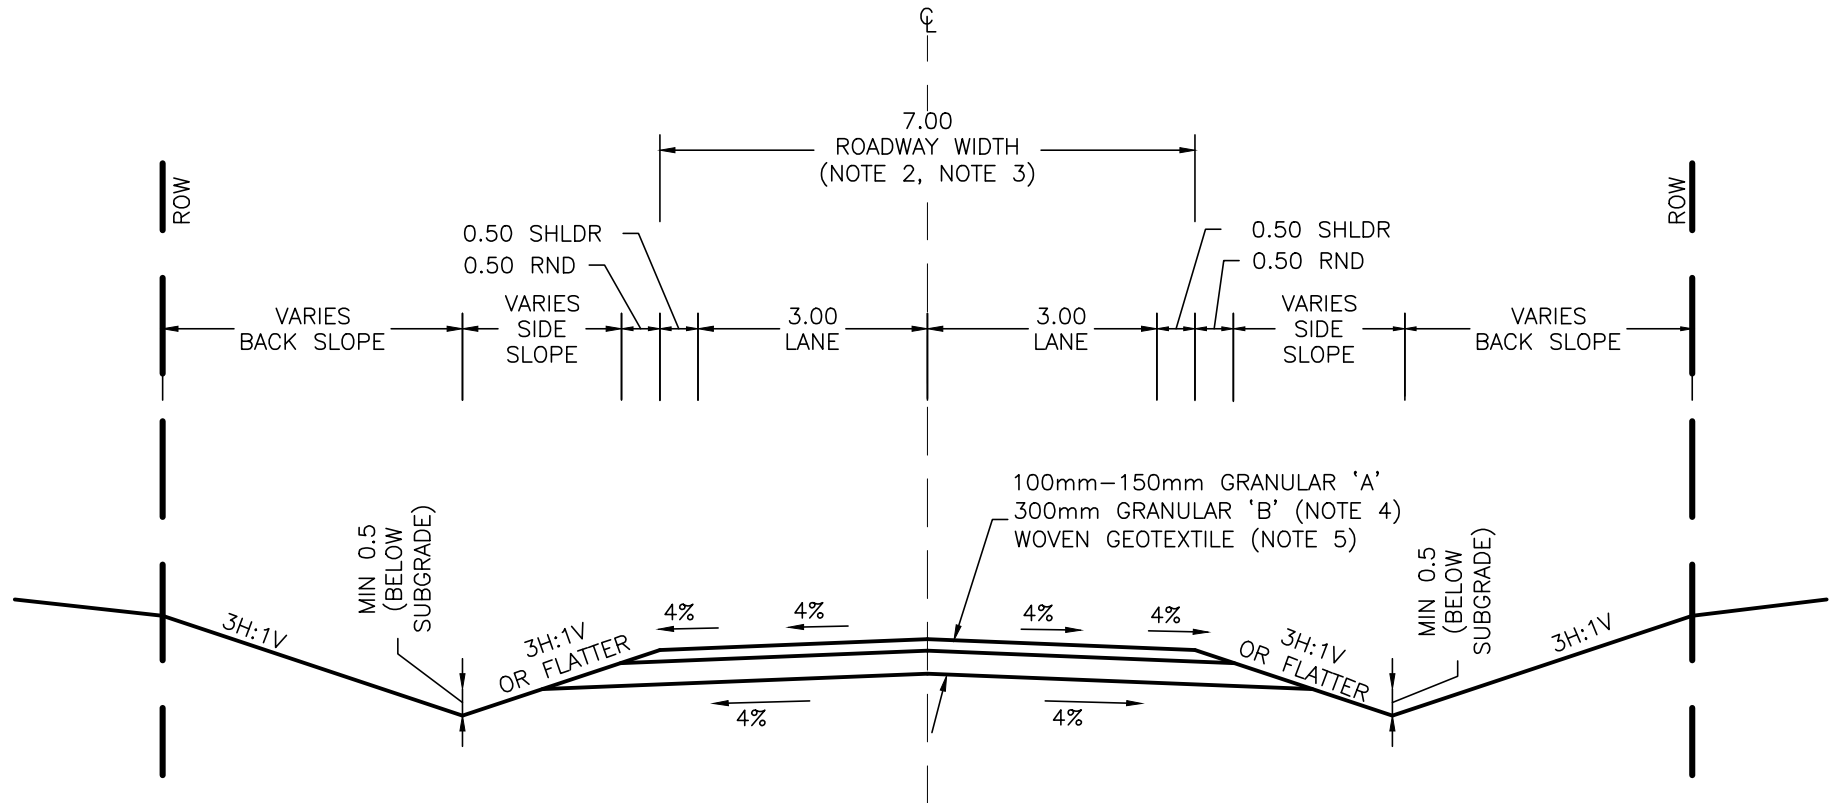
Drawing RG-2 is a typical rural cross section for 2-lane 2-way gravel roads (based on a design speed of 80 km/hr). This detail shows the reconstruction efforts for the gravel roadway, including installing woven geotextile (if warranted), installing new lift of Granular 'B' subbase, and installing new lift of Granular 'A' base/road surface. It should be noted that gravel roads typically do not require full reconstruction as normal maintenance activities maintain the existing condition of the road. Therefore, rehabilitation efforts for a gravel road would typically include the addition of new lift of Granular 'A' base/road surface. Similar to the typical cross-section for LCB roads, humps or "berms" in the gravel shoulders should be graded to promoted water to drain off the road to the ditches. The roadway width on special gravel roads is dependant on the design speed and the average daily truck traffic.

1. ALL UNITS IN METERS UNLESS OTHERWISE NOTED.
2. WHERE TRAFFIC BARRIERS ARE USED, INCREASE ROADWAY WIDTH BY 0.5m ON TRAFFIC BARRIER SIDE, PLUS WIDTH TO SUPPORT FOR THE BARRIER.
3. ROADWAY WIDTH (LANES PLUS SHOULDERS): MIN 7.0m (<15 AVERAGE DAILY TRUCK TRAFFIC) OR MIN 7.4m (>15 AVERAGE DAILY TRUCK TRAFFIC)
2. GRANULAR 'B' ONLY REQUIRED IF RECOMMENDED BY GEOTECHNICAL ENGINEER IN AREAS CONSIDERED FOR FULL DEPTH DIGOUT OR FULL RECONSTRUCTION. TYPICALLY ONLY GRANULAR 'A' IS ADDED FOR GRAVEL ROAD REHABILITATION.
3. WOVEN GEOTEXTILE TYPICALLY ONLY INSTALLED IN FULL RECONSTRUCTION, WHERE SEPARATION IS NEEDED BETWEEN THE SUBGRADE AND GRANULAR MATERIALS.
4. CROSS SECTION ELEMENTS AND DIMENSIONS AS PER "TAC GEOMETRIC DESIGN GUIDE FOR CANADIAN ROADS CHAPTER 11: SPECIAL ROADS", BASED ON DESIGN SPEED OF 80km/hr

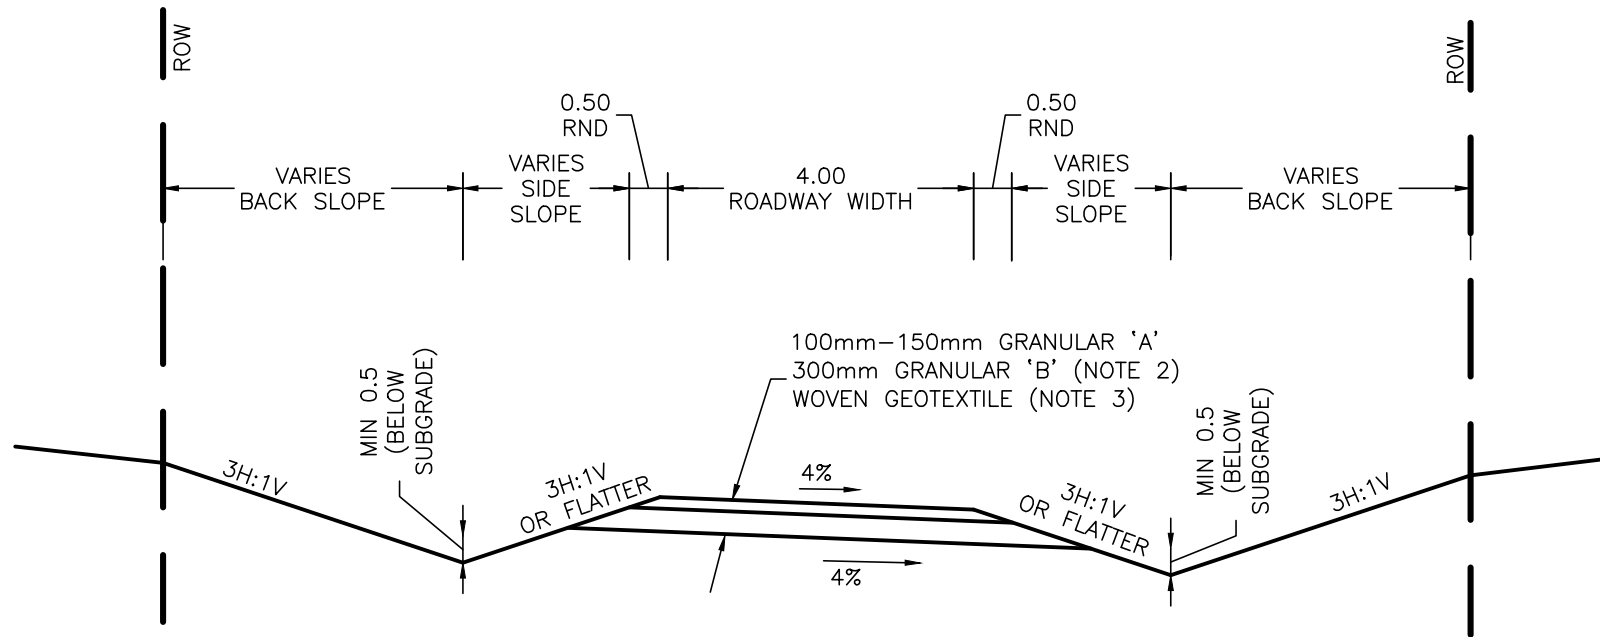
Drawing RG-1 is a typical rural cross section for 1-lane 2-way gravel roads. One-lane two-way roads can be used to provide access to isolated communities, recreational sites, or resource developments and are located off a higher classification of road. These roads are short, serve a single purpose and are not part of a continuous route. For reasons of safety, the one-lane two-way roads may only be considered if the average daily traffic (ADT) is less than 50 vehicles/day and the design speed is 50 km/h or less. If the road conditions encourage operating speeds in excess of 50 km/hr, a 1-lane 2-way should not be considered. On 1-lane 2-way roads, turnouts are required at a maximum of 300m spacing, to allow passing on this type of road. Turnouts should have clear sight lines between them. A typical detail for a turnout is included in Appendix F (refer to TO-1).

REQUIREMENTS TO CONSIDER ONE-WAY, TWO-LANE ROADS:

- A. MAXIMUM DESIGN SPEED OF 50km/hr.
- B. AVERAGE DAILY TRAFFIC (ADT) < 50 VEHICLES/DAY.
- C. TYPICALLY USED TO PROVIDE ACCESS TO ISOLATED COMMUNITIES, RECREATIONAL SITES, OR RESOURCE DEVELOPMENTS.
- D. ROADS ARE SHORT, SERVE A SINGLE PURPOSE, AND ARE NOT PART OF A CONTINUOUS ROUTE.
- E. TURNOUTS ARE REQUIRED, NO MORE THAN 300m APART. REFER TO DRAWING TO-1 FOR MORE DETAILS.

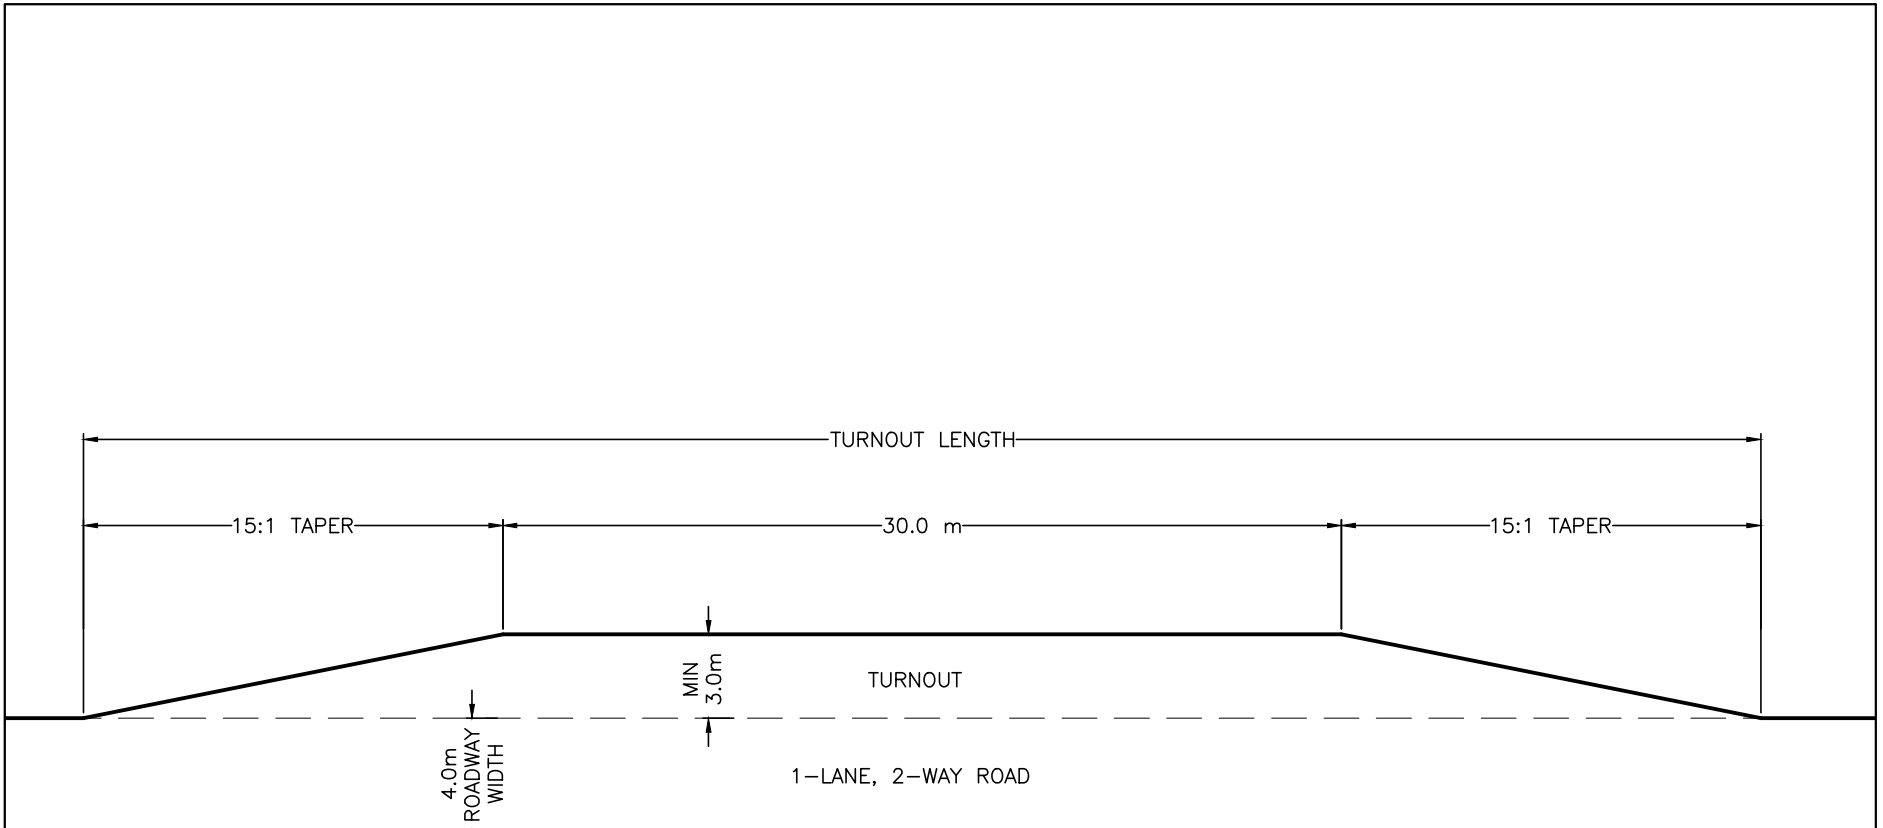
**TYPICAL RURAL GRAVEL TURNOUT
PLANVIEW**
GRAVEL SURFACE - ONE-LANE, TWO-WAY ROADS
