Municipality of Calvin

1355 & 1238 Peddlers Drive Facility and Building Condition Assessment – Final

1355 & 1238 Peddlers Drive
Mattawa, Ontario

April 13, 2026
RJC No. KIN.143609.0001

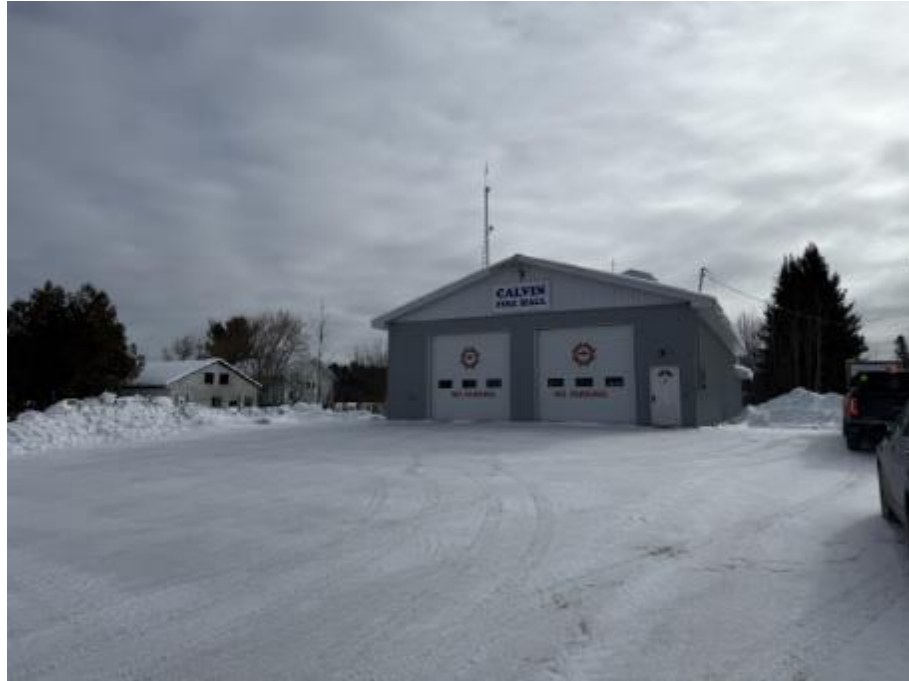
Photo 1: Fire Hall - Overview

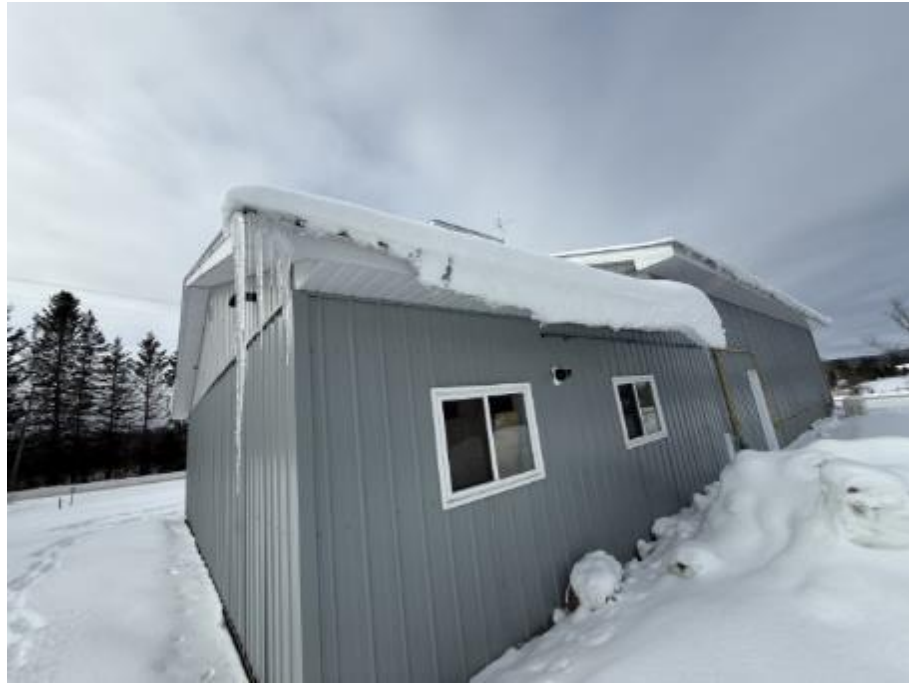
Photo 9: Fire Hall – Snow and Icicle Coverage

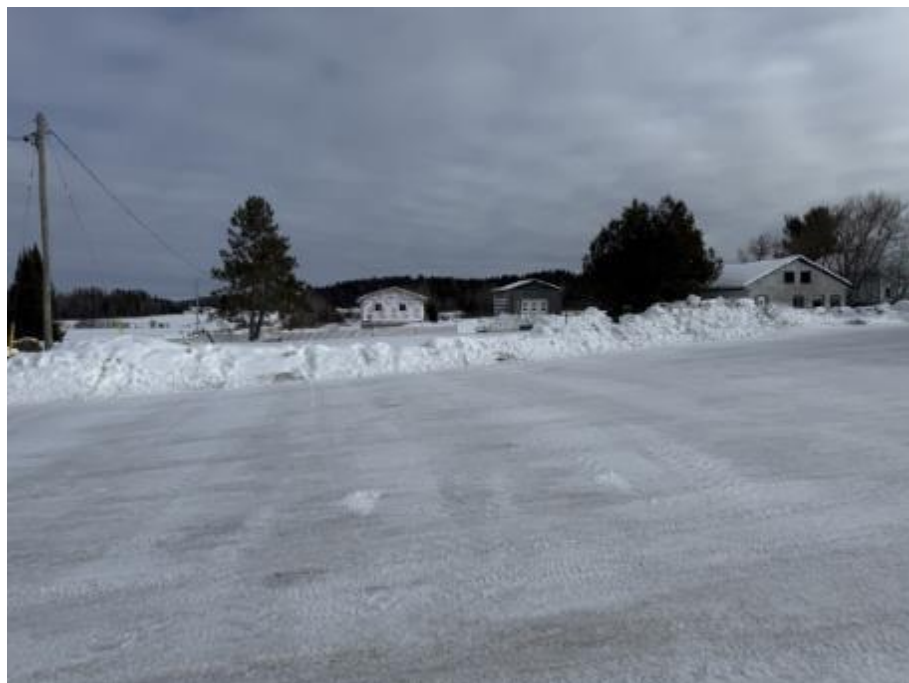
Photo 12: Fire Hall – Driveway and Parking Area

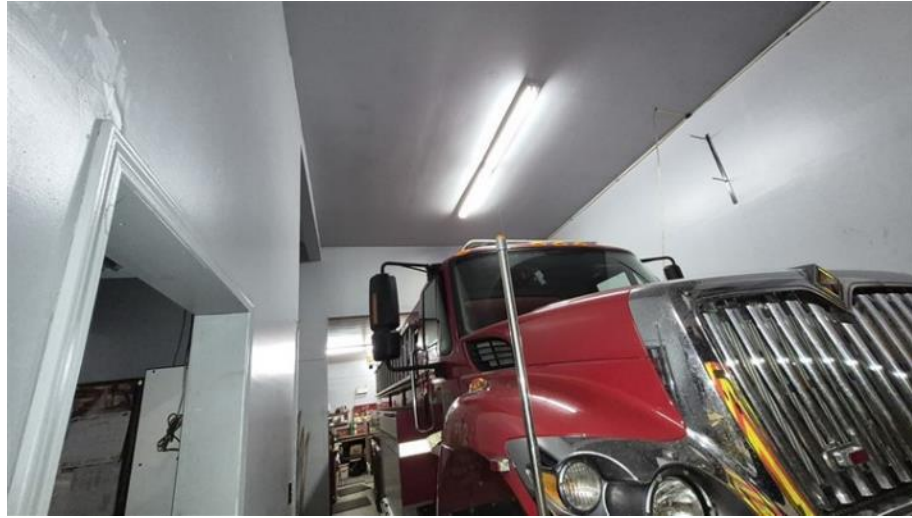
Photo 13: Fire Hall – Typical Existing Fluorescent Lighting

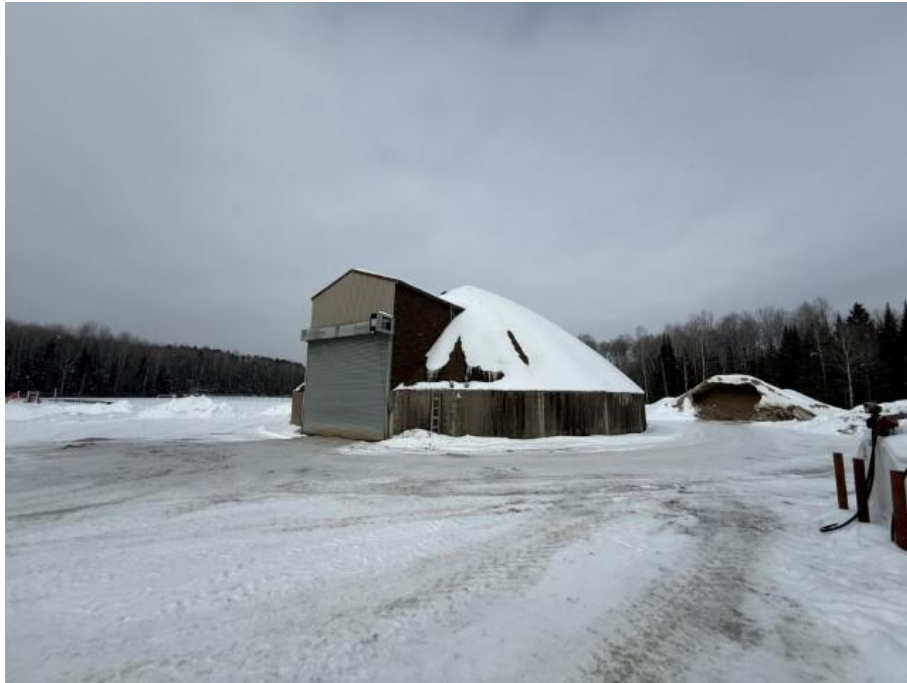
Photo 1: Sand Dome –Overview

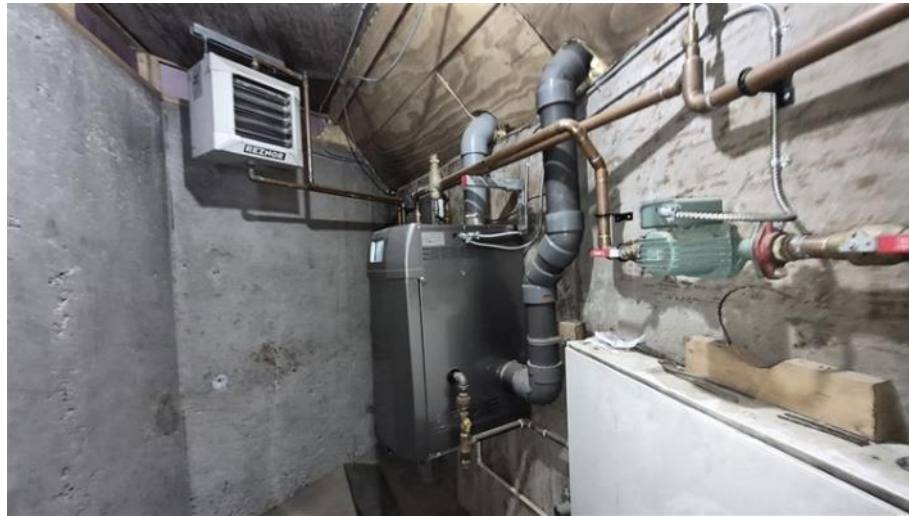
Photo 11: Sand Dome – Existing Heating Boiler and Mechanical Room Heater

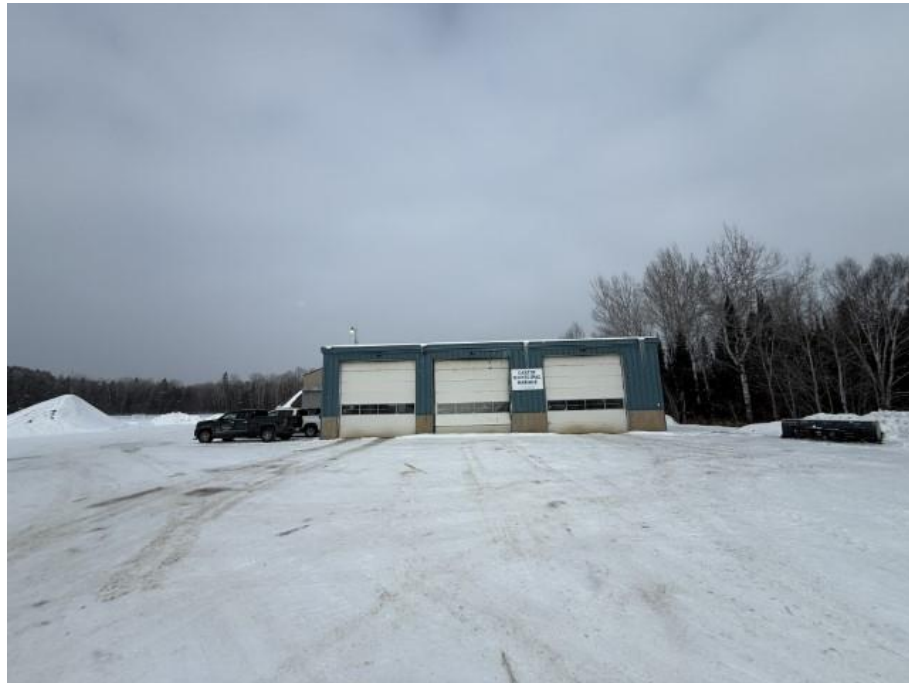
Photo 1: Municipal Garage – Overview of Building

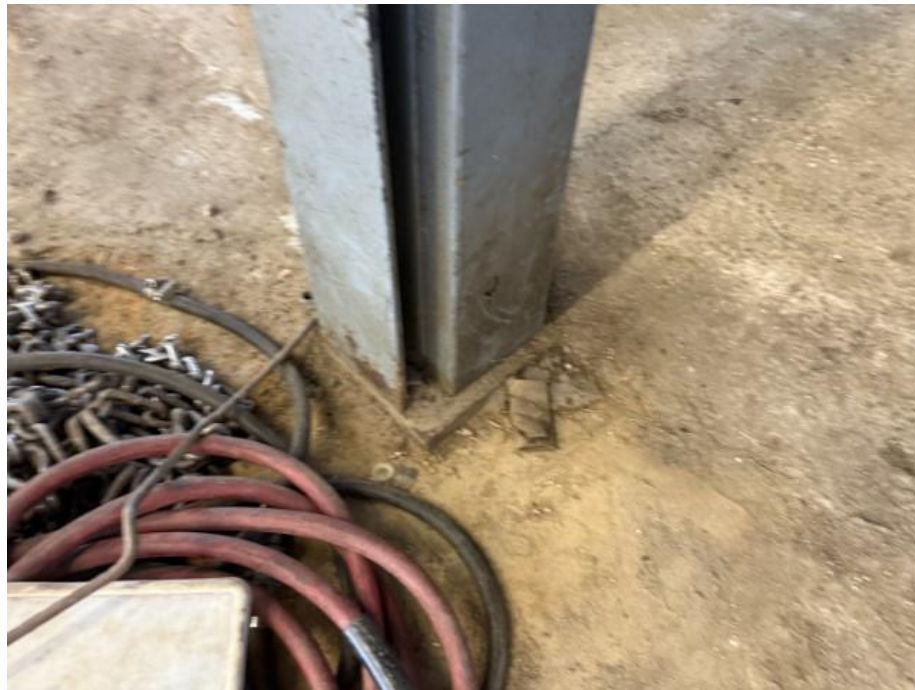
Photo 2: Municipal Garage – Typical Column Base

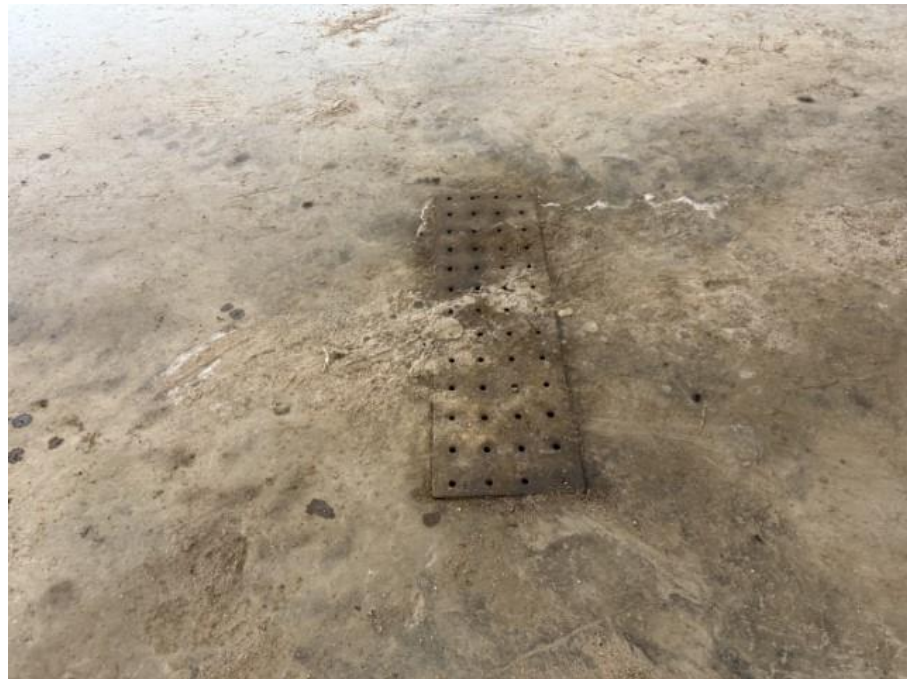
Photo 4: Municipal Garage – Typical Slab Drain

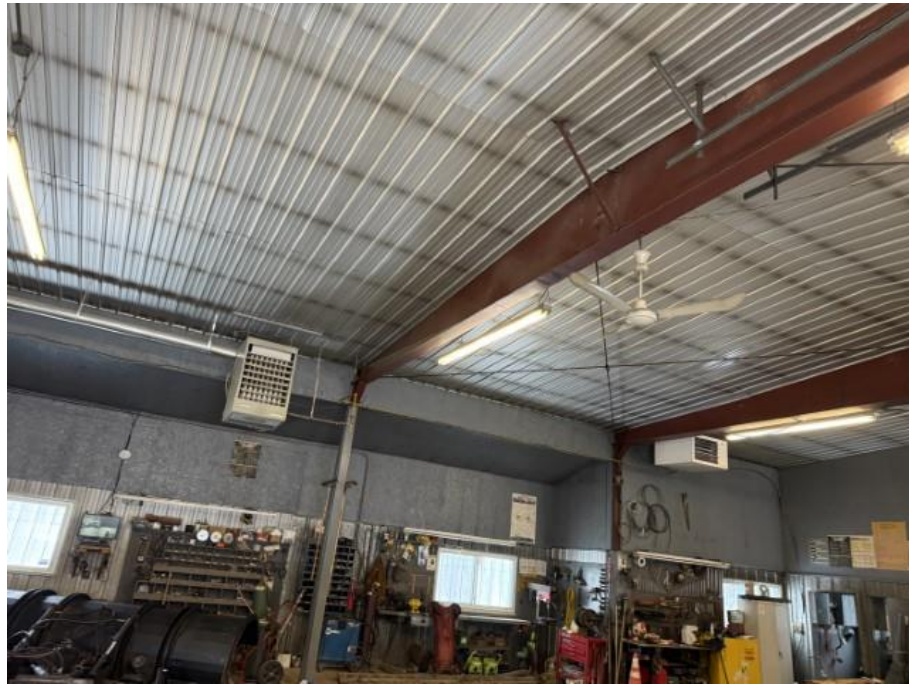
Photo 5: Municipal Garage – Overview of Steel Structure

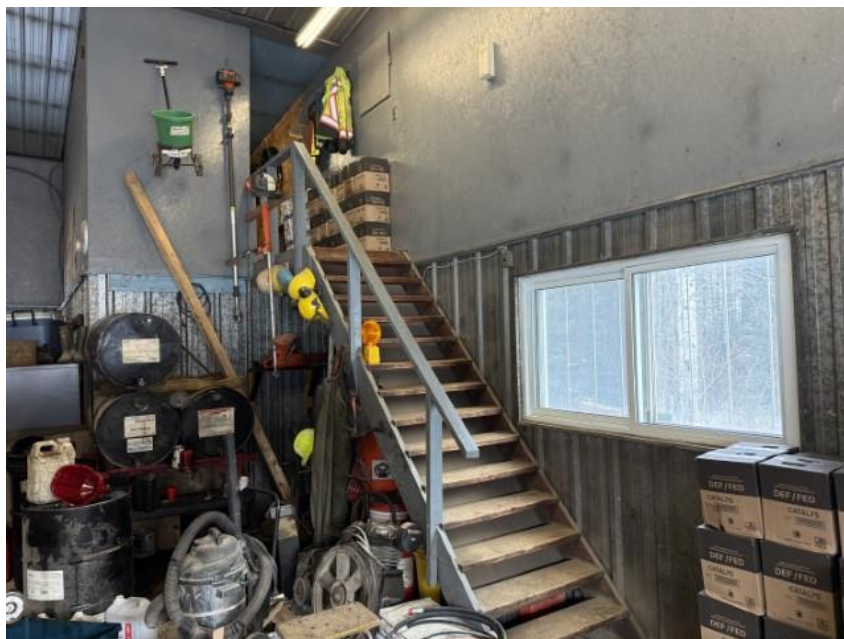
Photo 6: Municipal Garage – Wood Framed Loft Structure

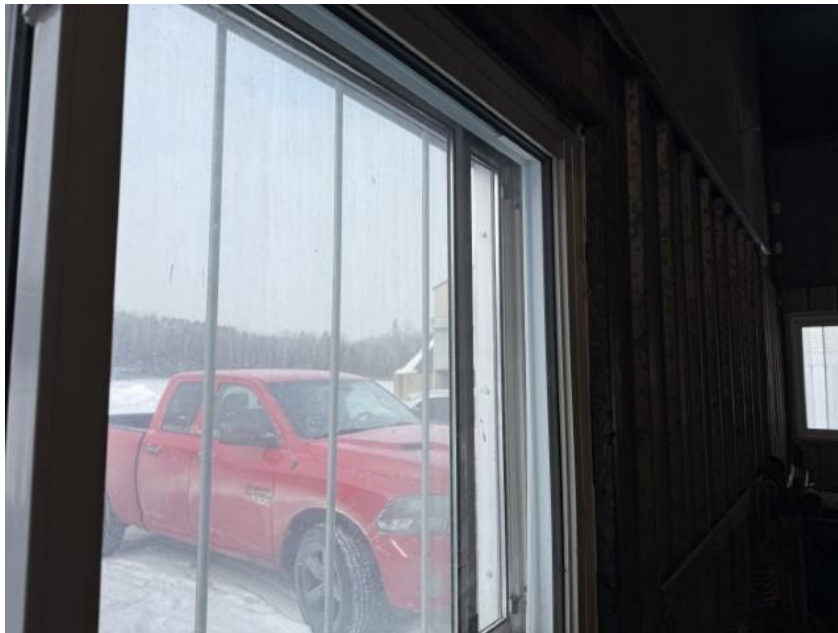
Photo 8: Municipal Garage – Overview of Interior Windows

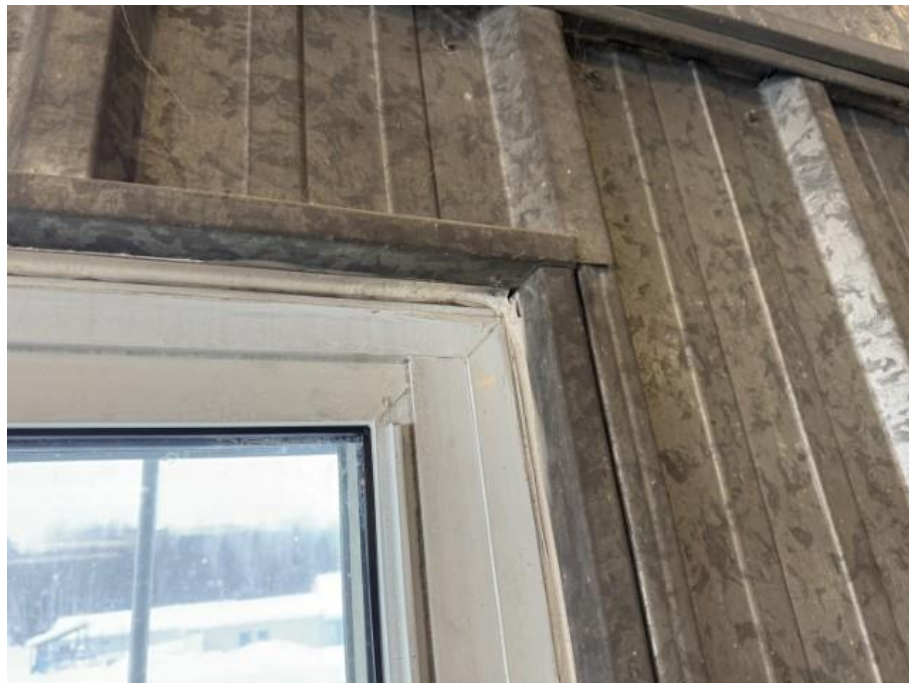
Photo 10: Municipal Garage – Overview of Interior Sealant

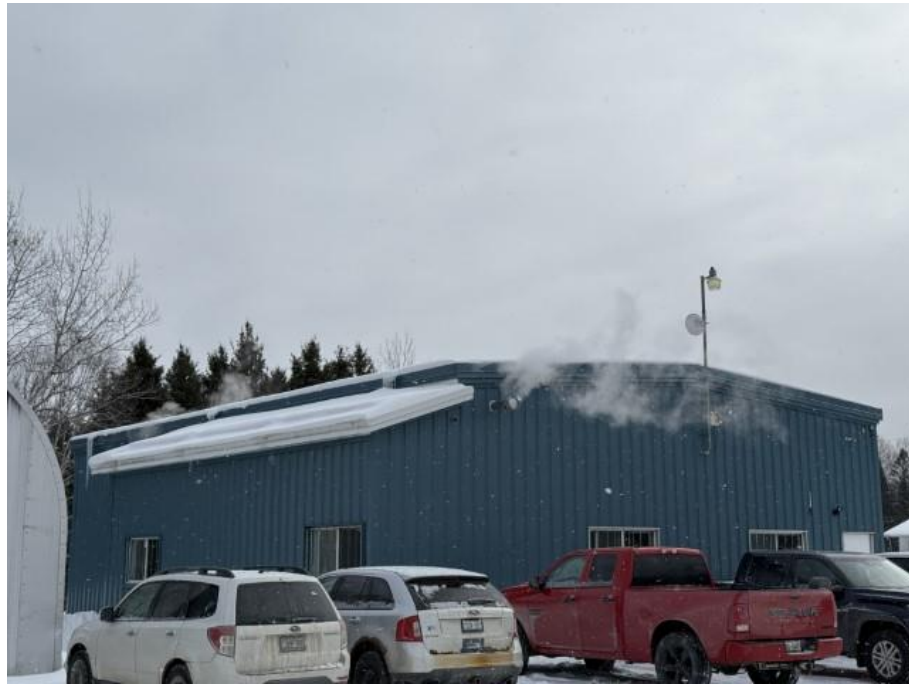
Photo 13: Municipal Garage – Overview of Covered Roof

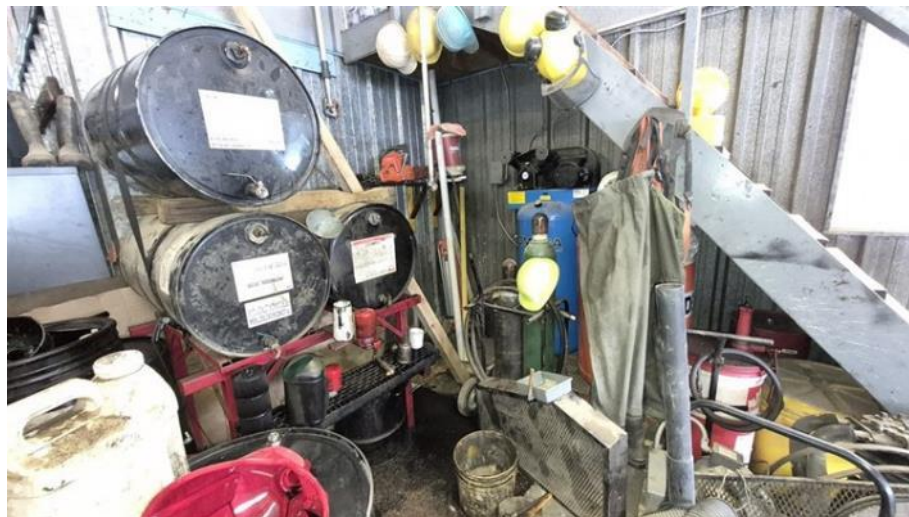
Photo 14: Municipal Garage – Lubricant Storage Obstructing Access to In-Floor Oil Interceptor

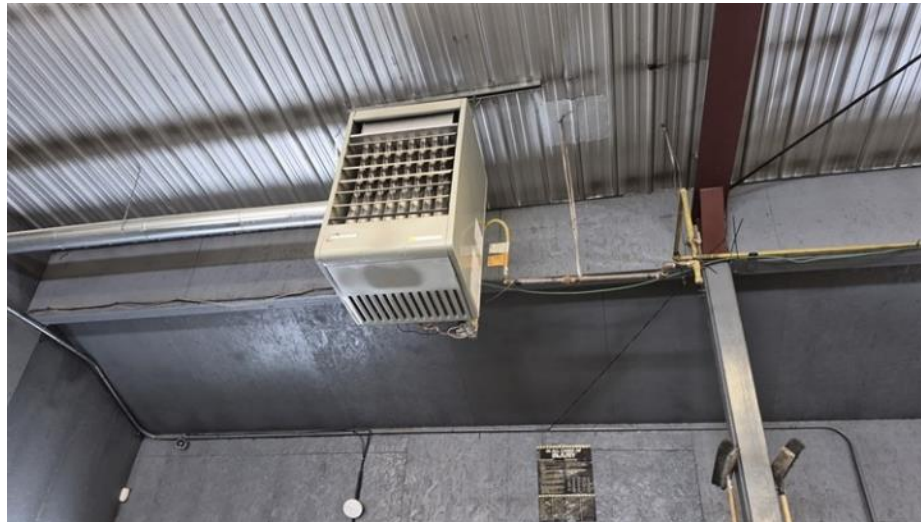
Photo 15: Municipal Garage – Existing Older Garage Area Unit Heater

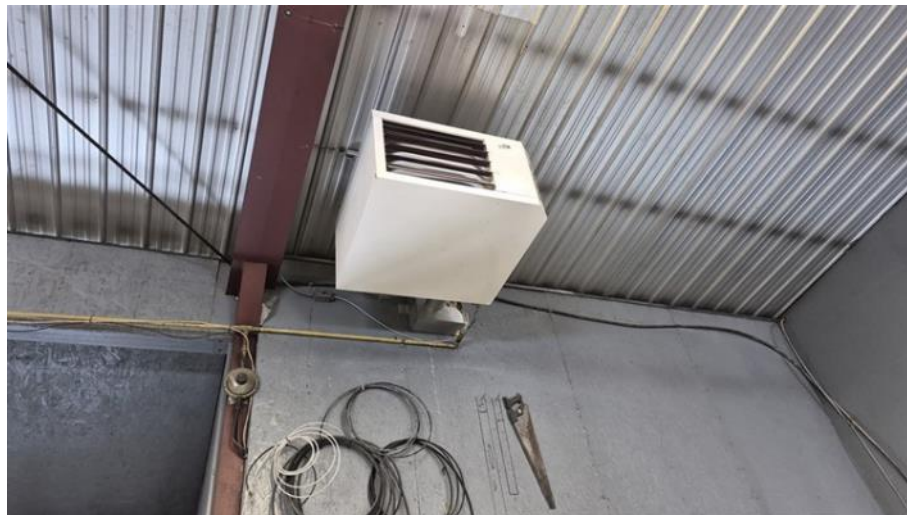
Photo 16: Municipal Garage – Existing Newer Garage Area Unit Heater

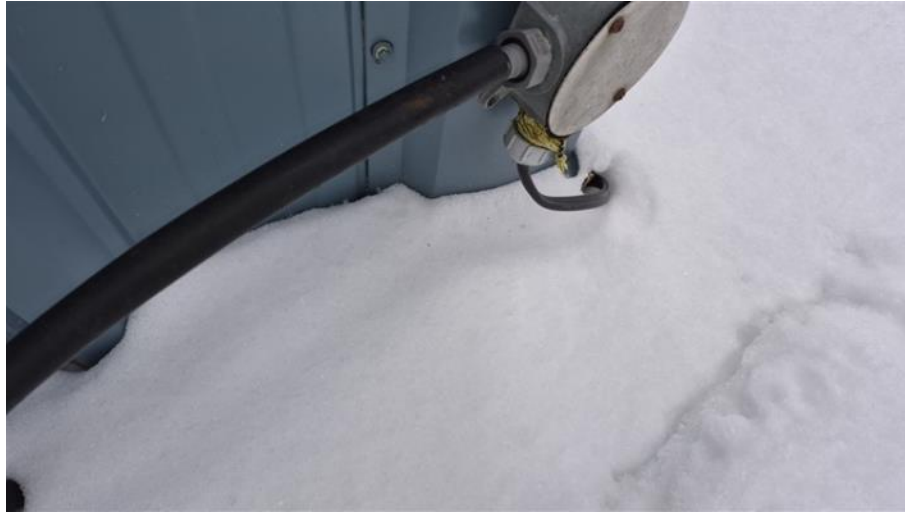
Photo 17: Municipal Garage – Existing Unprotected Power Cabling at Ground Level

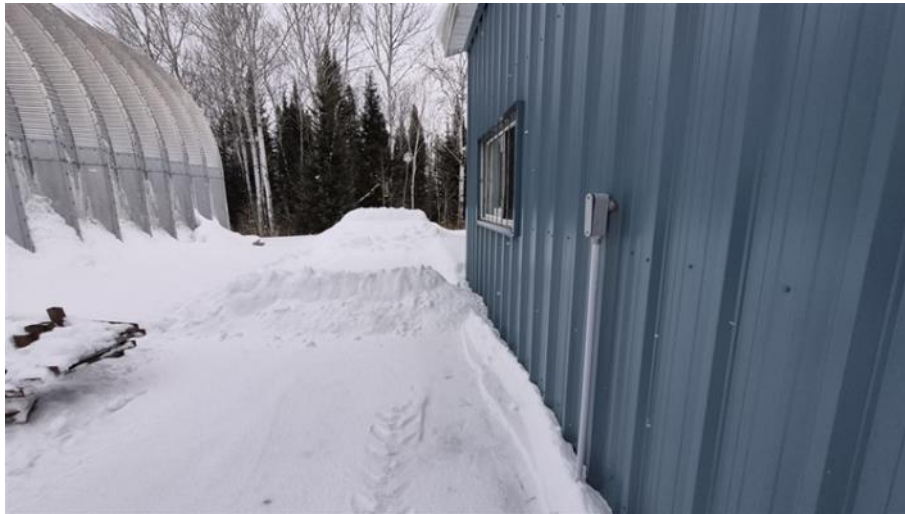
Photo 18: Municipal Garage – Existing Unprotected Power Conduit

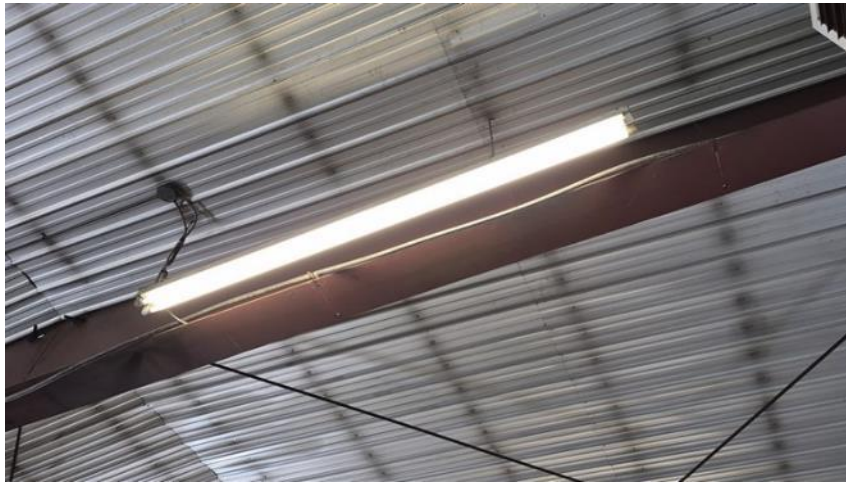
Photo 19: Municipal Garage – Existing Fluorescent Interior Lighting

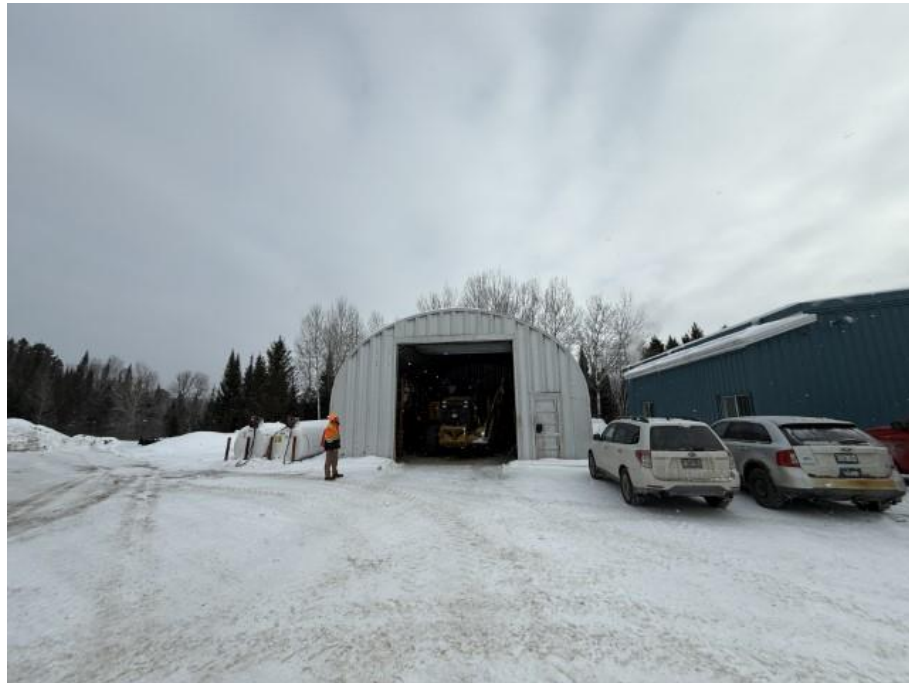
Photo 1: Quonset Hut –Overview

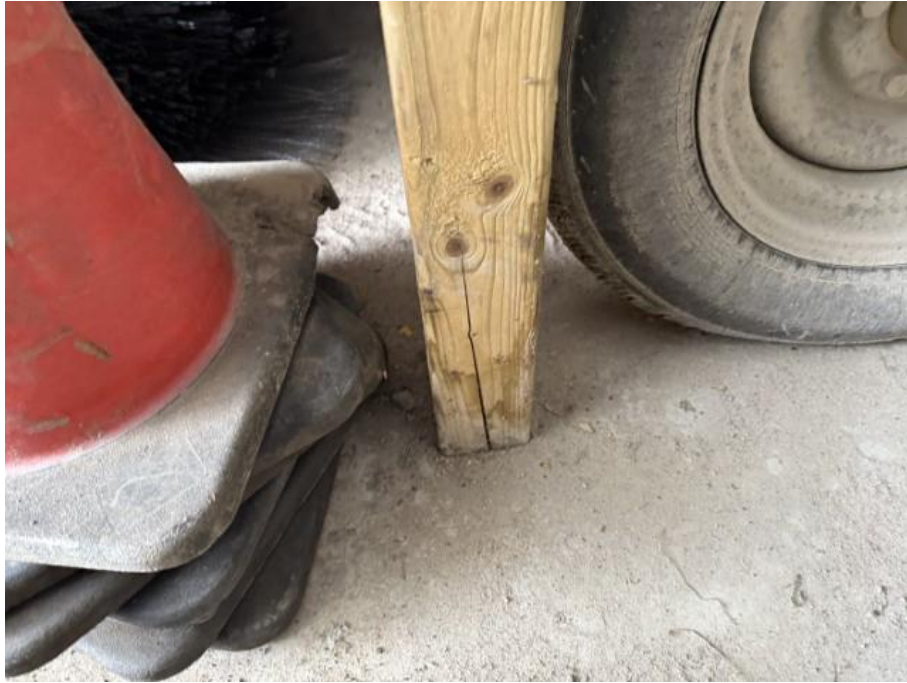
Photo 5: Quonset Hut – Typical Base of Landing Posts

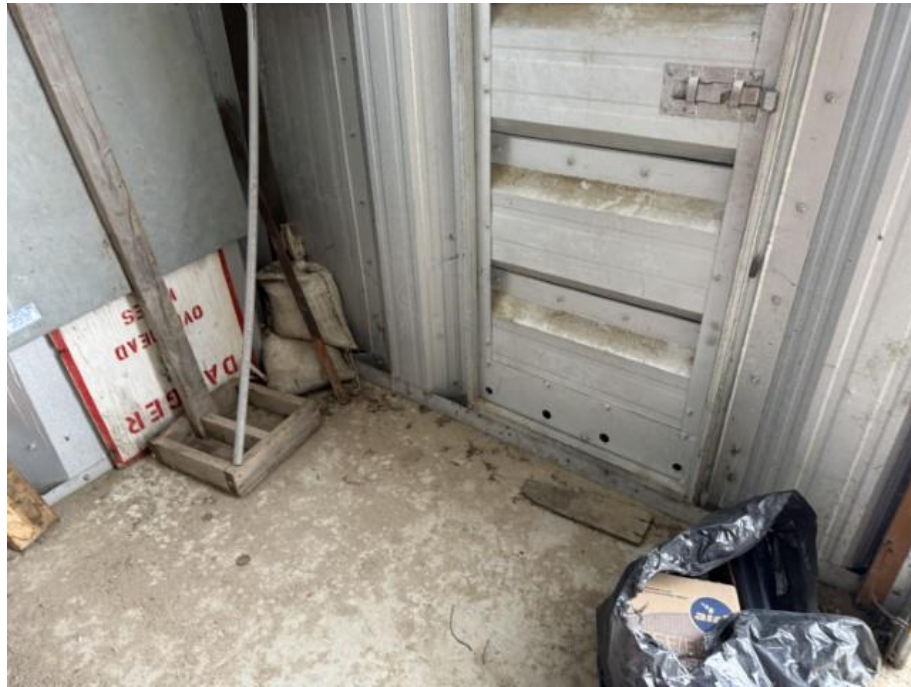
Photo 7: Quonset Hut - Man Door

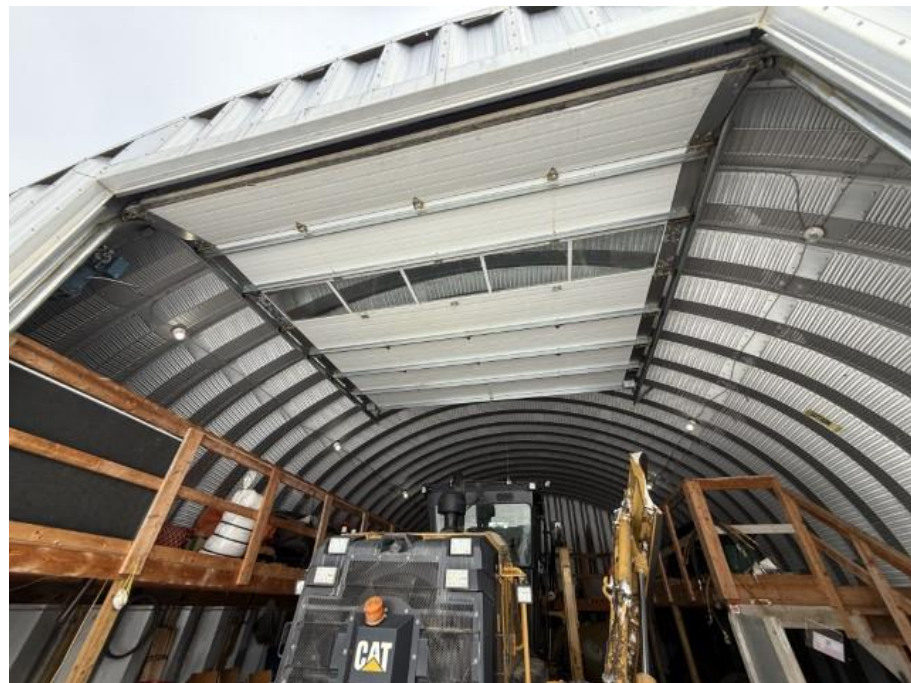
Photo 8: Quonset Hut – Overhead Door

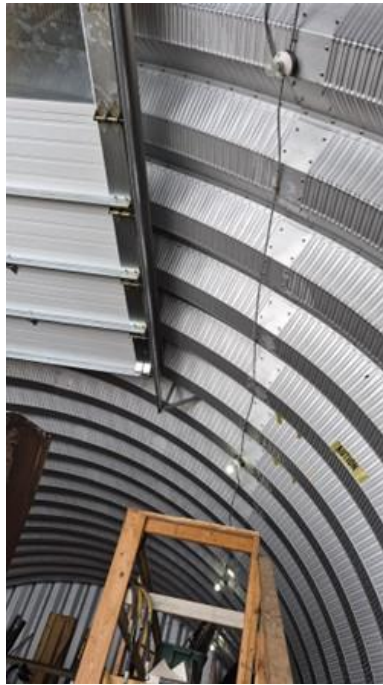
Photo 9: Quonset Hut – Existing Interior Lighting

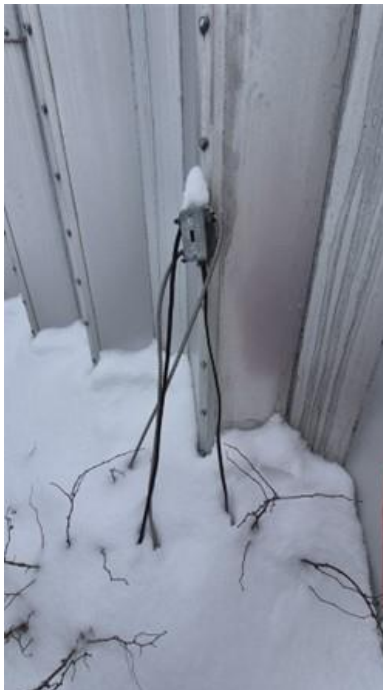
Photo 10: Quonset Hut – Existing Exterior Electrical Wiring

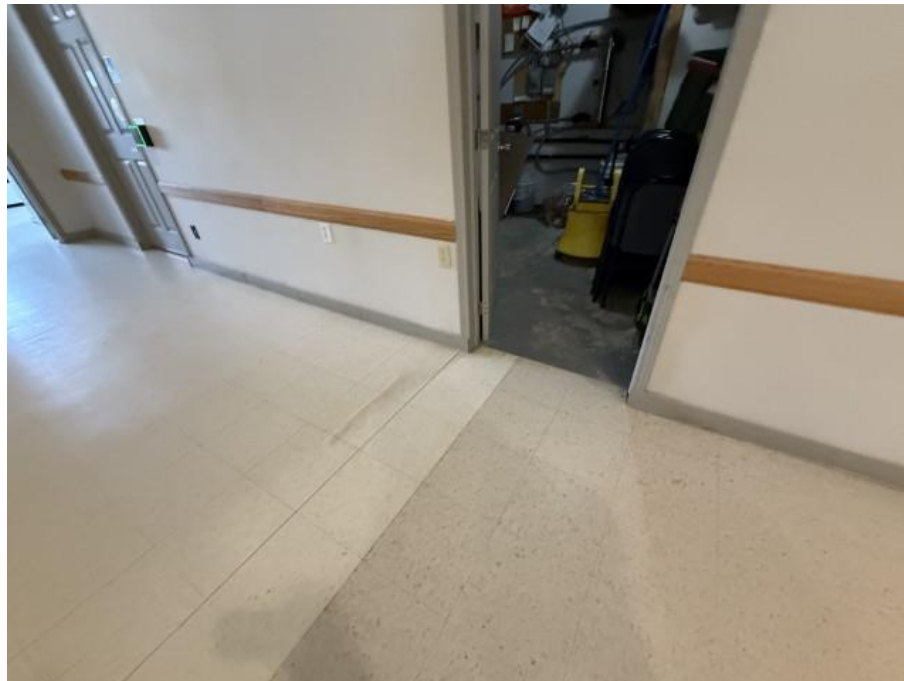
Photo 2: Recreation Hall – Slab-on-Grade Joint Displacement

We propose carrying an allowance for these likely localized slab repairs in the intermediate term, in the order of **\$5,0000 +H.S.T** in Q1 2026 dollars.

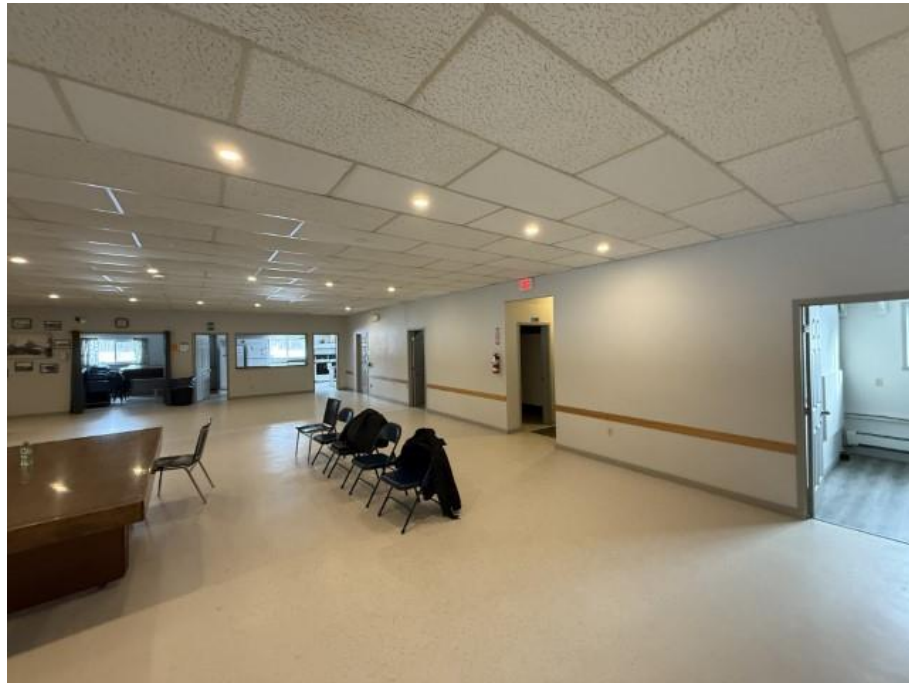
Photo 3: Recreation Hall – Overview of Interior Finishes

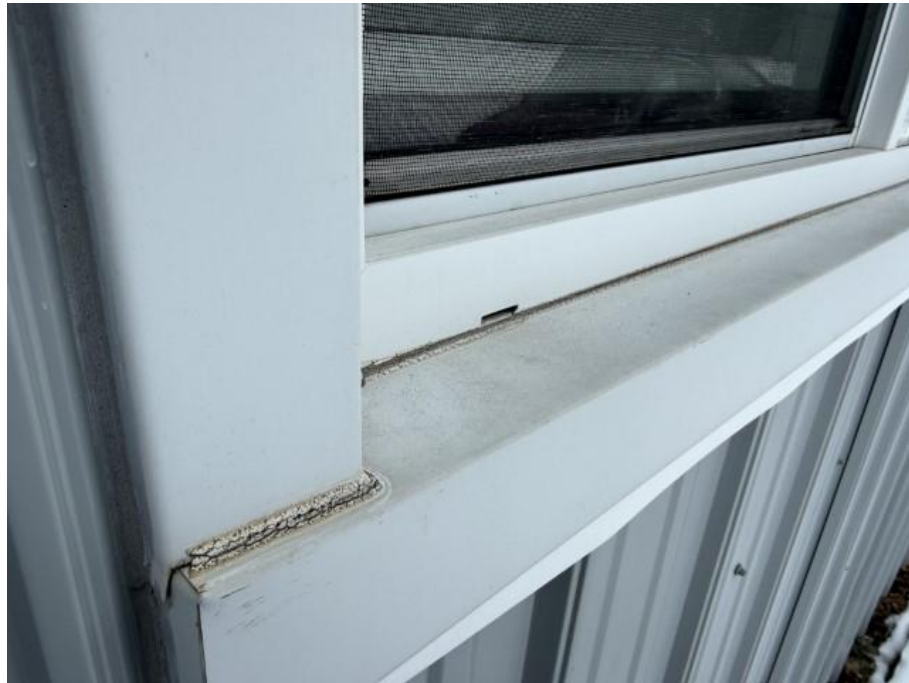
Photo 7: Recreation Hall – Windows and Sealant Exterior

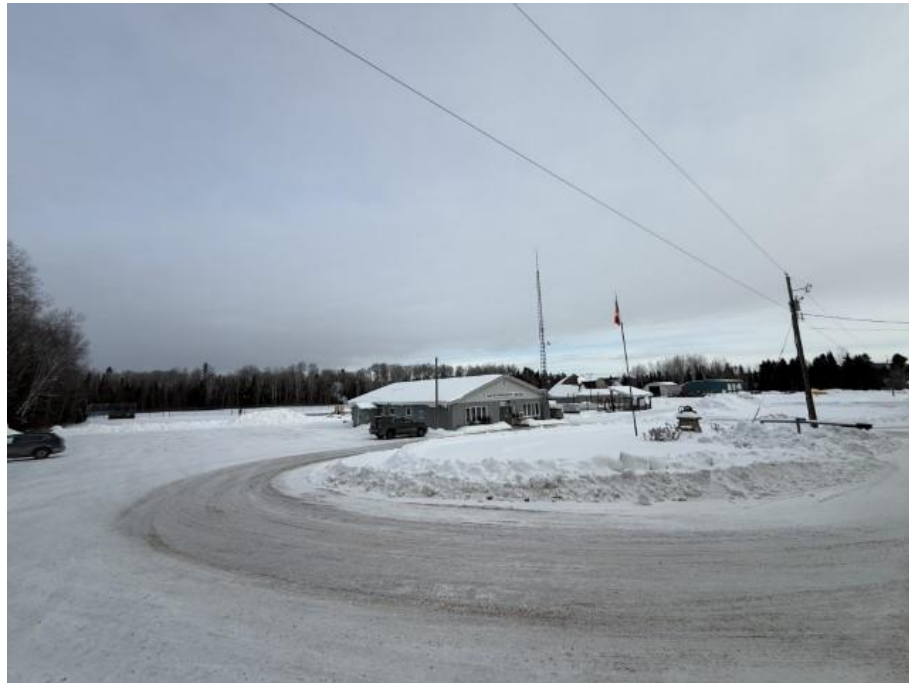
Photo 11: Recreation Hall – Overview of Covered Roof

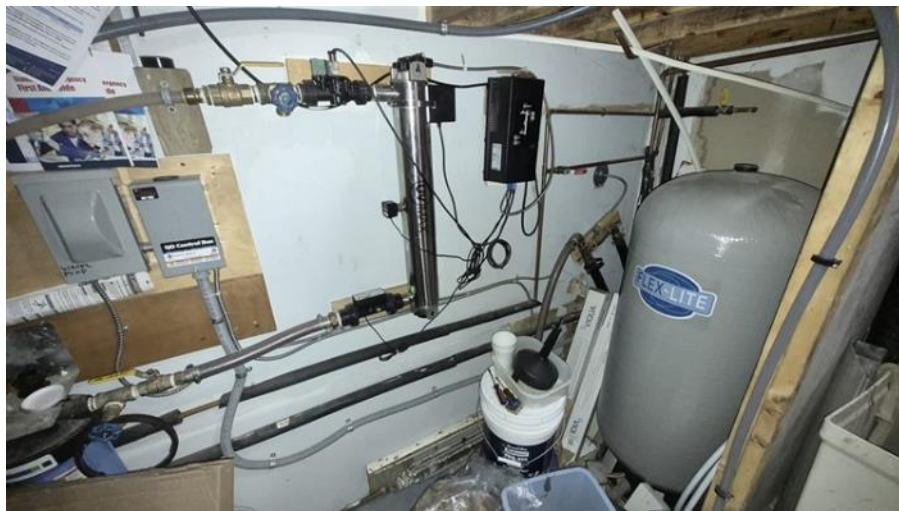
Photo 12: Recreation Hall – Existing UV Water Sterilizer and Associated Plumbing

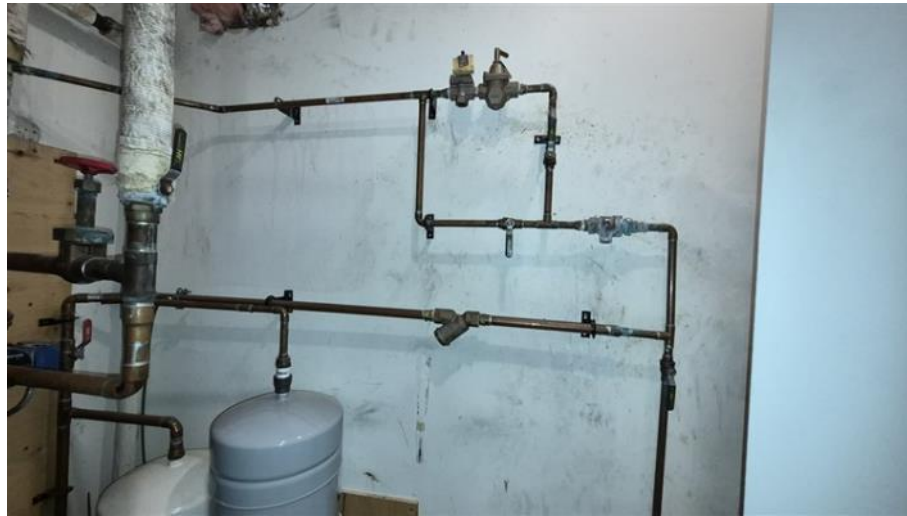
Photo 13: Recreation Hall – Domestic Hot Water Piping Interface to Heating Boiler

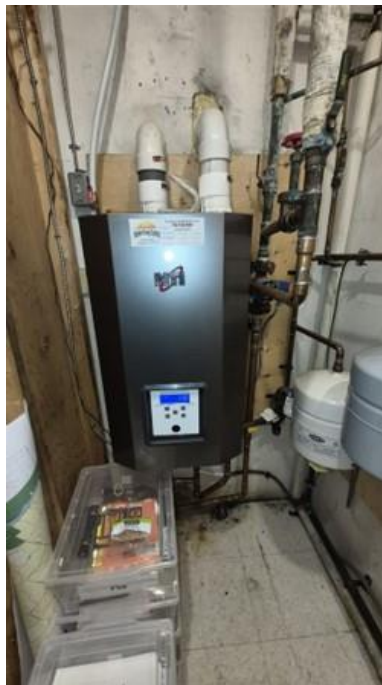
Photo 14: Recreation Hall – Heating and Domestic Water Boiler

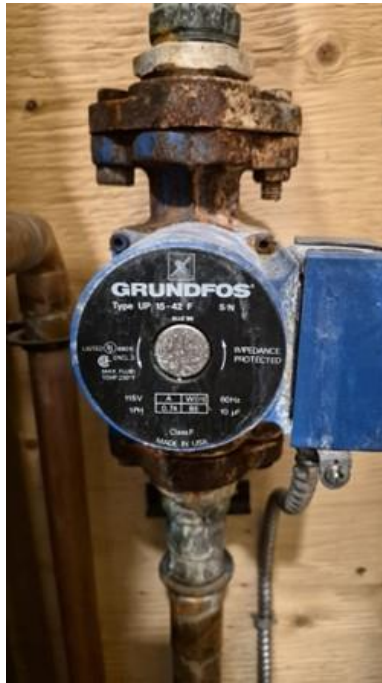
Photo 15: Recreation Hall - Heating Water Circulation Pump

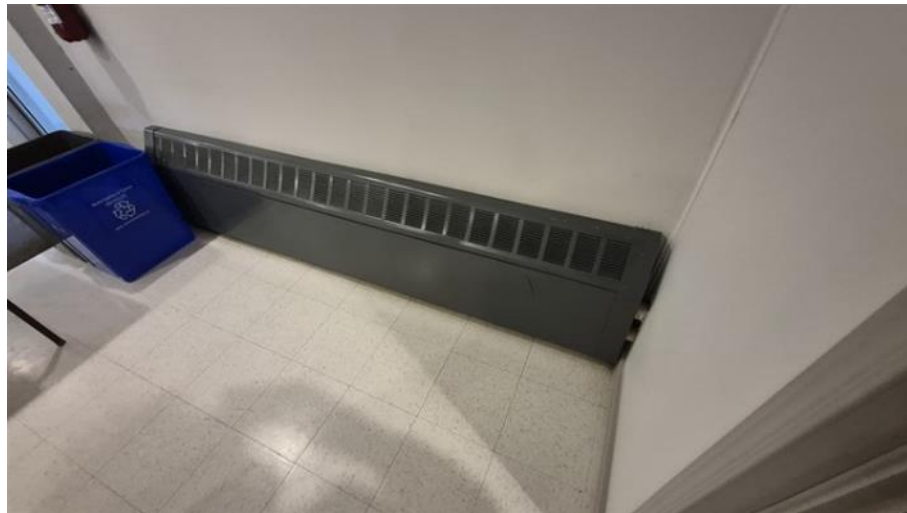
Photo 16: Recreation Hall – Typical Original Fin-Tube Hydronic Heating Convectors

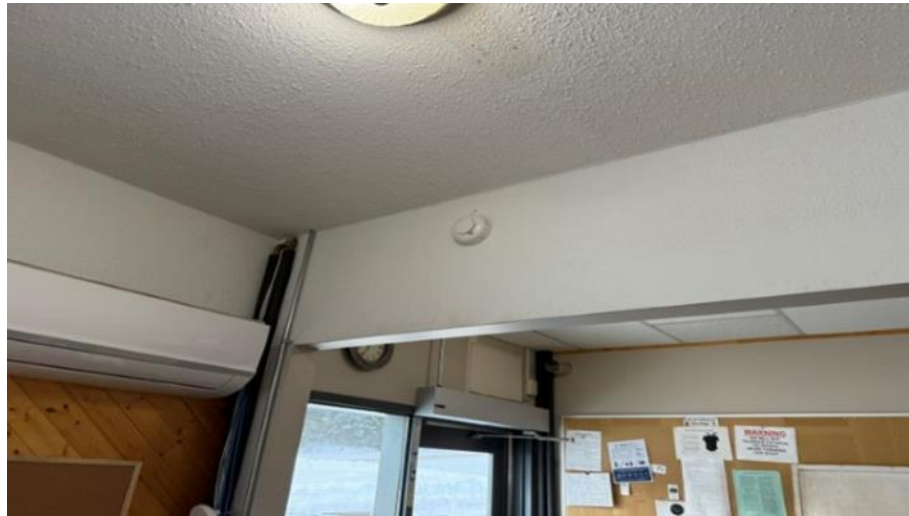
Photo 17: Recreation Hall – Local Smoke Detector. Typical for 2 such Detector Installations

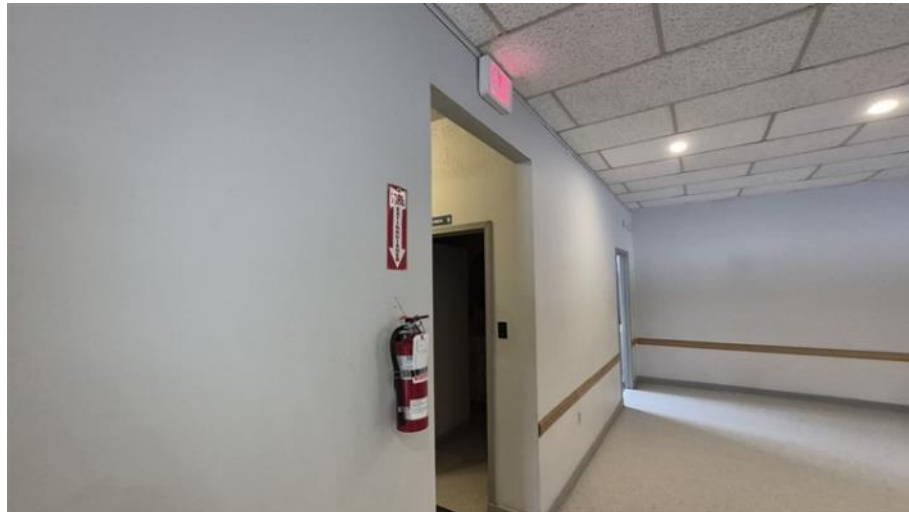
Photo 18: Recreation Hall – Typical Portable Fire Extinguisher

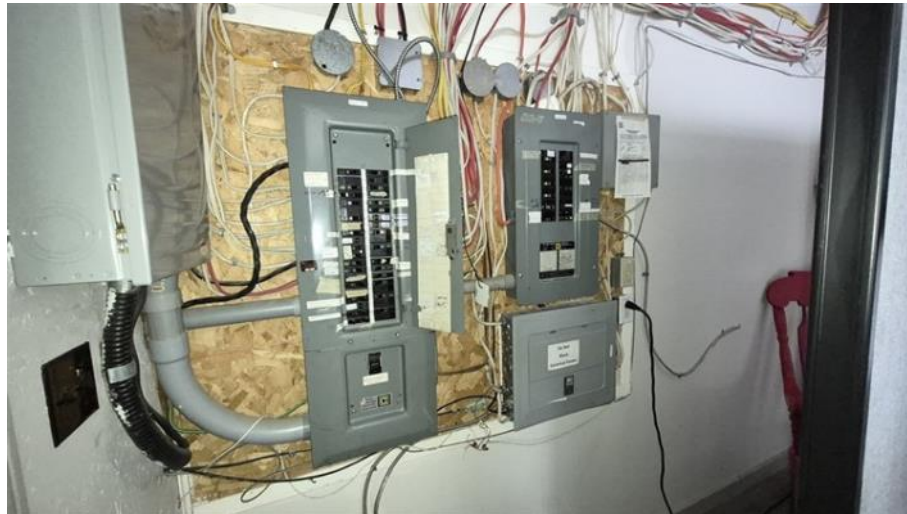
Photo 19: Recreation Hall – Existing Electrical Panels – Circuit Balancing and Identification

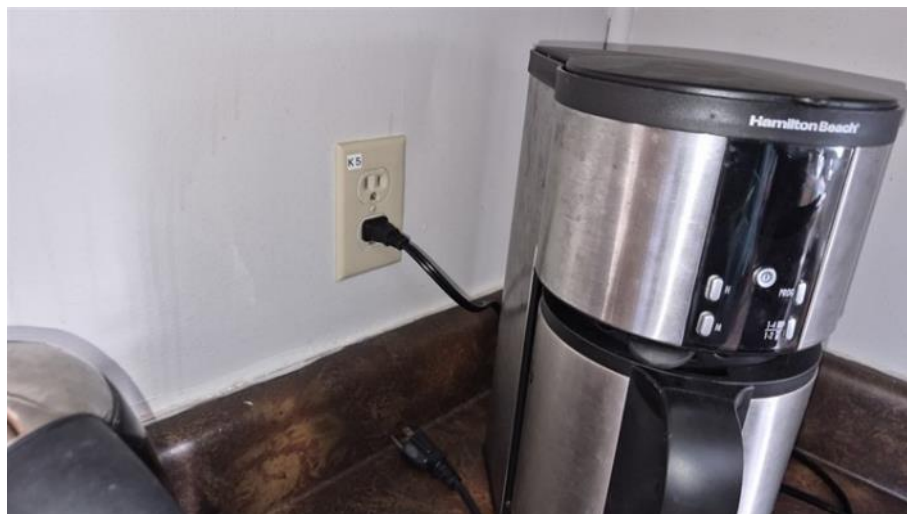
Photo 20: Recreation Hall – Kitchen Power Distribution – Circuit Balancing to permit Multiple Appliance Operation

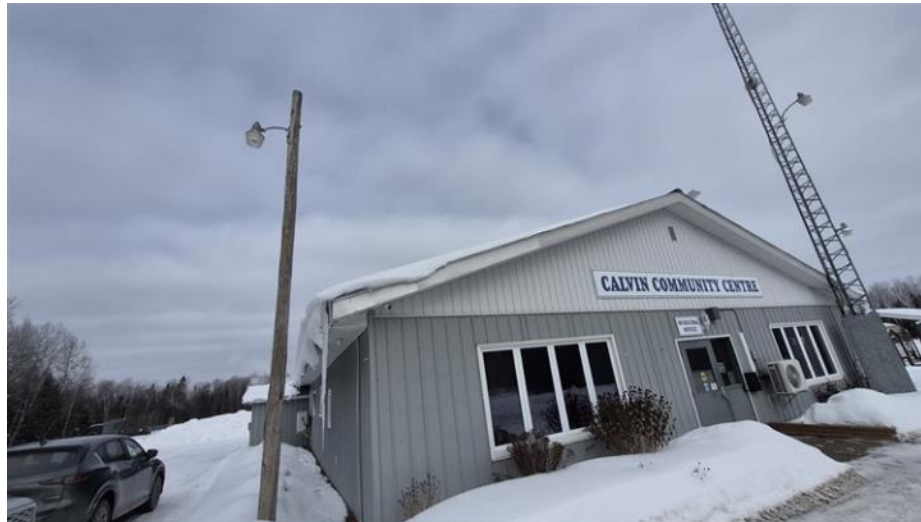
Photo 21: Recreation Hall – Existing HID Exterior Lighting

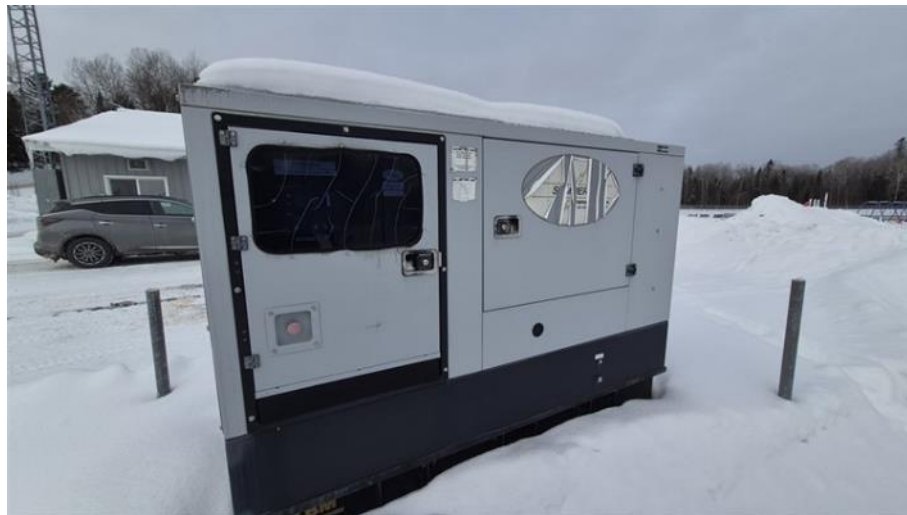
Photo 22: Recreation Hall – Existing Emergency Backup Power Generator

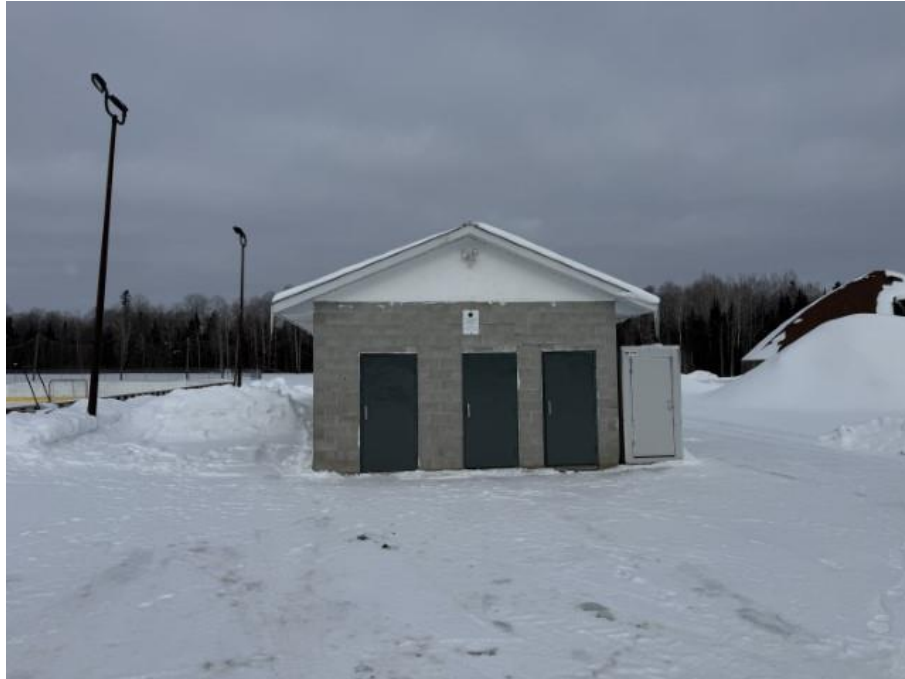
Photo 1: Changing/Storage Building - Overview

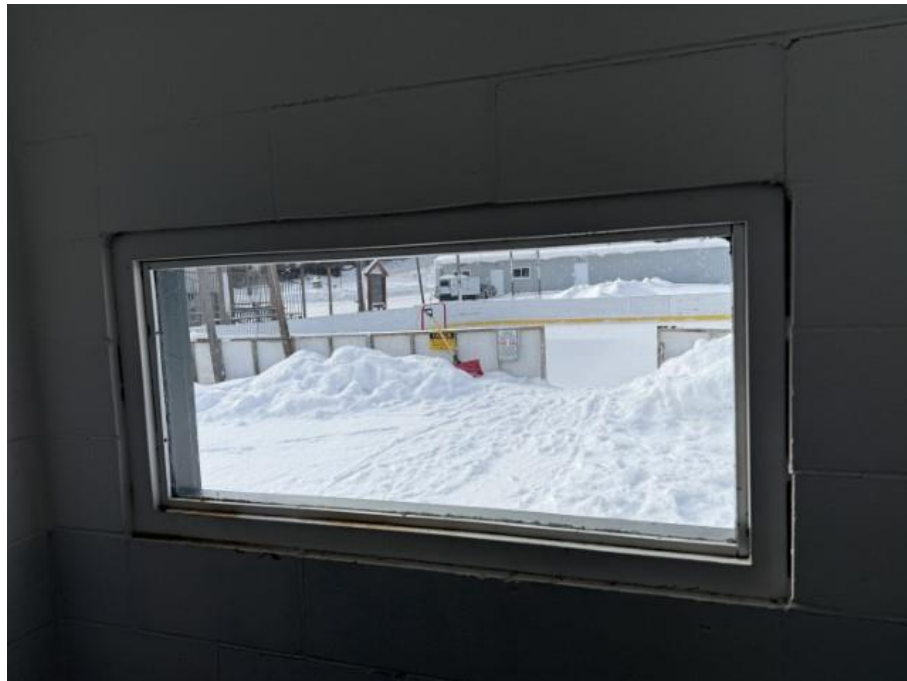
Photo 6: Changing/Storage Building - Windows
