Municipality of Calvin

1355 & 1238 Peddlers Drive Facility and Building Condition Assessment – Final

1355 & 1238 Peddlers Drive
Mattawa, Ontario

April 13, 2026
RJC No. KIN.143609.0001

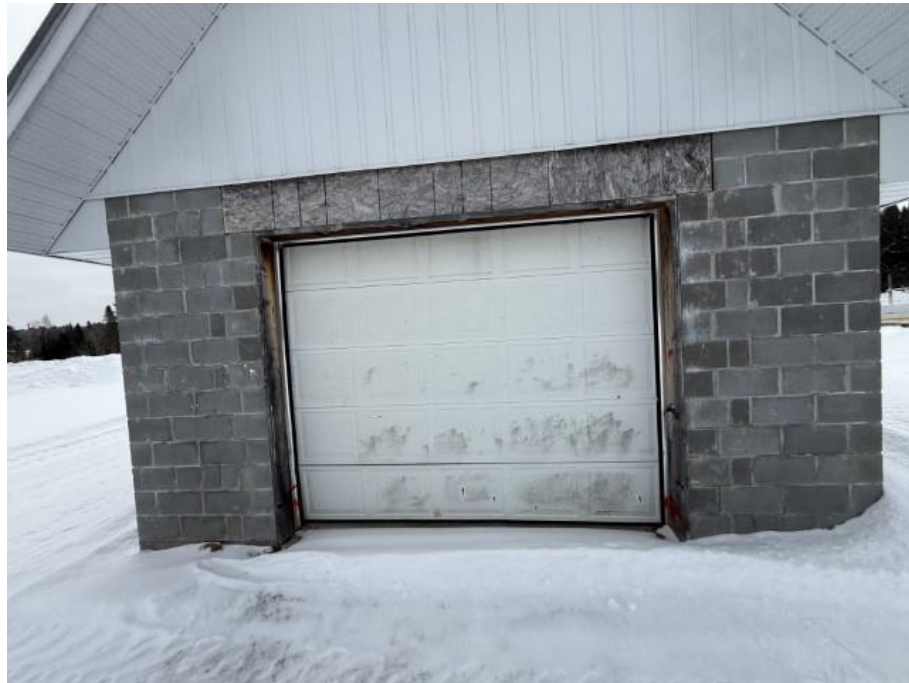
Photo 7: Changing/Storage Building – Garage Door

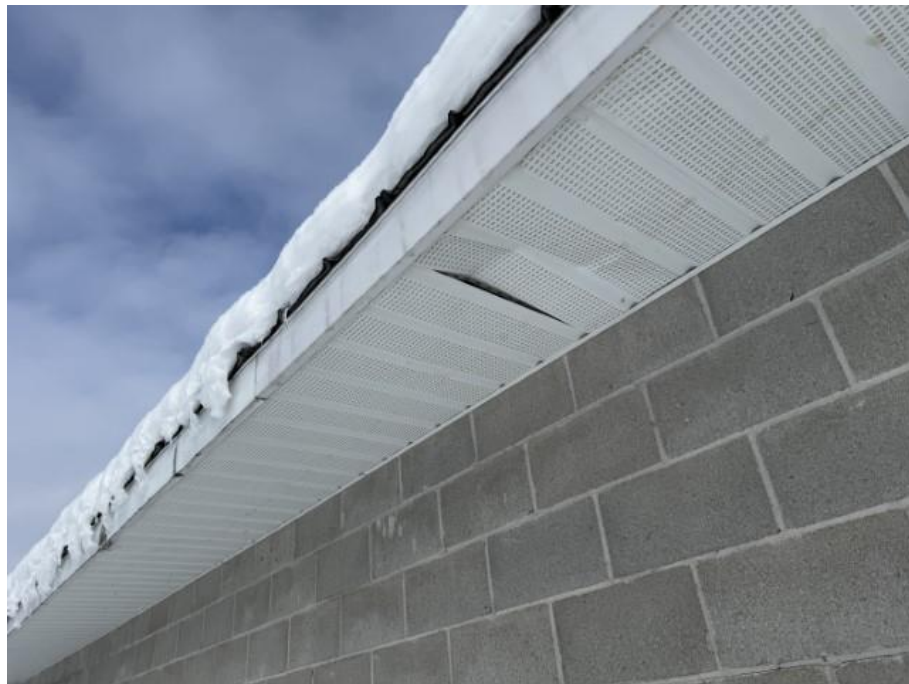
Photo 8: Changing/Storage Building – Metal Soffit

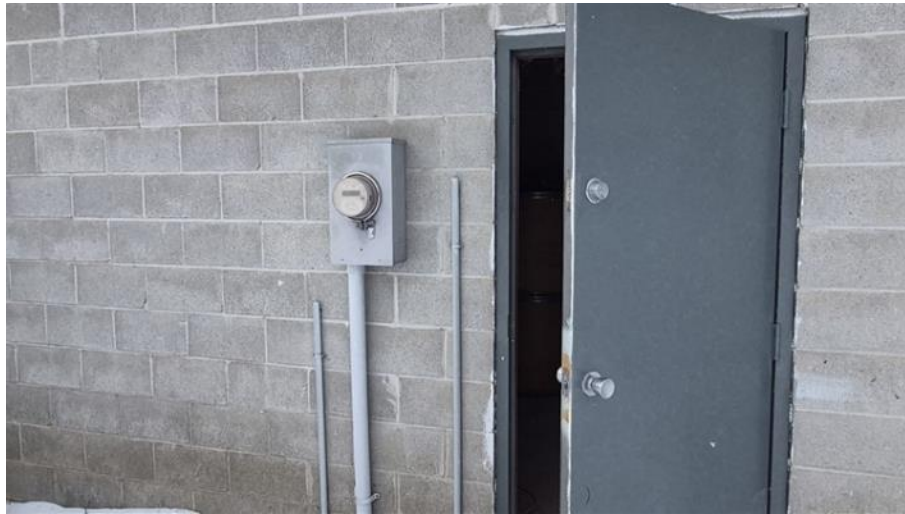
Photo 9: Changing/Storage Building - Electrical Power Service to Recreation Change Room

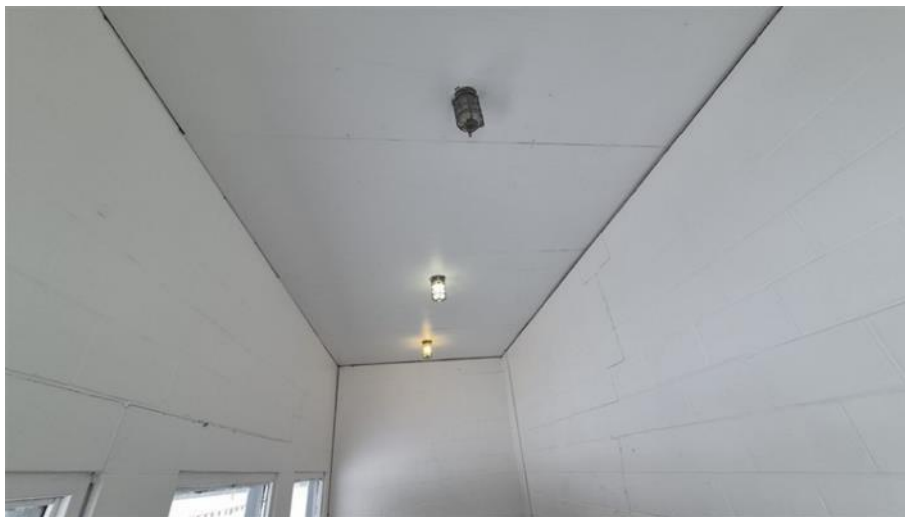
Photo 10: Changing/Storage Building – Changeroom Interior Lighting

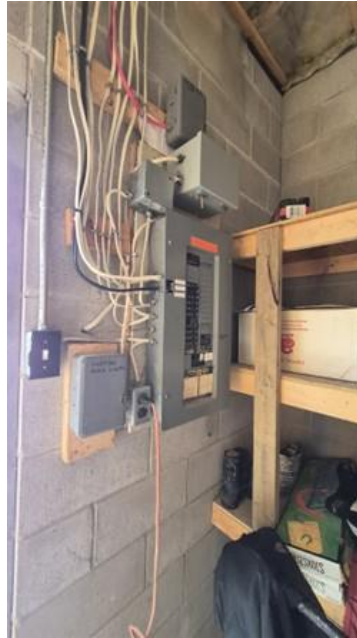
Photo 11: Changing/Storage Building – Electrical Power Distribution and Controls

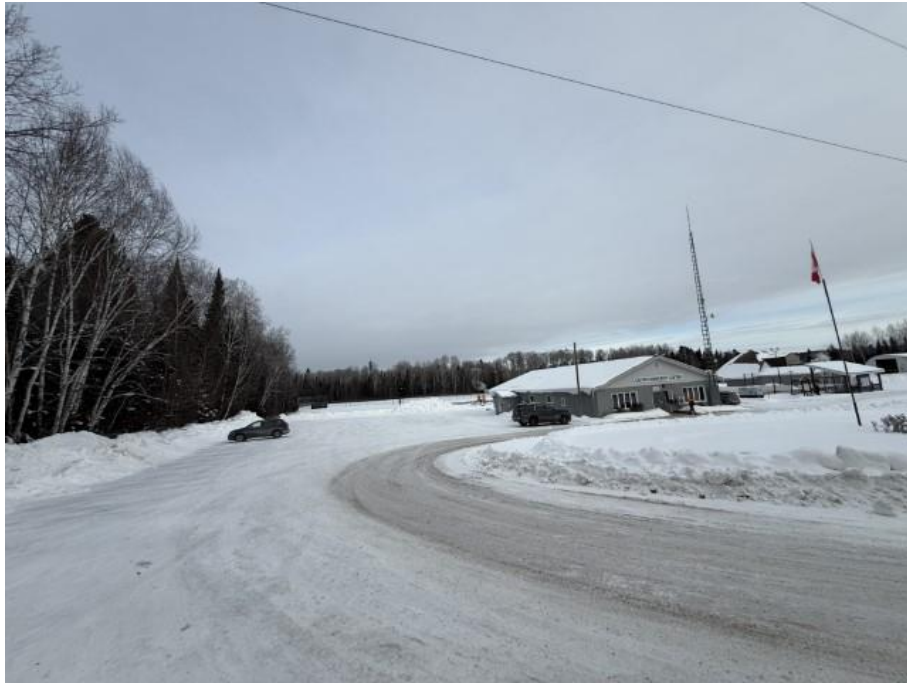
Photo 1: Main Parking Area

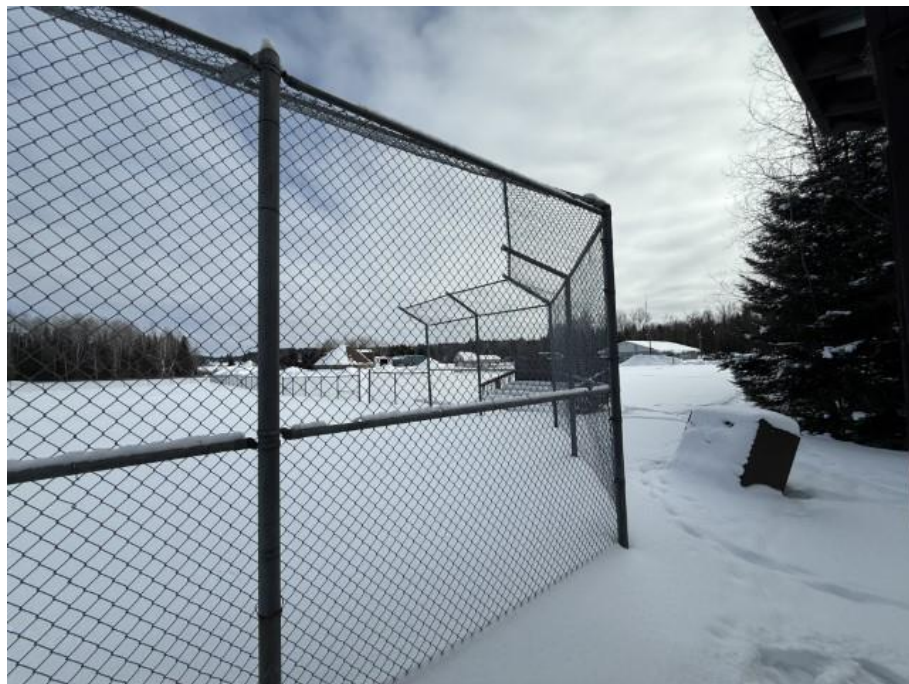
Photo 6: Overview of chain Link Fence

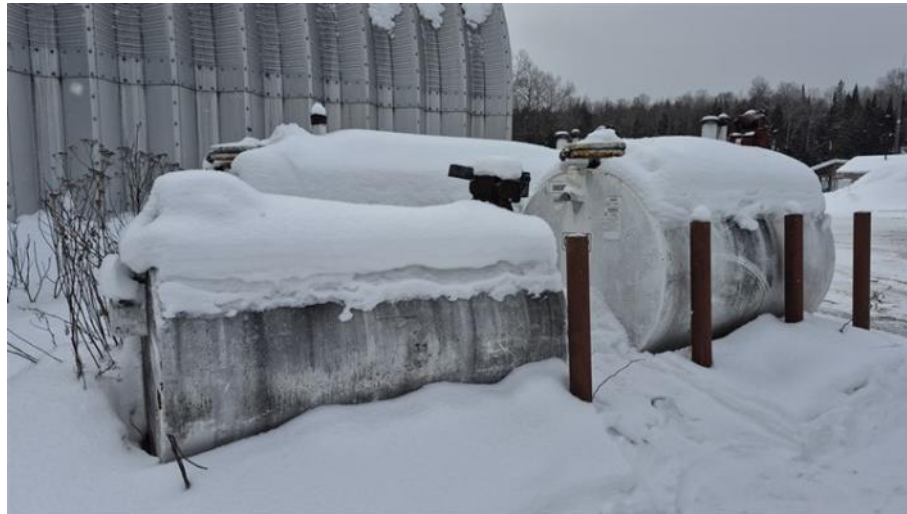
Photo 7: Diesel and Gasoline Bulk Storage Tank Farm

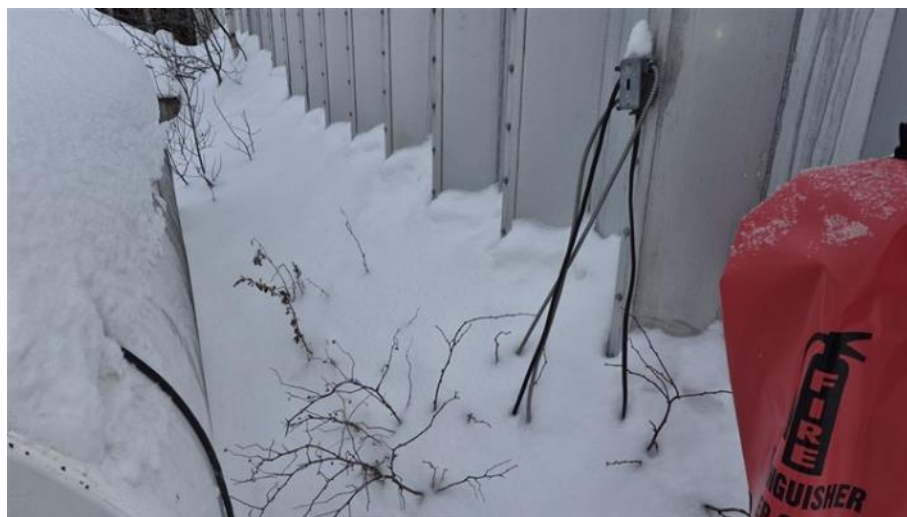
Photo 8: Diesel and Gasoline Tank Dispenser Pump Wiring

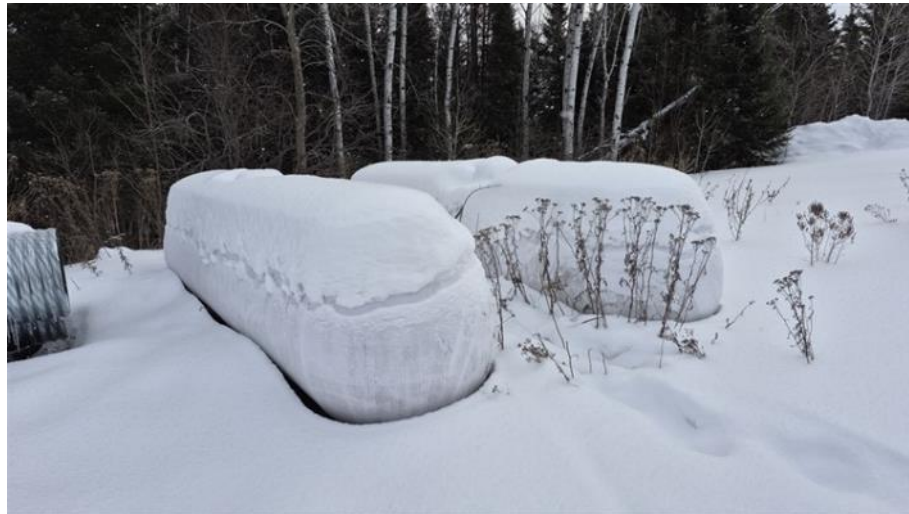
Photo 9: Garage Building Propane Fuel Tank Farm

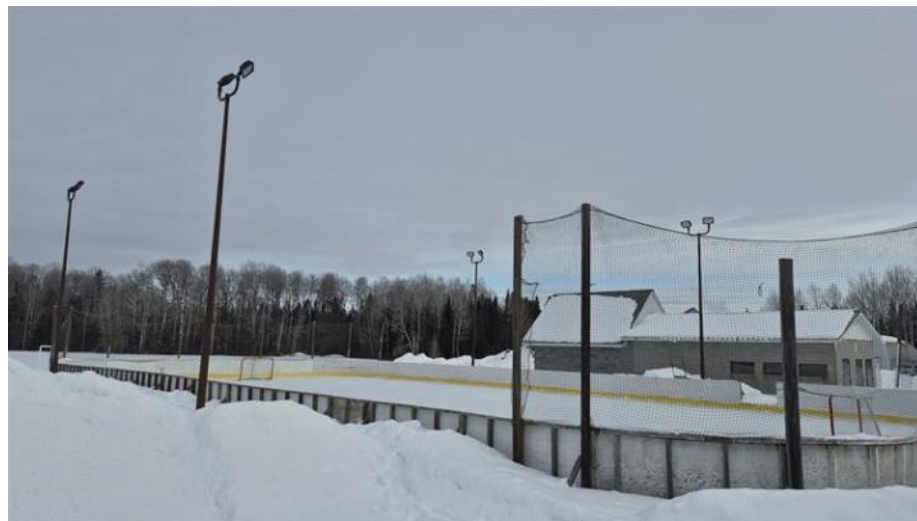
Photo 10: Ice Rink – LED Floodlighting
