Municipality of Calvin

1355 & 1238 Peddlers Drive Facility and Building Condition Assessment – Final

1355 & 1238 Peddlers Drive
Mattawa, Ontario

April 13, 2026
RJC No. KIN.143609.0001

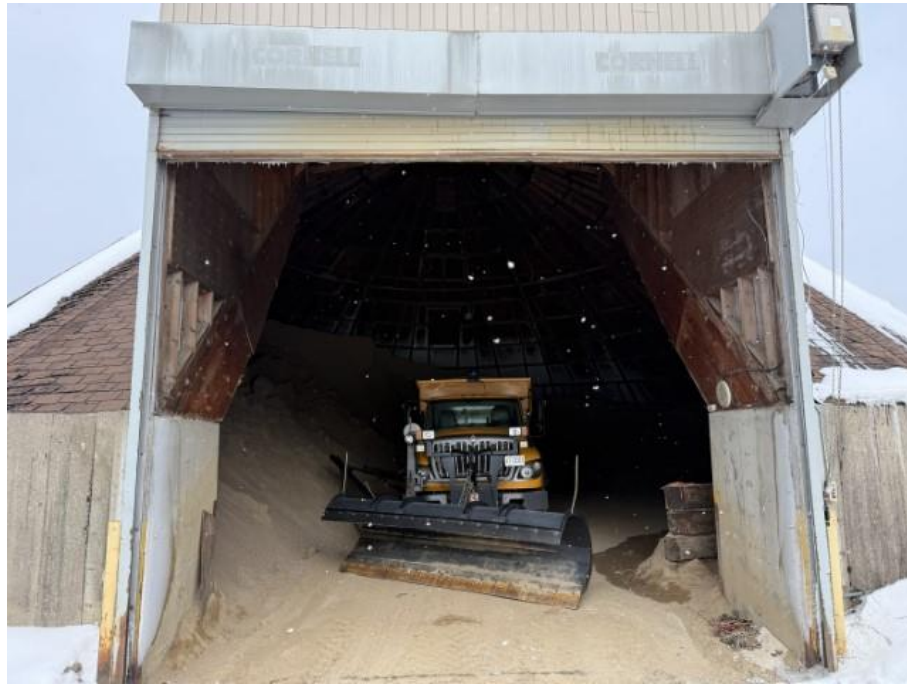
Photo 5: Sand Dome –Overhead Door

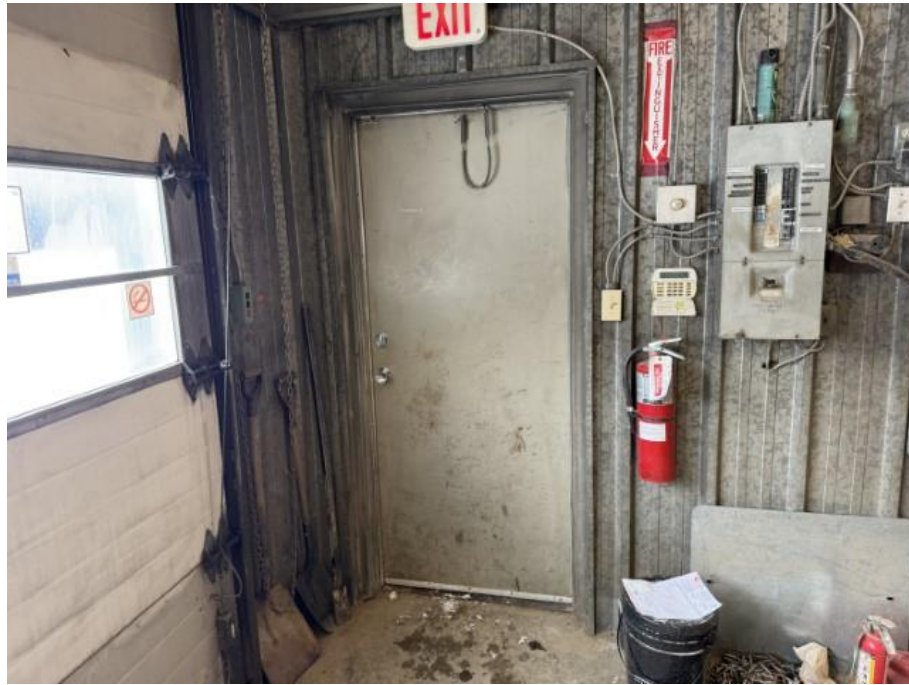
Photo 11: Municipal Garage – Overview of Man Door

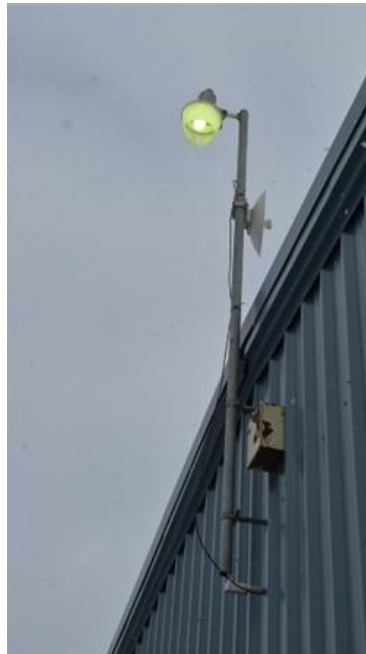
Photo 20: Municipal Garage – Existing HID Exterior Lighting.

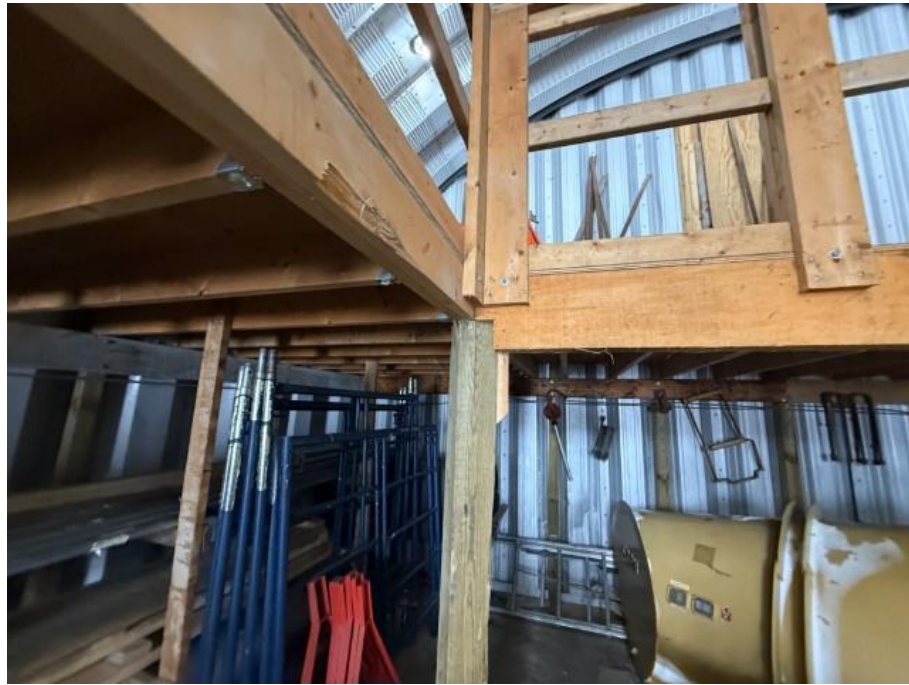
Photo 3: Quonset Hut – Overview of Landing Structure

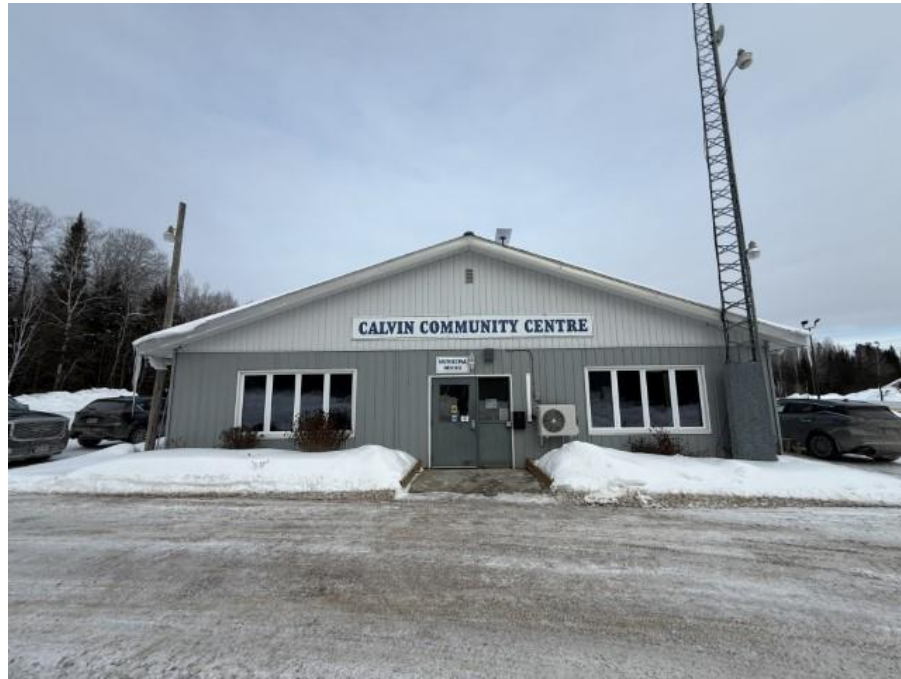
Photo 1: Recreation Hall – Overview

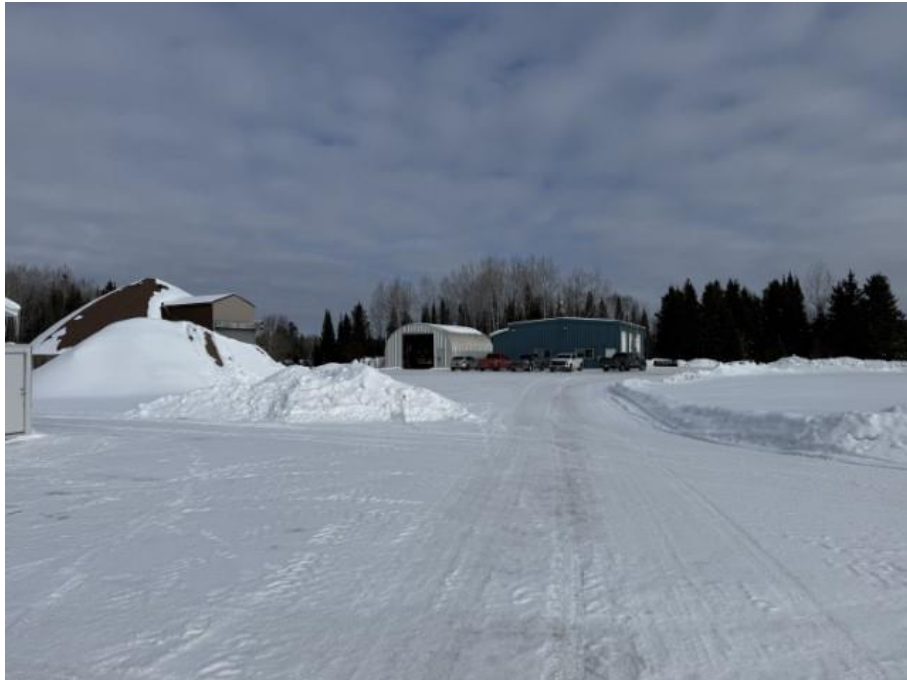
Photo 2: Additional Roadways and Parking Areas

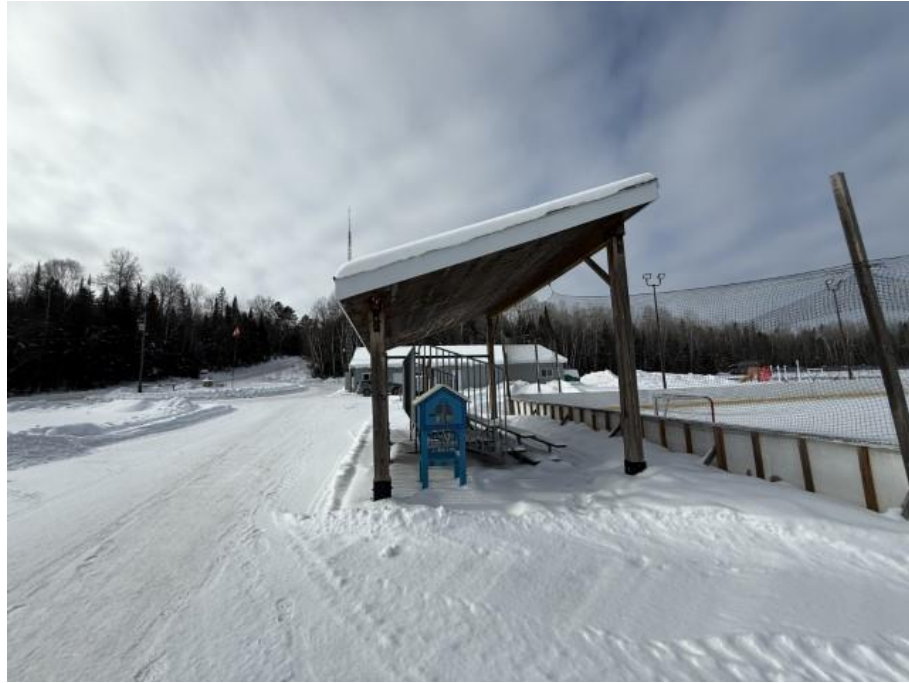
Photo 3: Rink Canopy and Bleacher

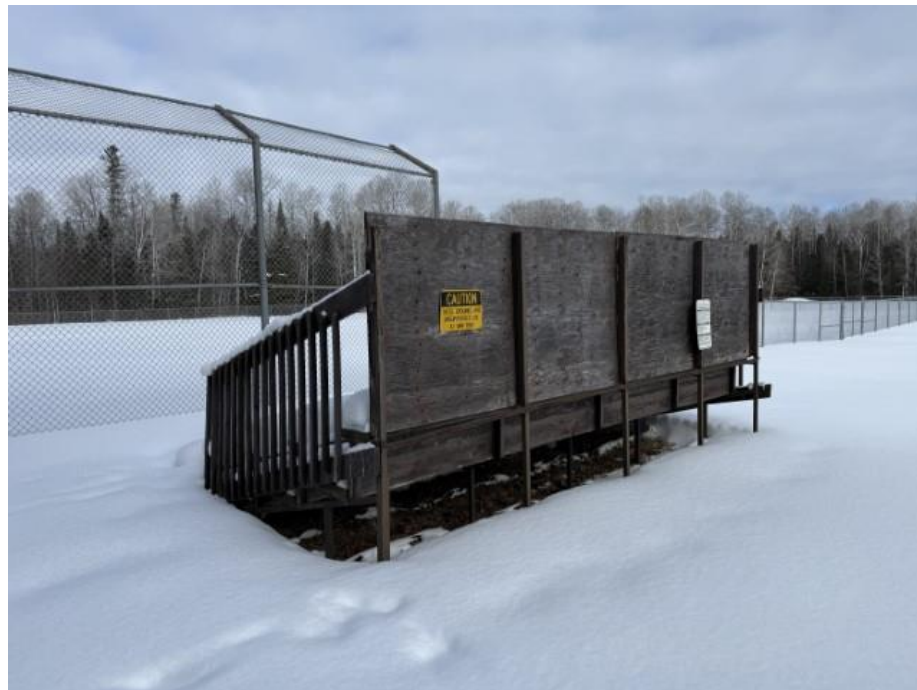
Photo 4: Uncovered Baseball Bleacher

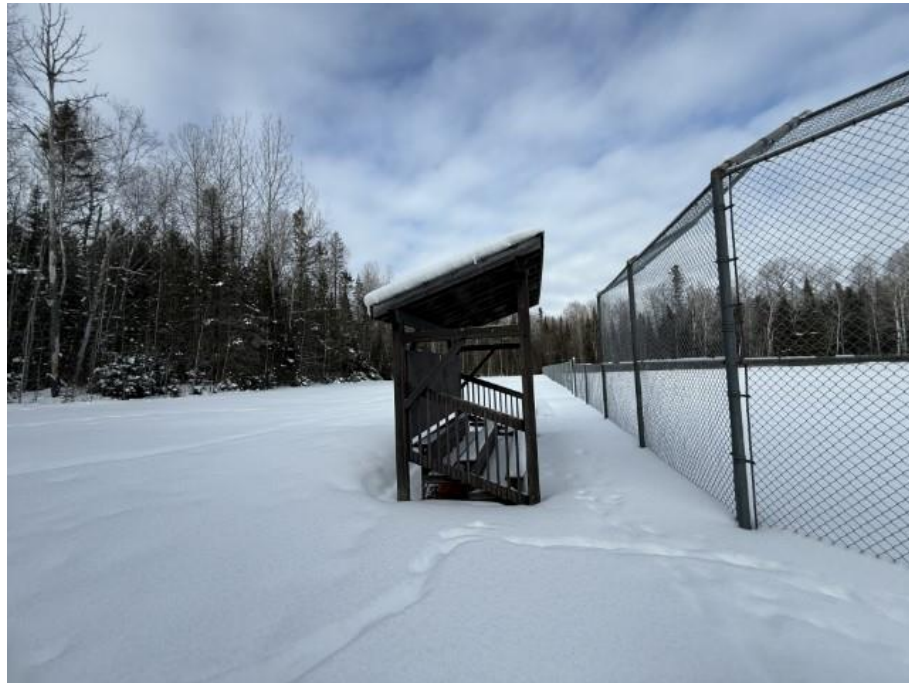
Photo 5: Covered Baseball Bleacher
